ROADWAY SAFETY AUDIT

Eagle Drive, from North Texas Boulevard
to Bell Avenue

City of Denton

North Central Texas
Council of Governments

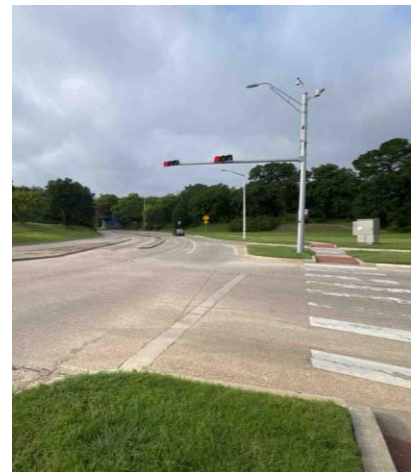
Figure 6 – Example of Faded Pavement markings

During the in-field visit, safety deficiencies were observed in the corridor, including faded pavement markings, sidewalk gaps (areas where the sidewalk is missing), overgrown vegetation, bus stops in need of improvement, and insufficient lighting. Pavement markings, such as lane markings, stop bars, and crosswalks, were faded in places. Faded pavement markings, such as those shown in **Figure 6**, can confuse drivers, especially at night, when it is difficult to see the division between lanes.

One of the most common observations on the corridor was faded pavement markings and the absence of some turn lane arrows. The RSA Team recommends that all crosswalks and pavement markings be refreshed. At key intersections (signalized or high pedestrian crossings), it is recommended to install high-visibility crosswalks (**Figure 17**). This would aid in pedestrian visibility at intersections. Pavement markings to be refreshed would also include stop bars at intersections and the installation of edge lines along the corridor.

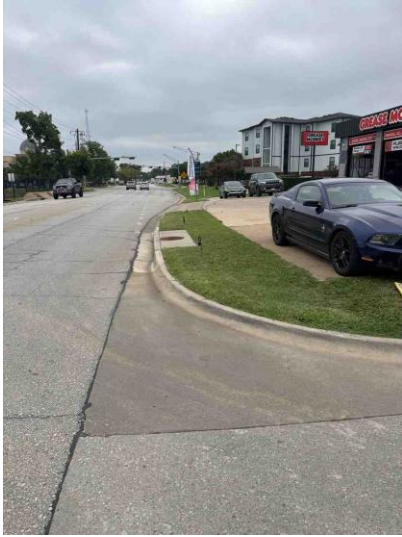
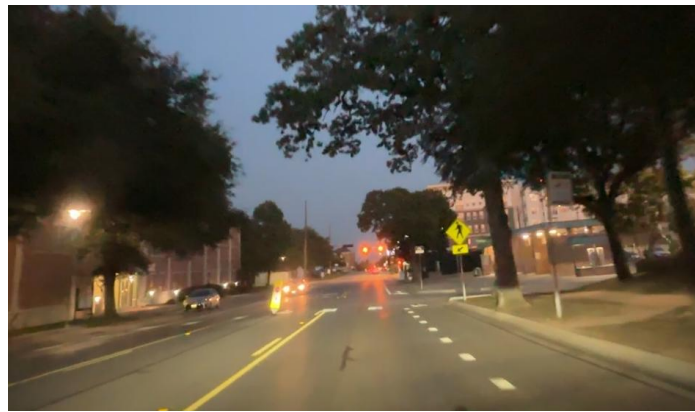
Figure 10 – Example of Missing Lighting

Insufficient lighting exists on one side of the corridor for the entire duration of the corridor. During the nighttime site visit, it was apparent that the existing luminaires do not provide sufficient lighting for the corridor, resulting in poor driver visibility. **Figure 10** shows a section of the corridor that is missing lighting.

The corridor is lacking in lighting coverage since the existing luminaires are only on one side of the corridor and are not sufficient at some crosswalks. The RSA Team recommends that a lighting study be conducted to ensure proper coverage of roadway and pedestrian facilities (Figure 21). By increasing corridor lighting, visibility of the roadway at nighttime will be enhanced, allowing for increased driver awareness along the corridor.

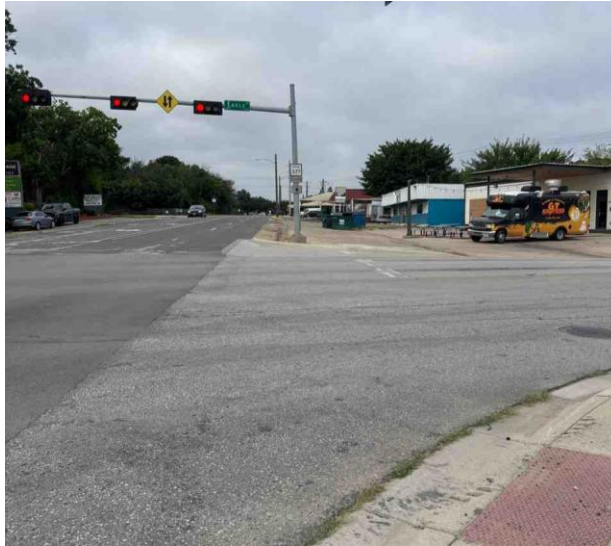
Figure 11 – Example of Missing Crosswalks

At intersections, both signalized and stop-controlled, there are missing or faded crosswalk markings, non-directional curb ramps, and missing detectable warning surfaces. Faded or missing crosswalks (**Figure 11**) were frequent throughout the entire corridor. Refreshing existing high-visibility crosswalks and installing them where they are missing allows for increased visibility of upcoming crosswalks and pedestrians using them.

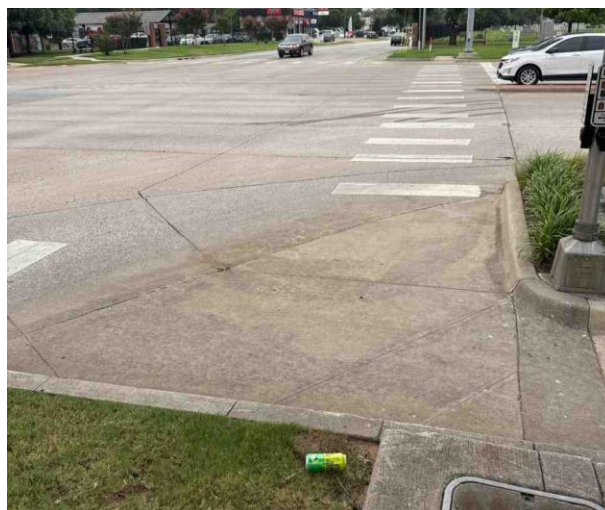
Figure 12 – Example of Faded Crosswalk Markings and a Non-Directional Curb Ramp

Several intersections have diagonal curb ramps, as shown in **Figure 12**. At some of these crossings, the curb ramps have old-style detectable warning surfaces or are missing them. These curb ramps may direct pedestrians with visual disabilities toward the center of the intersection, posing a safety hazard.

Throughout the corridor, several intersections had either non-accessible or missing curb ramps. To create safe crossings for vulnerable road users, it is recommended that directional, accessible curb ramps with detectable warning surfaces be installed where necessary. **Figure 19** shows a typical example of these curb ramps.

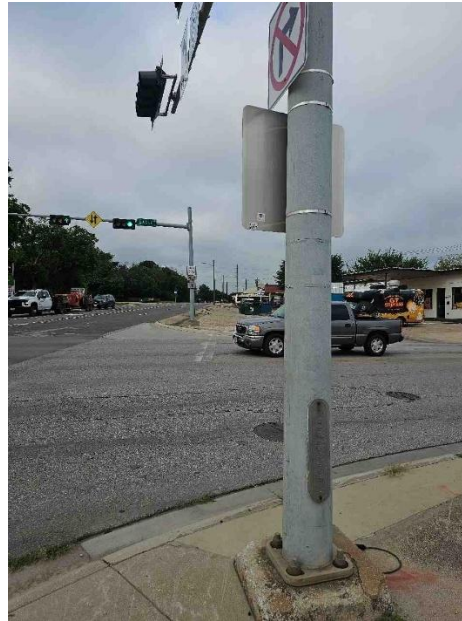
Figure 13 – Example of Missing Push Button

At Carroll Boulevard and intersections to the east, the pedestrian signals need improvement. The pedestrian push buttons are older style with fewer accessibility functions or are missing, as shown in **Figure 13**. Installing accessible pedestrian signals (APS) with push buttons enables increased communication with individuals who are visually or audibly impaired.

At signalized intersections, it was observed that the pedestrian equipment consisted of older-style push buttons, rather than APS. The RSA Team recommends that accessible pedestrian signals (**Figure 20**) be installed at all signalized crossings. This will also relocate the pedestrian signals closer to the crosswalks and replace faded signage.

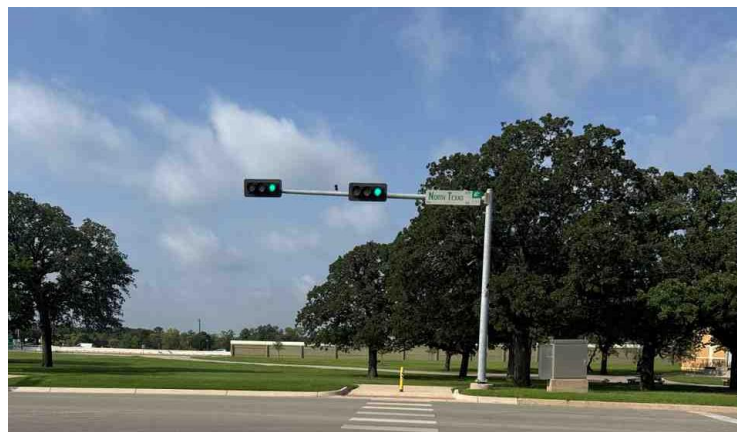
Figure 14 – Example of Missing Retroreflective Backplates

Many intersections along this corridor do not have retroreflective backplates on the signal heads shown in **Figure 14**. Adding a reflective border around the signal head increases visibility of the traffic signals, especially at night or in poor weather conditions.

At various signalized intersections on the corridor, it is recommended to install retroreflective backplates (**Figure 18**) on all signal heads to increase driver awareness when approaching the intersection, especially at night or in certain weather conditions. Retroreflective backplates are currently not present on all signal heads at the signalized intersections.

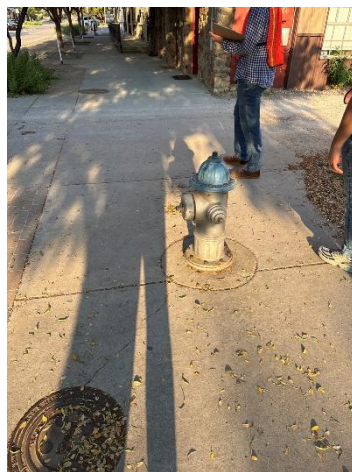
During the in-field visit, safety deficiencies were observed in the corridor, such as obstructed sidewalks, turning movements that might result in conflict, insufficient lighting, and bus stops that needed improvement. Obstructed sidewalks exist on both ends of the corridor, but they are more prevalent east of Locust Street. Sidewalk obstructions include fire hydrants, vegetation, and utility features as shown in **Figure 5**. These sidewalk obstructions narrow the pedestrian paths and may create mobility challenges for some users.

(A) Fire hydrant on the north side of the corridor, east of Oakland St

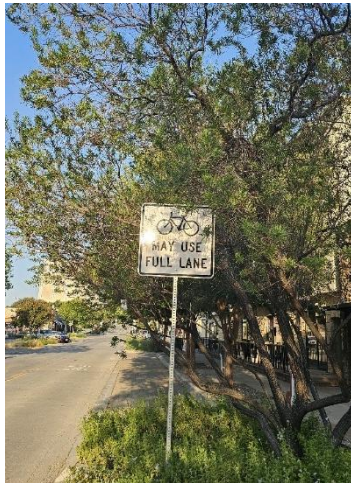
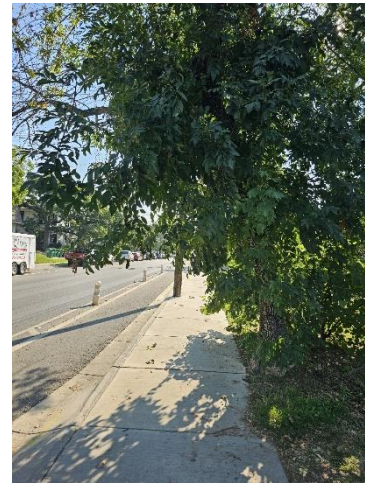
Figure 6 - Example of Overgrown Vegetation

In addition to sidewalk obstructions, other deficiencies were observed. Overgrown vegetation and other debris obstructing signs and signals were consistent observations along the corridor. At some intersections the overgrown vegetation obstructed the visibility and sight distance of traffic signals and signs, specifically at the S. Bell Avenue intersection, as shown in **Figure 6**.

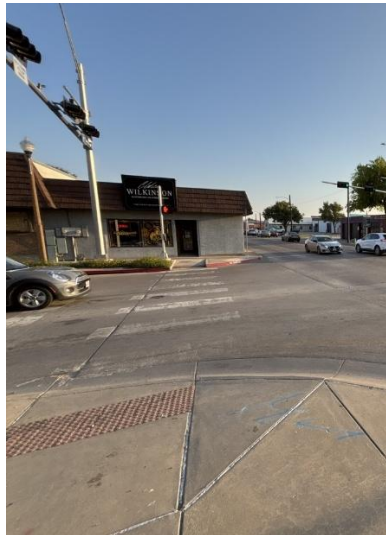
At intersections, both signalized and stop-controlled, there was a lack of crosswalks, existing marked crosswalks were faded, or directional curb ramps with detectable warning surfaces were missing. Faded or missing crosswalks were frequent along the entire corridor, more specifically east of the Carroll Boulevard intersection (**Figure 8**).

(A) Faded Crosswalk at S Bell Ave.

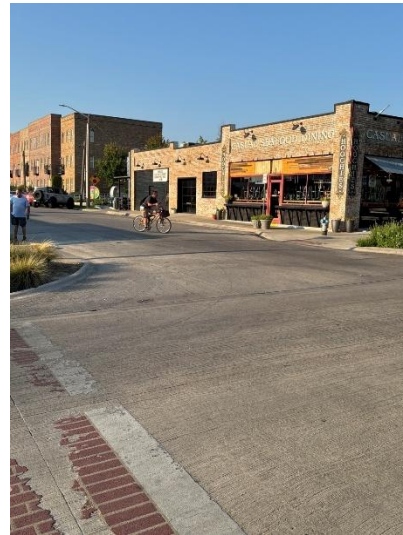
(B) Missing crosswalk at Industrial St.

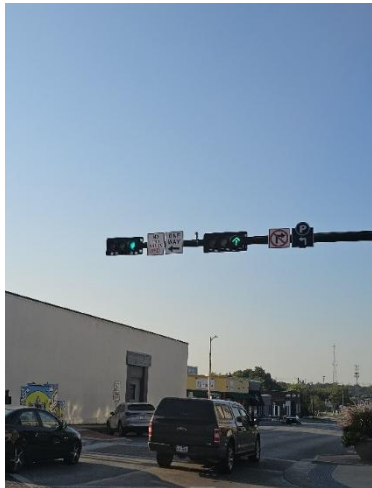
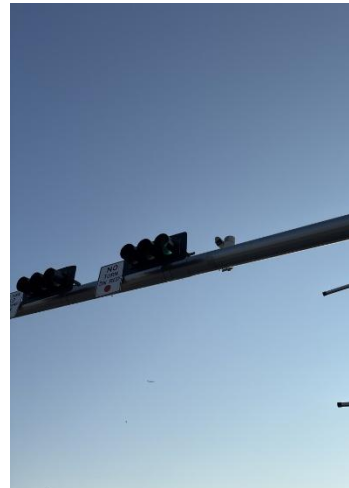
Figure 9 - Example of Missing Retroreflective Backplates

Many intersections along this corridor do not have retroreflective backplates on the signal heads, as shown in **Figure 9**. Adding a reflective border around the signal head increases visibility of the traffic signals, especially at night or in poor weather conditions.

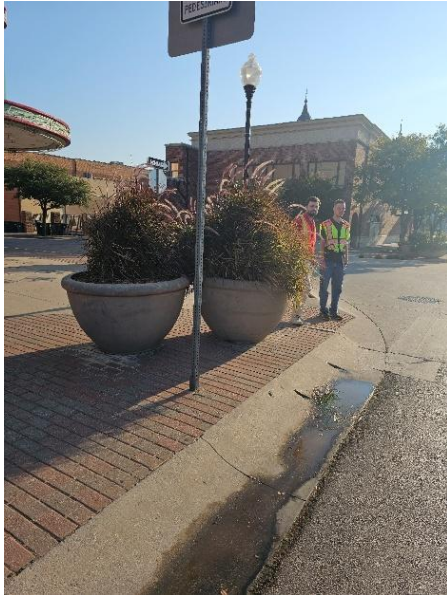
At the Cedar Street intersection, there was a sight distance issue due to the tall planters located close to the intersection (**Figure 10**). The location of the planters blocks drivers' view of pedestrians trying to cross the street safely when the drivers are approaching the intersection and trying to turn left onto Cedar Street. The planters should be relocated to provide adequate sight distance.
