RE: City of Denton Contract Number #5753

RE: **SITE VISIT AT DENTON ENTERPRISE AIRPORT
OCTOBER 14-15, 2015
ERECT-A-TUBE, INC. PROJECT NO. E-7754**

Project: Taxiway Queue Hangar Development, Denton Enterprise Airport
Topic: Construction Observation
Date / Time / Location: July 16, 2015 / 9:00 AM / Denton Airport Construction Site
Attendees: Quentin Hix, David Schaumberg, Zac Loiselle, Scott Aukerman, Dave Powyszynski, Richie Dailey and Hasim Isufaj
Distribution: Attendees; File

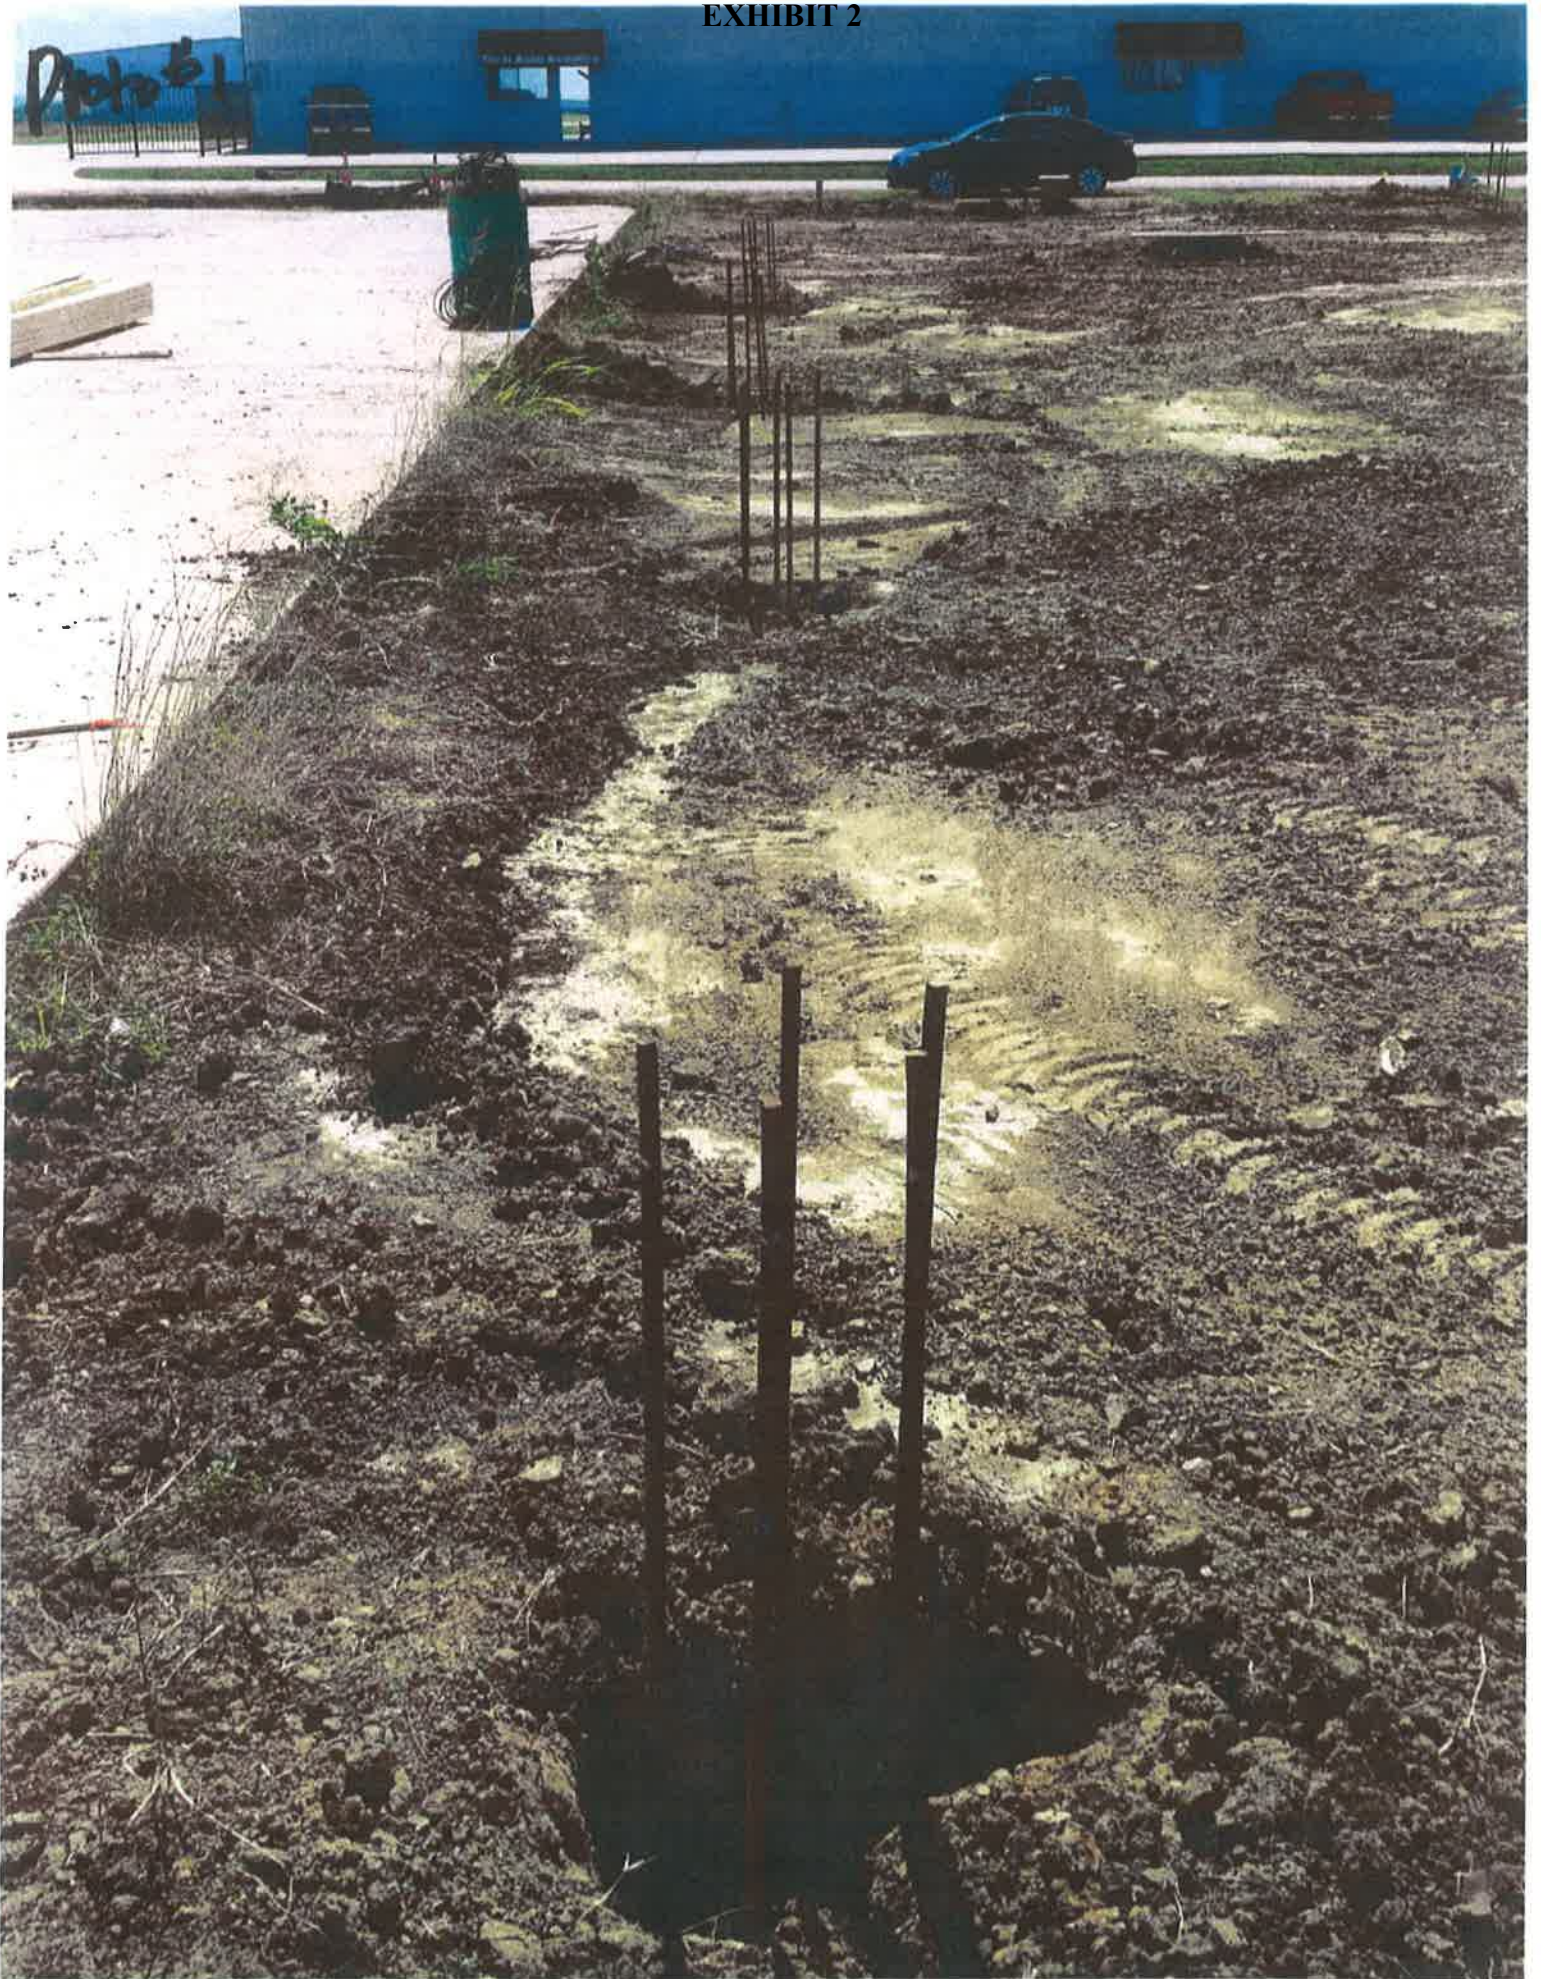
1. Exhibit A / Photo #1 – the piers appear to not be lined up correctly. Needs immediate correction.
2. Exhibit A / Photo #2 – Concrete edge is busted and not acceptable. Needs immediate correction.
3. Exhibit A / Photo #3 – Lag bolts not fully secured to concrete surface. Needs immediate correction.
4. Exhibit B – Erect-A-Tube Site Visit Report. This report indicates several serious construction deficiencies and unsafe practices regarding construction currently in process. Please review the report, and provide notices of immediate correction with the timeframe stipulated in this letter.
5. Exhibit C – Aguirre Roden Construction Meeting Minutes from 7-16-15. This report indicates several serious construction deficiencies. Please review the report, and provide notices of immediate correction with the timeframe stipulated in this letter.

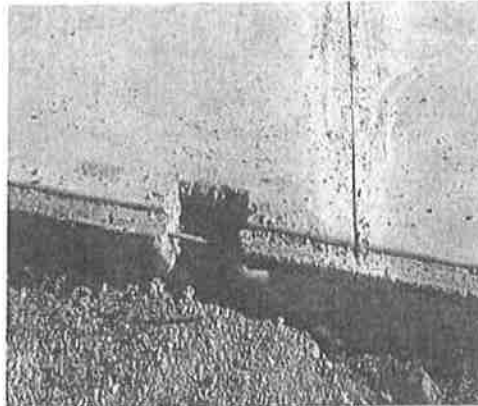
Picture 4

aligns with grade beam centerline. Refer to SK-4 for proposed solution.			ARI
	2. Floor socket embed plates per Erect-A-Tube submittal were not installed, refer to Picture 4.			MAG

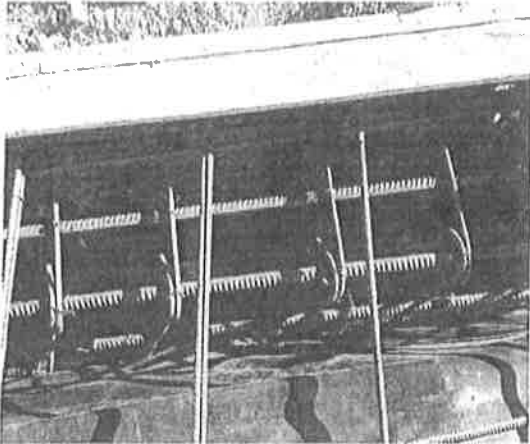
Picture 5

3. Pier rebar exposed, refer to picture 5.			MAG
	Proposed solutions: 1) Refer to SK-4.			ARI
	<u>Building 2051 Skylane and 2061 Skylane</u> On-going construction activity:			
	Work was in progress, and it was 85% (approximately) complete.			
	<ul style="list-style-type: none"> Scheduled grade beam and slab on grade reinforcing was provided per documents. Grade beam corner bar reinforcing installation was in progress. Most of anchor rods were installed. Anchor rods at interior columns were not installed at time of visit. Socket embed plate per Erect-A-Tube were not installed at time of visit. 			MAG
				MAG
				MAG
				MAG
	Discrepancies:			MAG

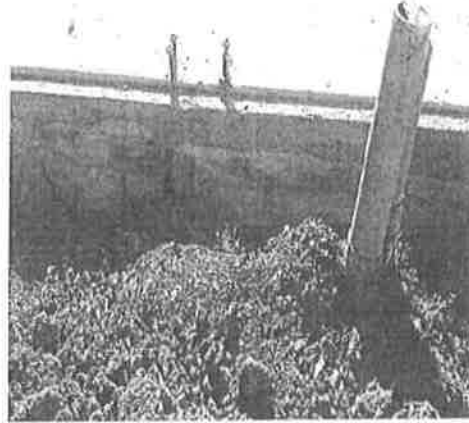
Picture 6

3. Bottom bar splicing was not conforming per construction documents (detail 2/S301). Add additional 3-#7 bars between piers per SK-5.			MAG
	4. Scheduled stirrups were provided per documents, however it was difficult to verify spacing, due to stirrups being inclined, refer to picture 6.			MAG

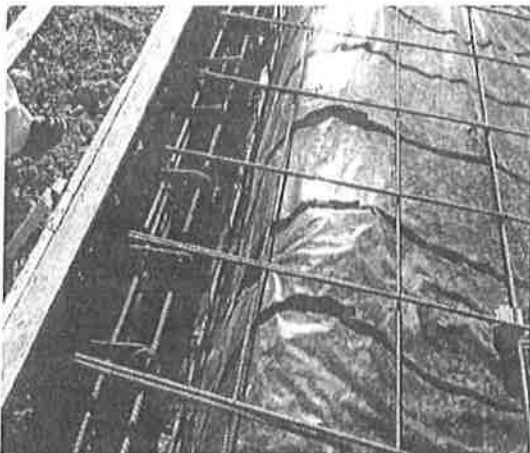
Picture 7

1. All piers and most of grade beams have not been cleaned of dirt and debris. Refer to picture 7 & 8.			MAG
	2. Wooden and concrete blocks were for grade beam and slab reinforcing, refer to picture 9.			MAG

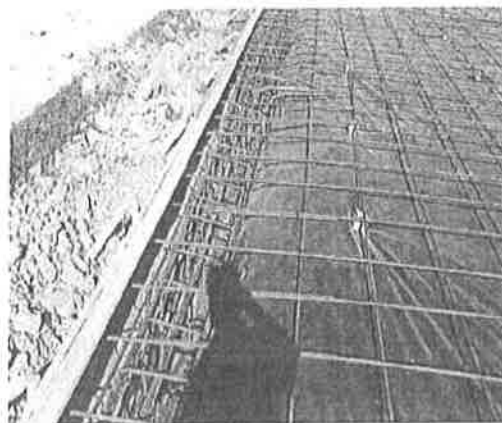
Picture 10

5. Grade beam bottom reinforcing splices were not installed per documents (detail 2/S301)			MAG
	6. Pier dowel standard hooks were too long and may interfere with top slab clearance, refer to picture 10.			MAG

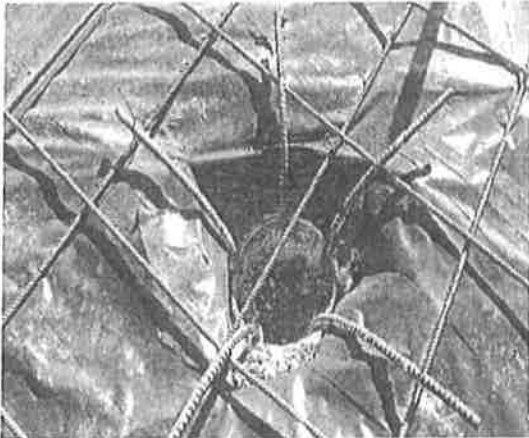
Picture 11

7. Pier dowels cut off at corner of building, refer picture 11 and 14.			MAG
	8. Dirt on all top of interior piers, refer to picture 12.			MAG
	9. Vapor barrier missing along exterior grade beams, refer to picture 13.			MAG

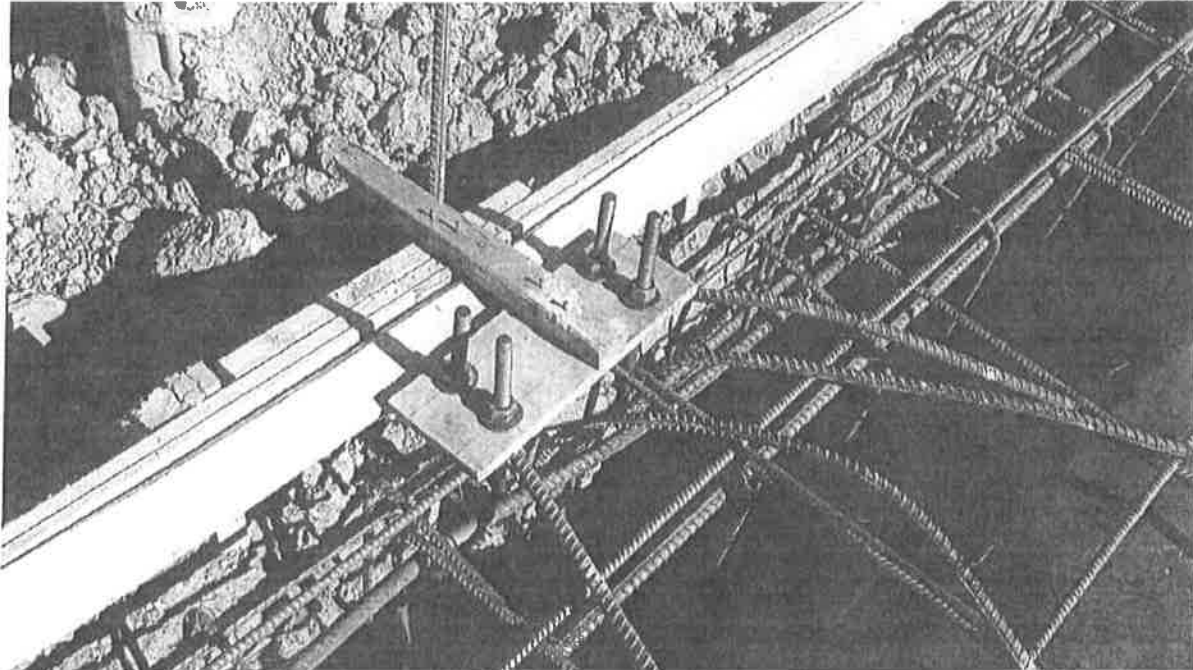
Picture 15

10. Pier dowel outside building perimeter, refer to picture 15.			MAG
