RE: City of Denton Contract Number #5753

The City of Denton requests your immediate attention, response, action, and ***timely resolution*** in regards to completion of the construction work mutually agreed to with Contract #5753 – Construction of the Denton City Airport Hangar Project.

PARTIAL DRAFT PUNCH LIST  
DENTON AIRPORT HANGARS  
February 25, 2016

COMPILED PUNCH LIST  
DENTON AIRPORT HANGARS  
May 26, 2016

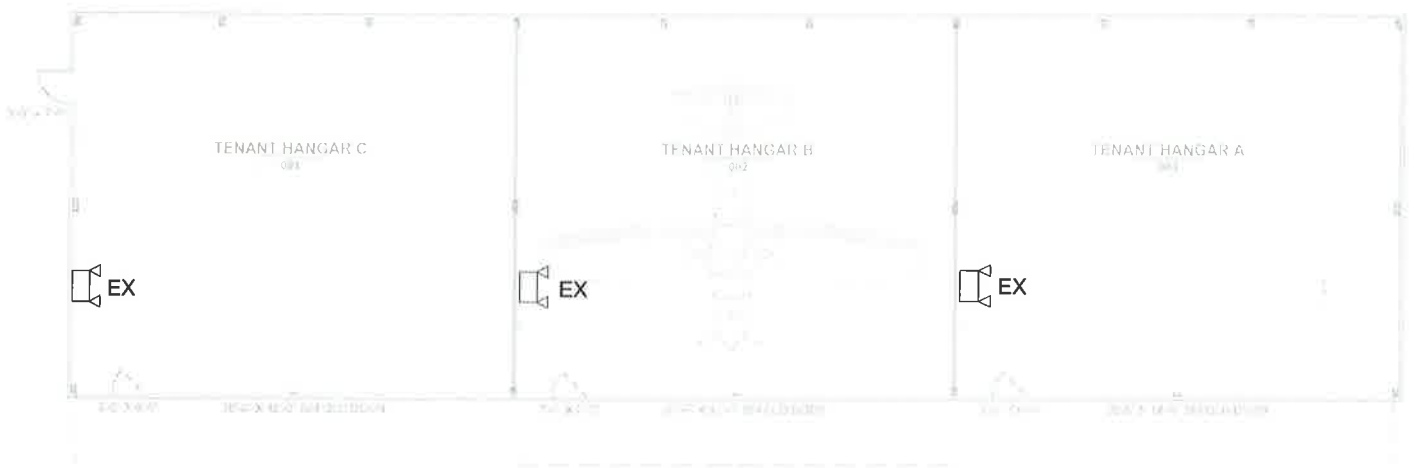
EMERGENCY LIGHT LEVEL MEASUREMENTS WERE TAKEN AND IT HAS BEEN DETERMINED THAT IT WOULD BE POSSIBLE TO OBTAIN THE MINIMUM LIGHT LEVEL REQUIREMENTS FOR EGRESS LIGHTING BY ADJUSTING THE (2) HEADS ON THE EMERG. FIXTURE SO THAT THEY PROVIDE ILLUMINATION ALONG PATH OF EGRESS. CONTRACTOR TO ADJUST HEADS AS REQUIRED.

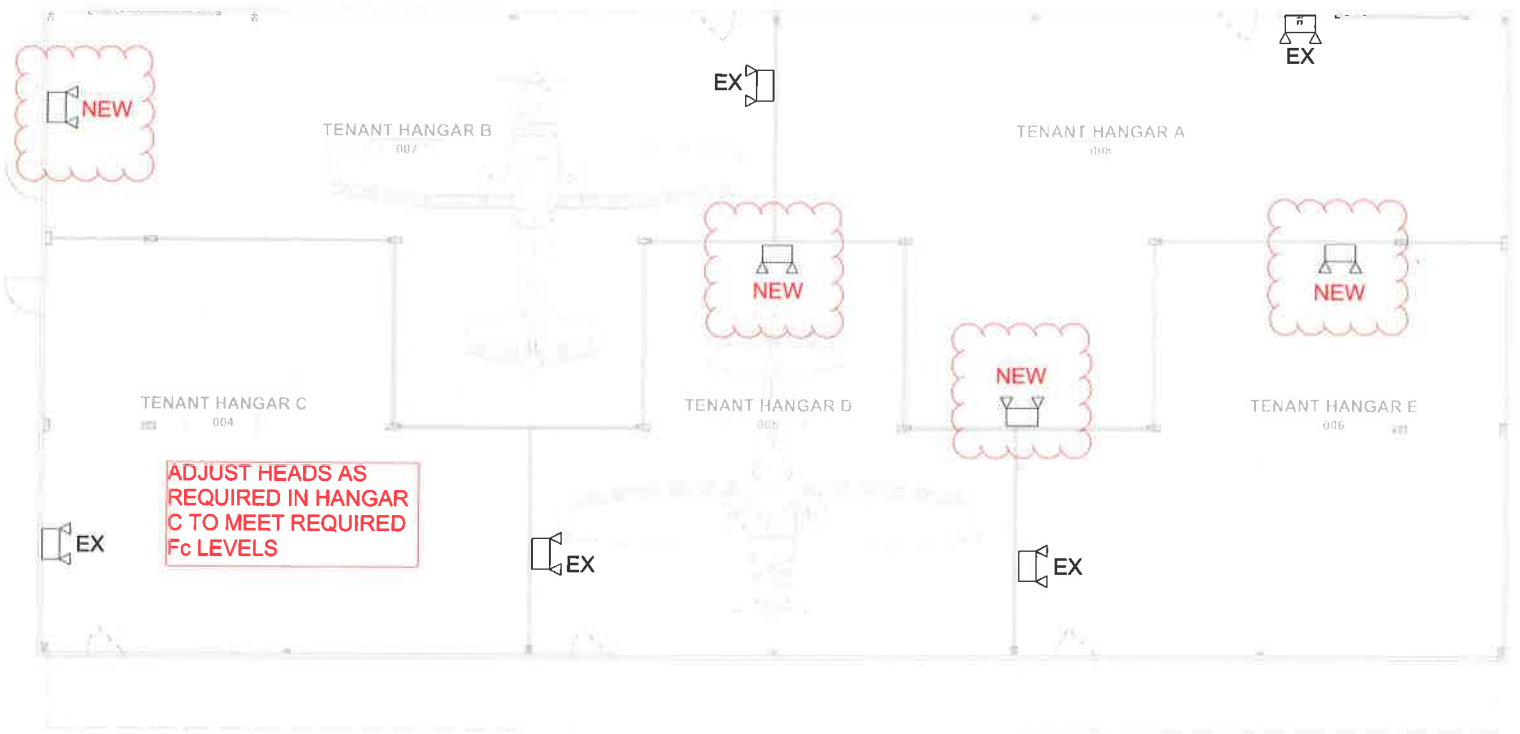
ARI RECOMMENDS PROVIDING ADDITIONAL  
EMERGENCY LIGHTS AS INDICATED BELOW.  
CONTRACTOR TO VERIFY EXACT QUANTITY,  
LOCATION, AND HEAD ADJUSTMENTS TO MEET  
REQUIRED  $F_c$  LEVELS ALONG PATH OF EGRESS.
