COMPILED PUNCH LIST
DENTON AIRPORT HANGARS
May 26, 2016

Hangar Facilities #2241, 2231, 2221, 2031, 2041 2051 , 2061
Denton Municipal Airport
Denton, TX

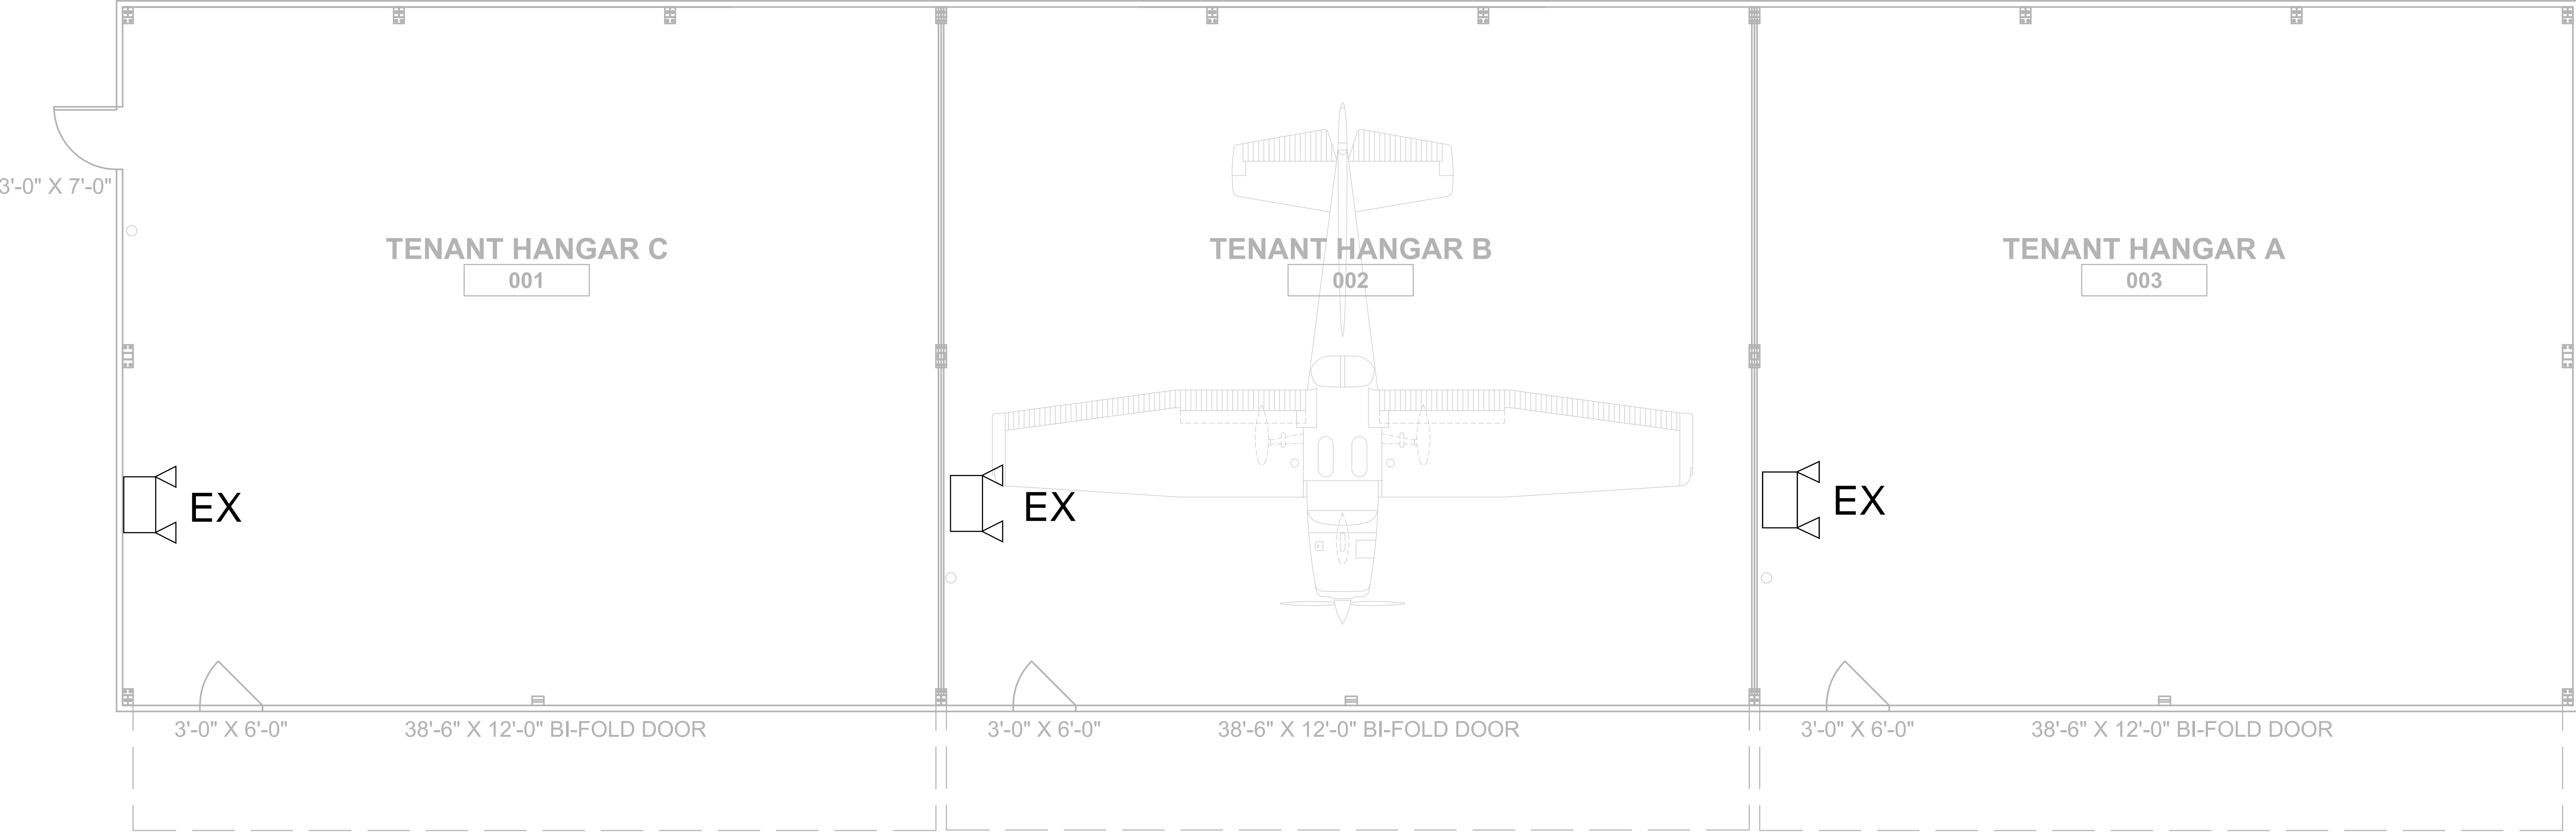
EMERGENCY LIGHT LEVEL MEASUREMENTS WERE TAKEN AND IT HAS BEEN DETERMINED THAT IT WOULD BE POSSIBLE TO OBTAIN THE MINIMUM LIGHT LEVEL REQUIREMENTS FOR EGRESS LIGHTING BY ADJUSTING THE (2) HEADS ON THE EMERG. FIXTURE SO THAT THEY PROVIDE ILLUMINATION ALONG PATH OF EGRESS. CONTRACTOR TO ADJUST HEADS AS REQUIRED.
