2017-08-10

City of Denton

**Old Denton City Hall
(City Hall West)
Preliminary Rehabilitation
Assessment Report
Denton, Texas**

This report includes a brief historical summary and architectural description. The building evaluation focuses on exterior and interior conditions with related recommendations for rehabilitation.

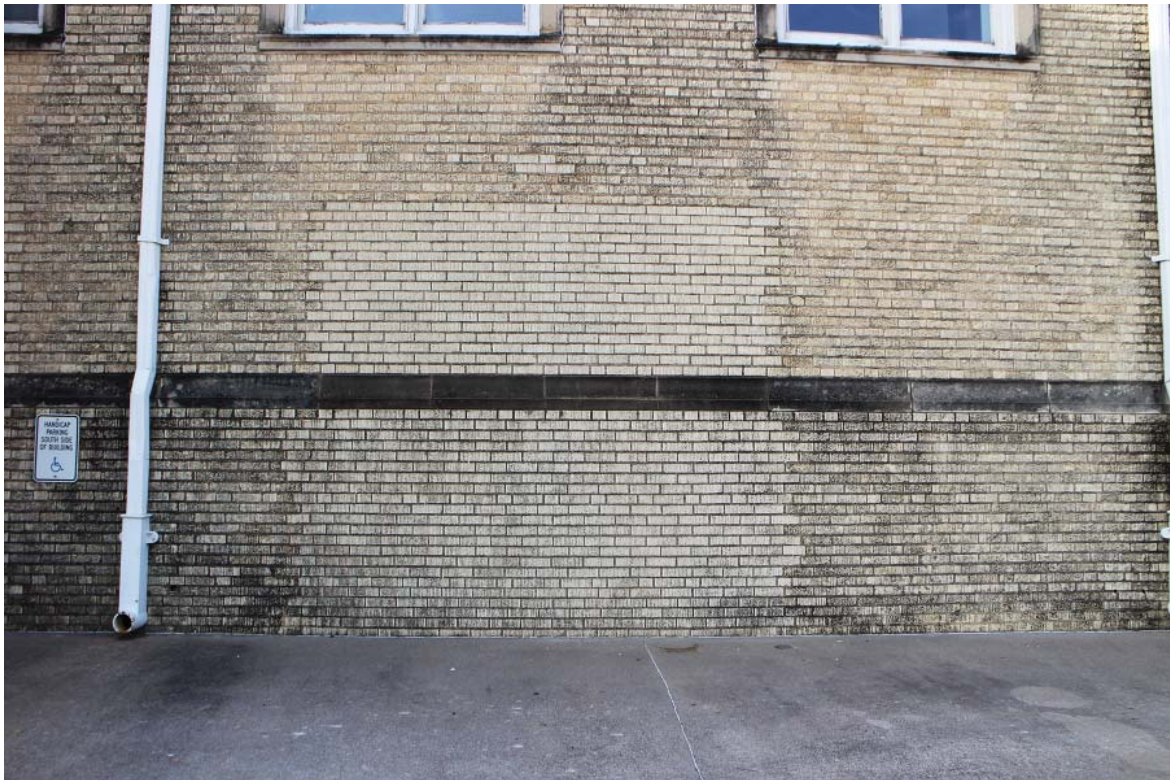
The brick was found to be in good condition with some general biological staining. Brick used at the north and south additions and as infill where doors and windows have been infilled is a close match, but slightly lighter than the original.

Typical masonry conditions at north elevation. Masonry needs cleaning. Brick infill at bay door location is evident. (Architexas 2017)

It is recommended that the brick be cleaned with a restoration cleaner designed for that purpose. The use of abrasive or high-pressure water blasting should be avoided.

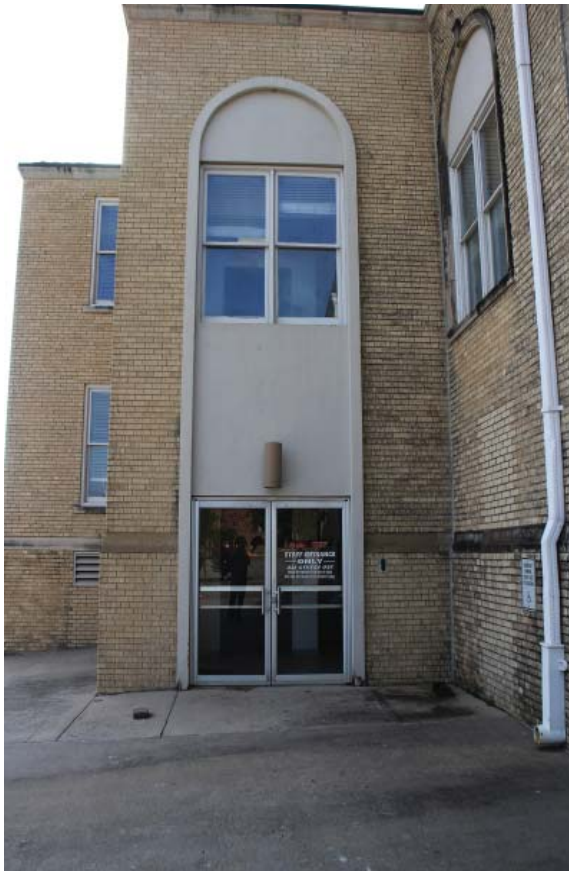
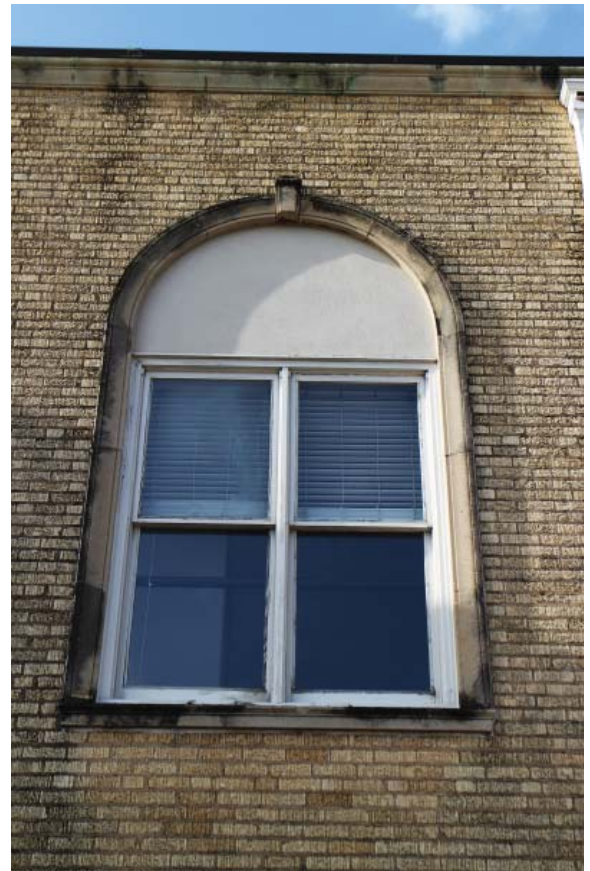
Doors are in good condition.

Left: Typical exterior door at the northwest facade. Right: Typical replacement windows at the auditorium level.
(Architexas 2017)

The windows are of inferior quality and are in fair to poor condition. Most of the windows on the rear el have been removed and the openings infilled.

It is recommended that the original doors at the east entry and the associated frame and transom be restored. At all other entries, new doors that are compatible with the historic design are recommended.

It is recommended that the windows be replaced with new units that match the original in profile, sight lines, and number of lights. Metal-clad windows may be appropriate if the appearance can be made to closely-match the original. Where additions are retained, their windows should be of compatible design but vary slightly from the original building.

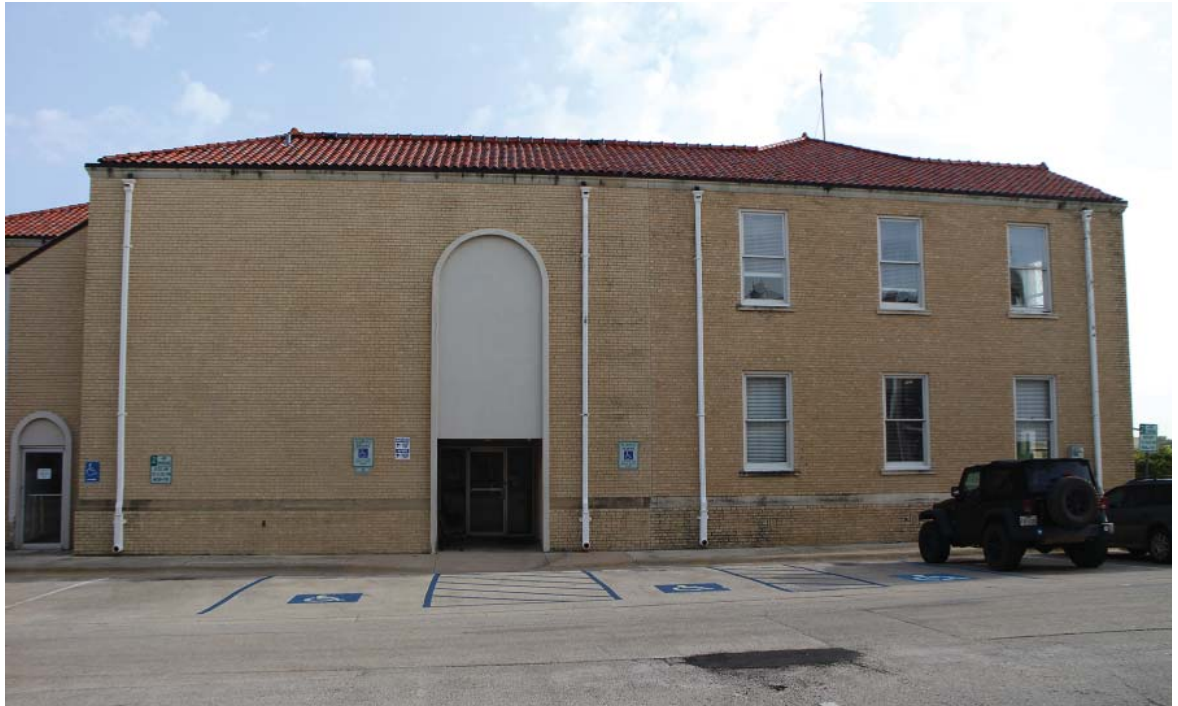
The additions are in fair condition but the plaster ornamentation is failing. These plaster elements are also not architecturally-compatible. Inside, the walls of the additions are generally CMU block.

View of the south facade showing the original building at right and the addition at left. If the addition is retained, the architectural details should be improved. (Architexas 2017)

Further study of the additions is recommended to determine if their retention is necessary to accommodate elevators and other upgrades. If retained, they should be improved to be more compatible with the original building. If removed, windows and other openings that were infilled in the 1980s should be

reopened and new doors and windows installed that match the original design.

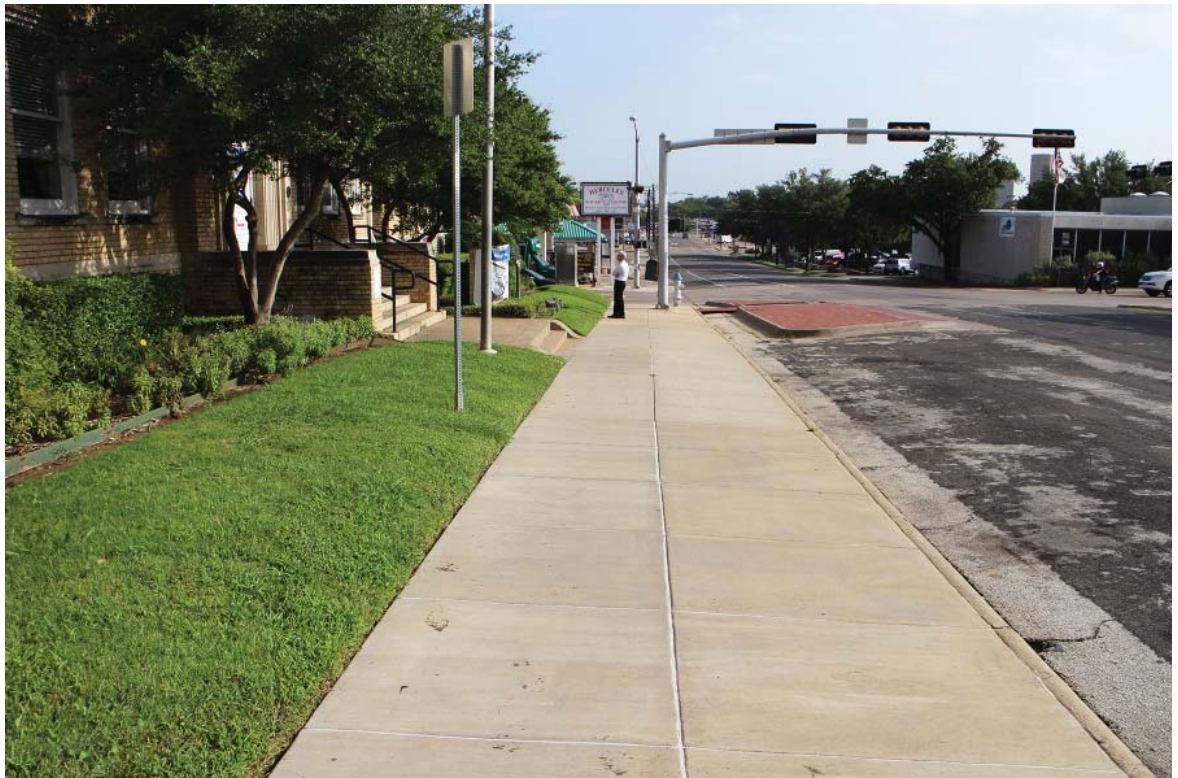
Site conditions were found to be good overall. The north side of the building lacks a sidewalk.

View of typical site conditions on the east side of the building. Site conditions are generally good. (Architexas 2017)

Site upgrades will be necessary when rehabilitation occurs to ensure the design is cohesive and properly serves the building and meets accessibility codes. However, these modifications should be relatively limited.

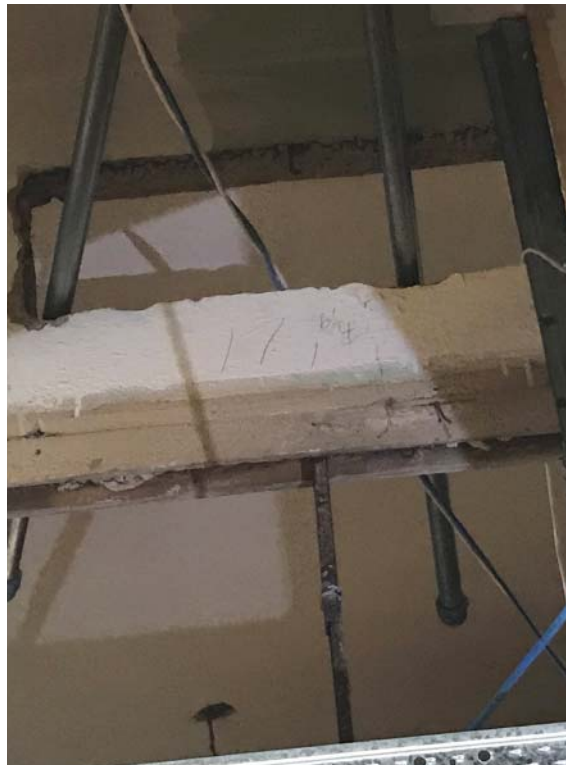
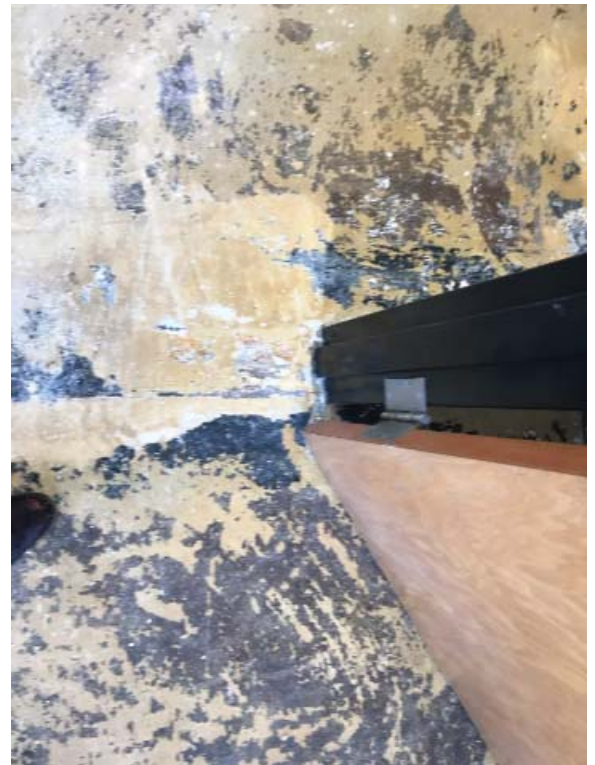
Original walls could not be fully assessed due to overlying materials. It appears that the majority of original walls remain in place, though covered. Some damage to the walls can be expected

Floors appear to be in fair condition though a full assessment was difficult.

Left: Typical original interior wall with steel studs, plaster and lath.
Right: The original concrete floor colors are visible under a layer of mastic: black at the center of the photo and reddish-brown at the bottom.
(Architexas 2017)

It is recommended that all existing contemporary walls be removed for examination of the underlying original walls for restoration. Where walls must be furred for the integration of infrastructure, it should occur on the office side of the wall, leaving the original corridor side of the wall exposed. In subdivided areas such as the fire station, removal of the existing non-historic walls will allow for reprogramming and compatible finish-out of these spaces. Rehabilitated walls should have the original sand finish and paint color restored. New walls should have a compatible new finish to differentiate them from original walls.

Future rehabilitation work should include the removal of contemporary floor coverings and the restoration of the original floor materials. In secondary spaces, the use of carpet or other flooring materials is appropriate. The use of area rugs in offices is encouraged.

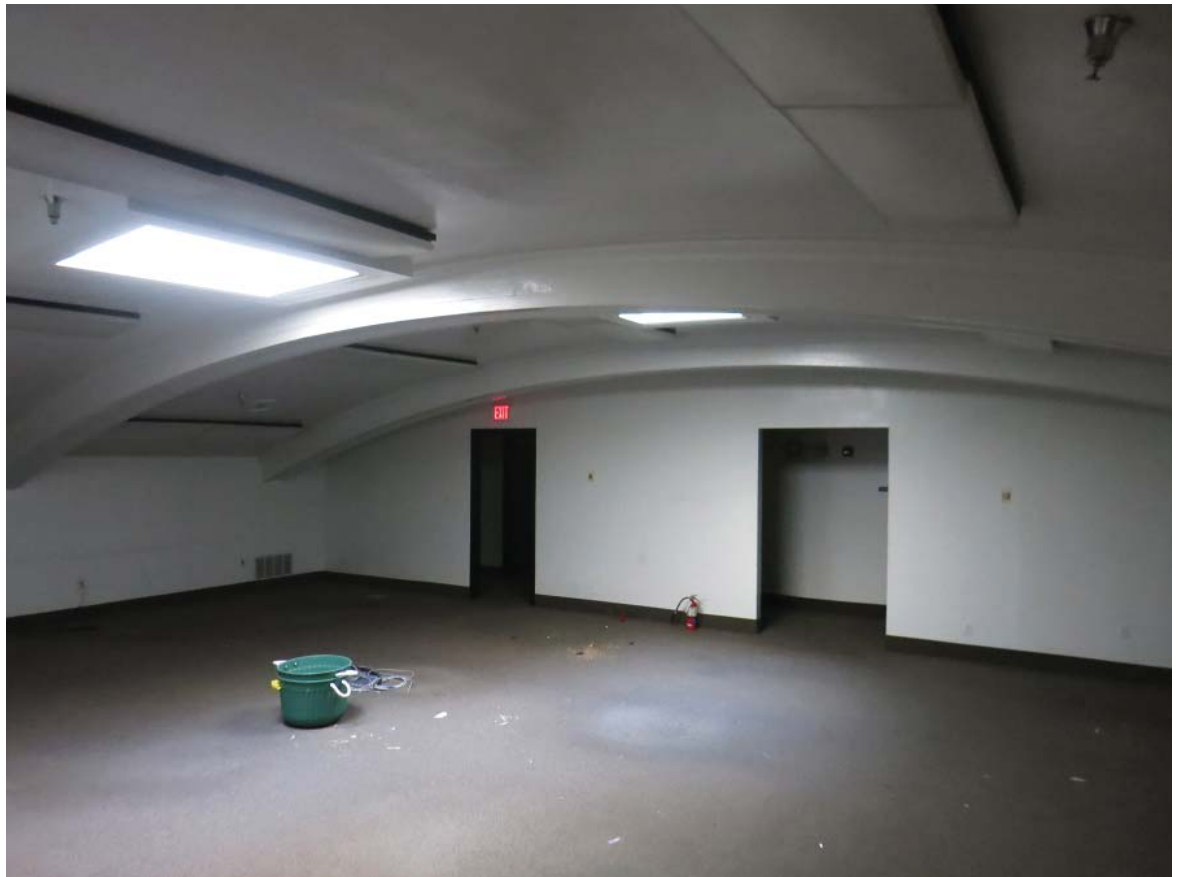
Modifications to the building in the 1980s included the removal of much of the balcony and the stage area. A floor was added within the space to create additional offices for the police department. The walls, ceiling and beams of the auditorium remain largely intact. It is presumed that the floor of the auditorium was fully or partially raked but this could not be confirmed. The floor is covered with contemporary materials and could not be evaluated. An important consideration in this area is that the floor levels in the auditorium wing of the building do not align with the office wing. This creates accessibility issues that are challenging, particularly in the area of the auditorium where the second floor was added. This floor is not accessible, rendering it unusable for most functions.

Partial view of the beamed ceiling at the auditorium. The floor in this image was added in the 1980s. (Architexas 2017)

It is recommended that the modifications to the auditorium be reversed and the space restored to its original configuration and finish. Accessibility can be achieved to the main floor of the auditorium with a new elevator connecting the primary entry lobby to the auditorium.

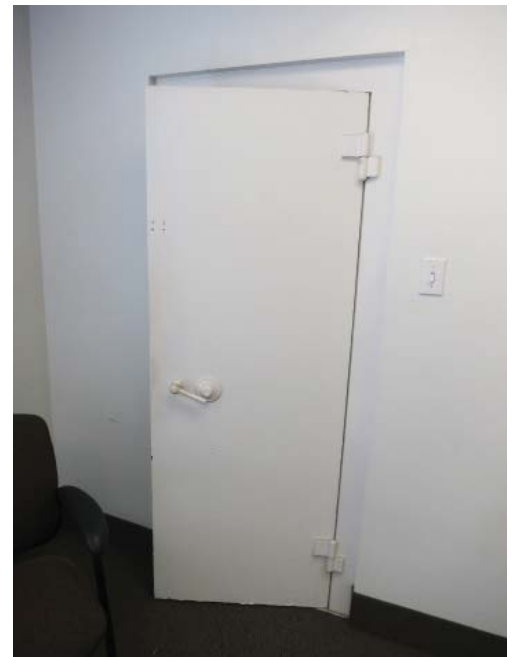
All but one of the vaults has been removed. Where vaults were removed, sections of the upper walls remain and are now hidden behind suspended ceilings. The single remaining vault is in good condition, but the vault door has been over-painted, obscuring the original decorative finish.

There is one original vault door in the building. (Architexas 2017)

The single remaining vault should be retained and the original vault door restored by a qualified conservator. Where vaults have been removed, it is recommended that the original floor-plan be restored. This can be accomplished with contemporary framing and drywall and will be more cost effective than attempting to remove the fragments of heavy concrete walls that remains.

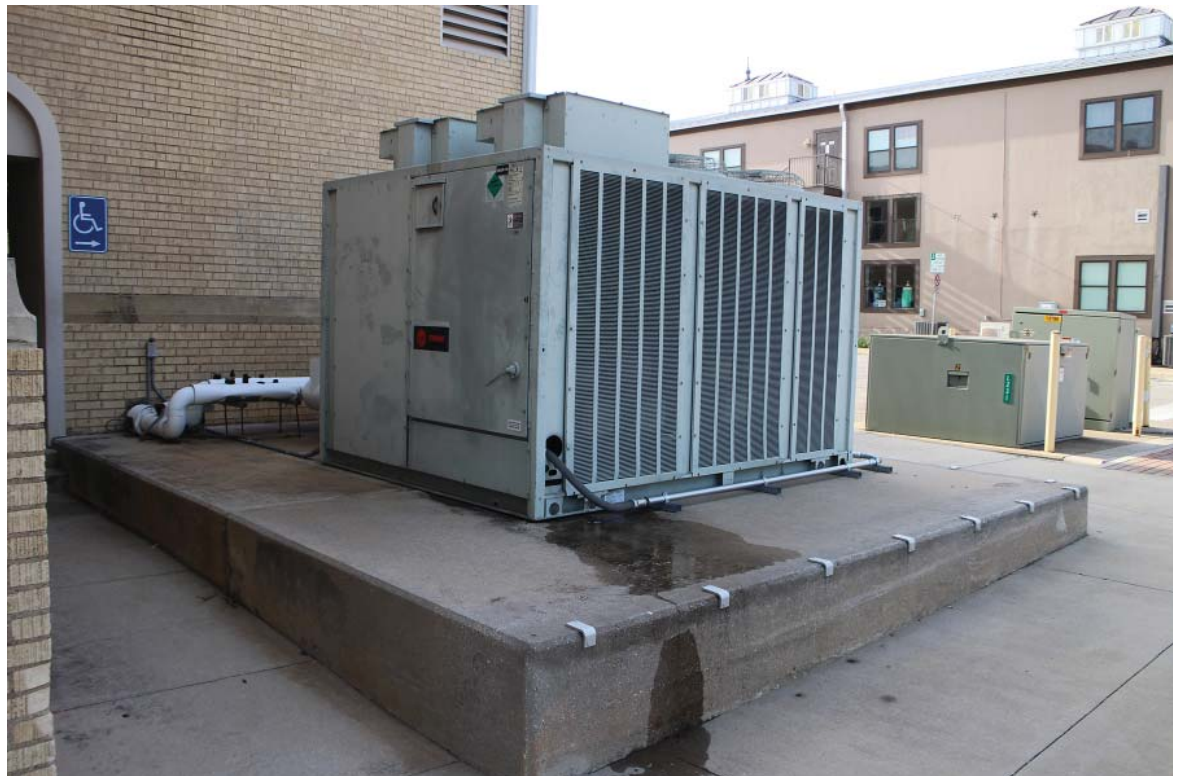
Existing mechanical unit at the southwest corner of the building. If feasible, the mechanical equipment should be placed remotely or screened. (Architexas 2017)

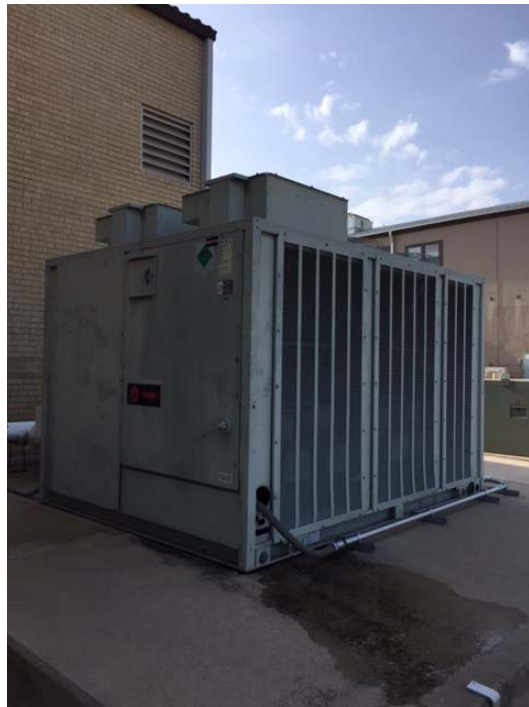
1. 60 Ton Trane Air Cooled Chiller.

1. Replace the 60 Ton Chiller with a 90 Ton Chiller.
2. Replace the Air Handler on the top floor.
3. Develop the Return Air System for the building.
4. The electric service and distribution may be adequate. However, if the heating is converted to gas the electric service would be adequate. There is currently gas service to the building
5. The building is using fluorescent and incandescent lighting fixtures. The fluorescent fixtures should be replaced with LED and the incandescent fixtures should be reused. Retrofit the incandescent fixtures with LED replacement lamps.
6. The emergency generator appears to be adequate to serve the buildings' egress and exiting lights.
7. The fire alarm control panel appears to be adequate to serve the re-design for this building.

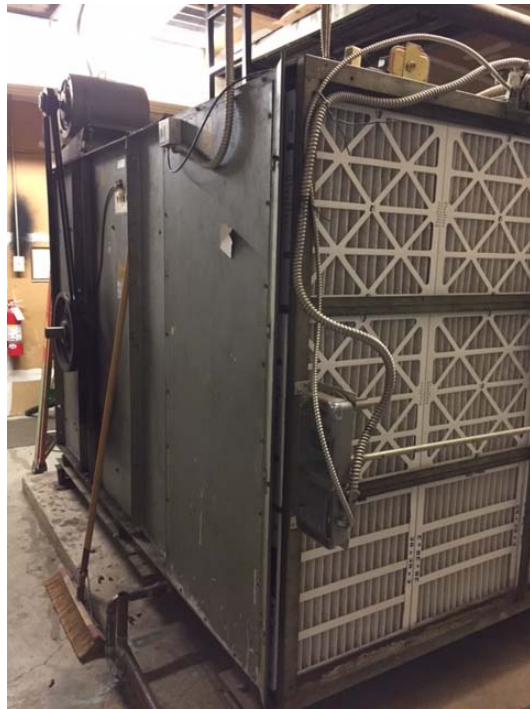
The air handler on the top floor was installed in approximately 1980 and is beyond its normally expected life. It is currently leaking and, with any renovation, should be replaced with a new 36,000 CFM air handler.

3. York Air Handling Unit on Top Floor.

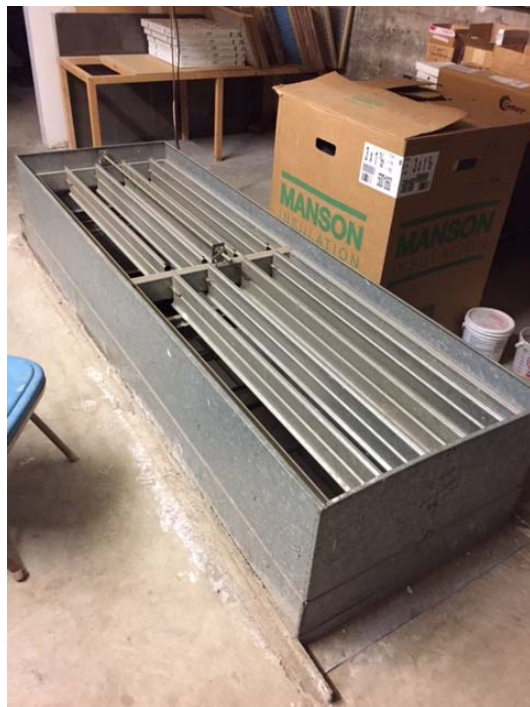
The return air system is somewhat suspect. There is no obvious return air chase and it was reported that some of the walls were used for return air. A renovation would require the system be addressed. The VAV terminal boxes on the exterior were reported and appeared to be in good condition.

4. Return Air Opening in Floor.

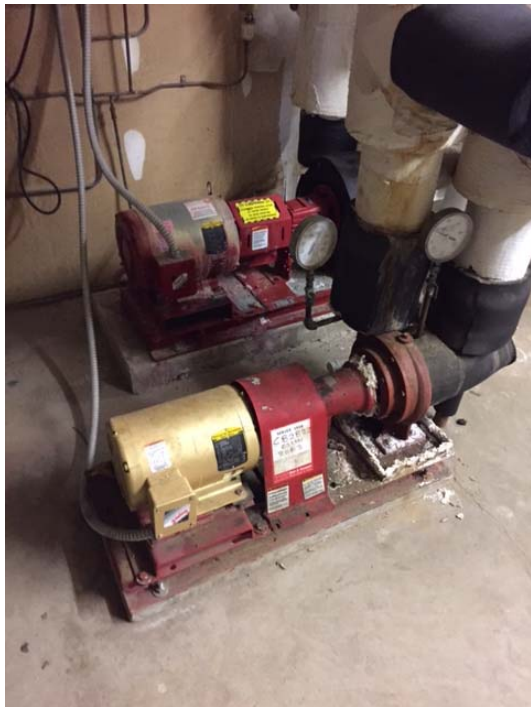
Two chilled water pumps circulate HVAC cooling water between the air handler and the chiller. The pumps appear to be in good condition.

5. Chilled Water Pumps in Mechanical Room.

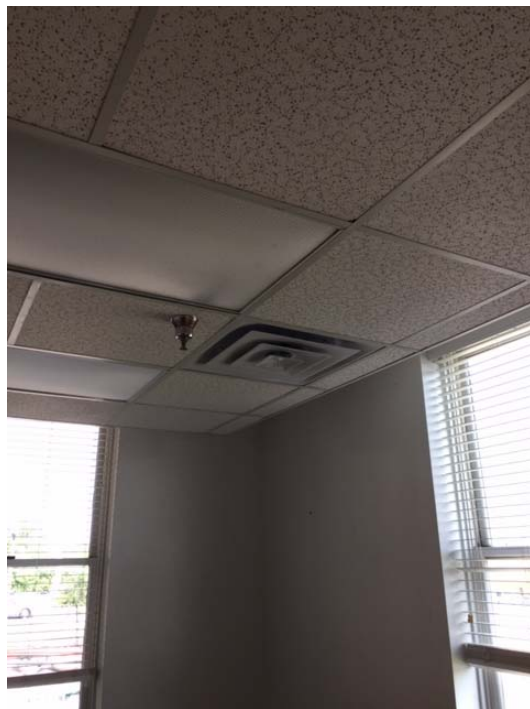
Lighting throughout the building is mostly fluorescent with some incandescent mixed in. The incandescent lights selected to remain could be retrofitted with LED replacement lamps. The fluorescent lights will need to be replaced with LED fixtures.

8. Typical Ceiling Fixtures.
