# **Electromagnetic Inspection and Visual Assessment Report**

## **30-Inch Raw Water Transmission Main**

**City of Denton**

**Pure Technologies U.S. Inc.**  
**(Revised DRAFT – September 6, 2017)**

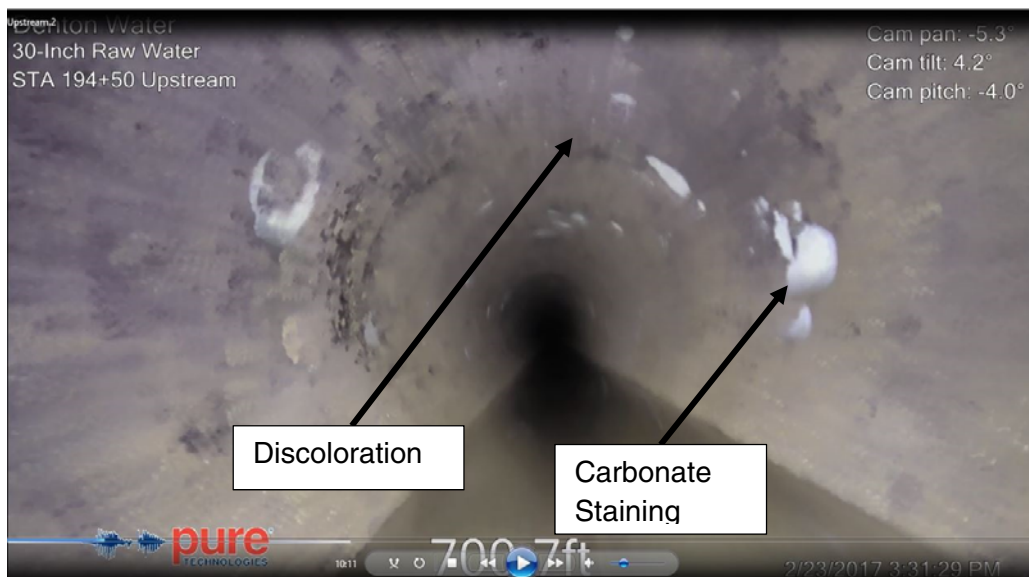
Figure 3.2: Pipe 2480, Areas of discoloration and carbonate staining, 706 feet from insertion  
(Station 194+50, Upstream, Video 2)

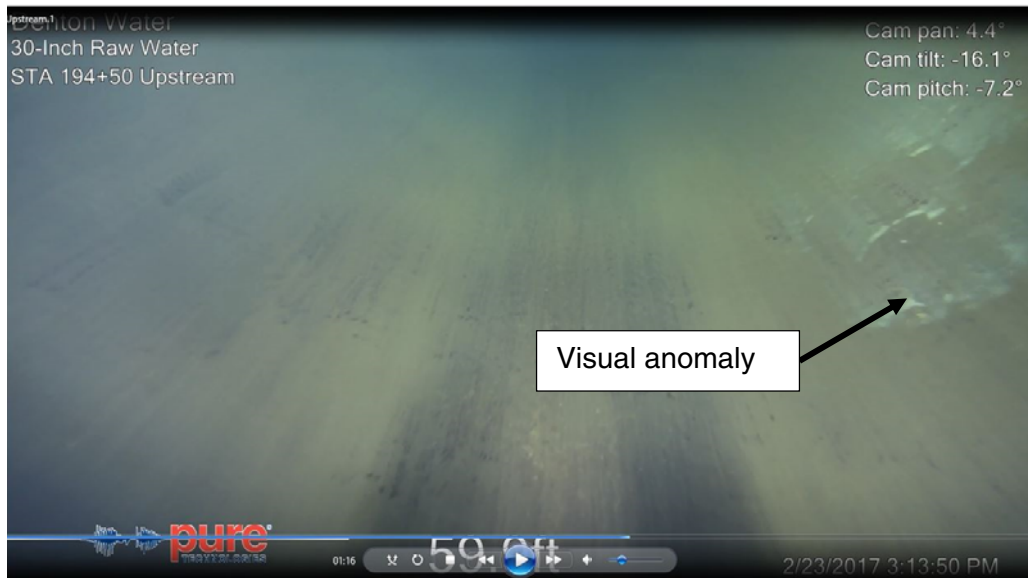
Figure 3.3: Pipe 2498, Visual anomaly observed at 5:00 position, 63 feet from insertion  
(Station 194+50, Upstream, Video 1)

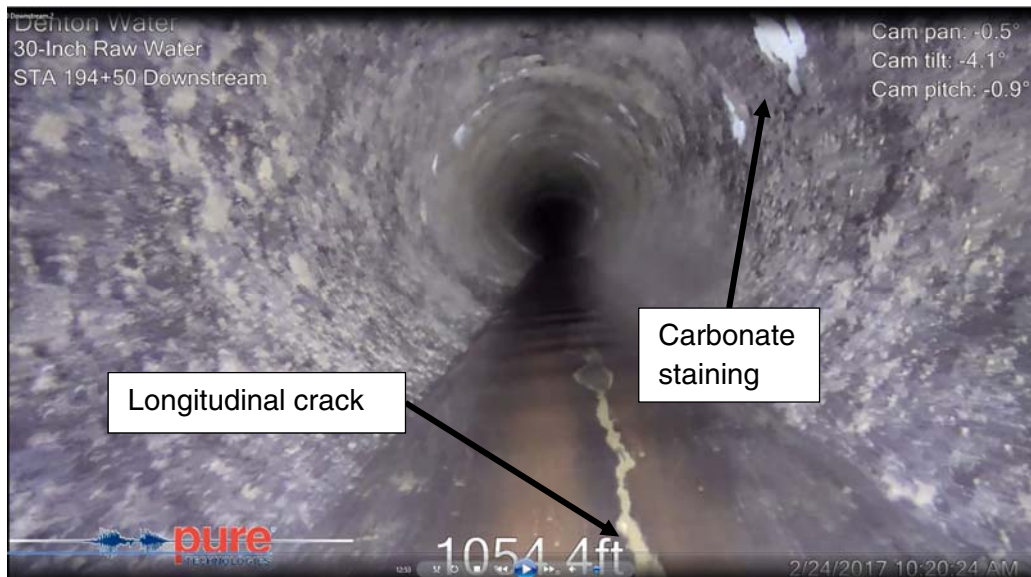
Figure 3.4: Pipe 2536, Longitudinal crack along invert, 30-feet in length,  
begins at 1,036 feet from insertion (Station 194+50, Downstream, Video 2)

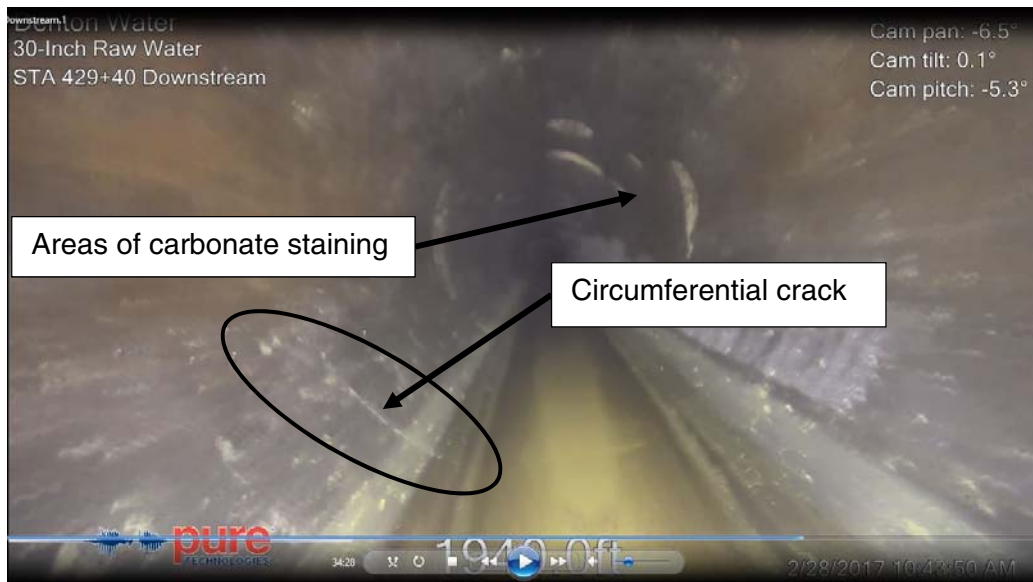
Figure 3.5: Pipe 3270, Circumferential crack, Carbonate staining and discoloration,  
begins 1,950 feet from insertion, (Station 194+50, Downstream, Video 1)

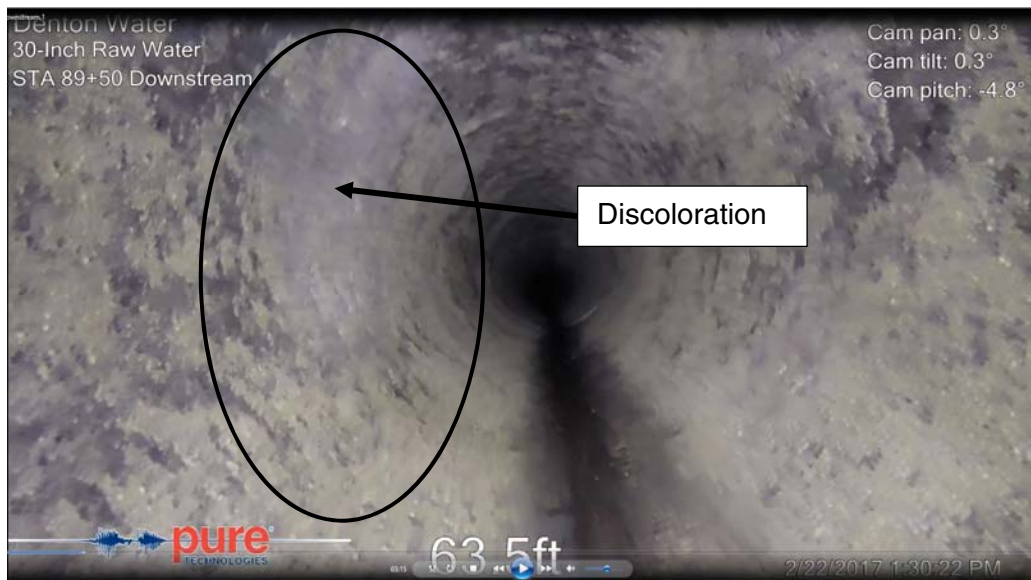
*Figure 3.6: Pipe 2202, Discoloration from 8:30 position to 11:30 position,  
located 67 feet from insertion (Station 89+50, Downstream, Video 1)*

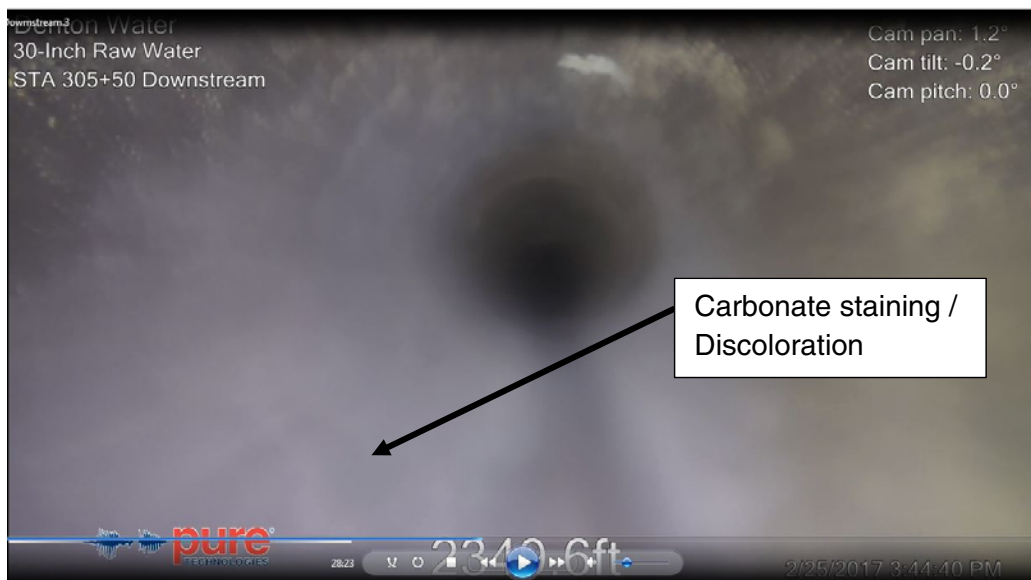
Figure 3.7: Pipe 2912, Carbonate staining / Discoloration, 2,340 feet from insertion  
(Station 305+50, Upstream, Video 3)

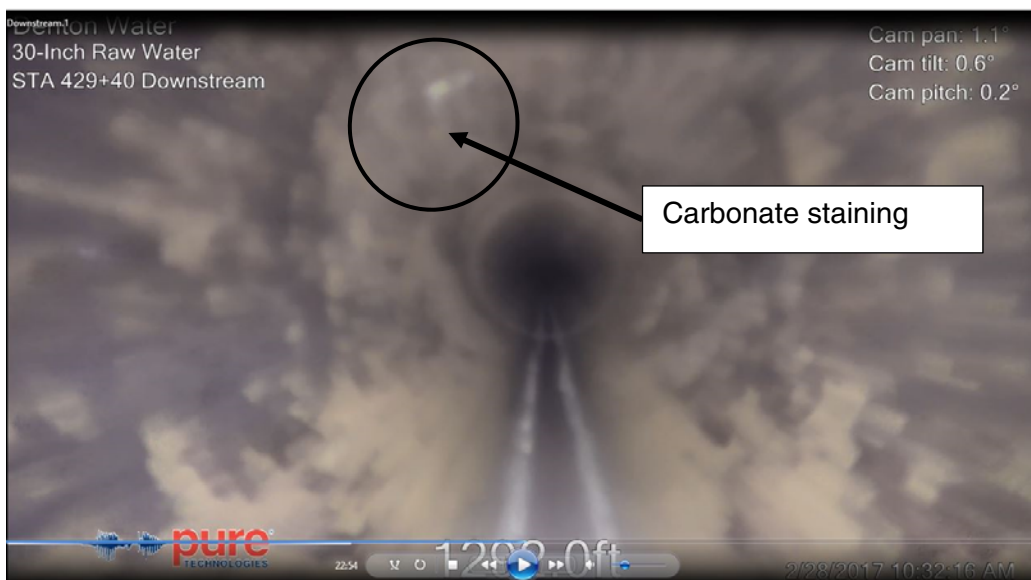
Figure 3.8: Pipe 3252, Area of carbonate staining, 11:00 position, 1,295 feet from insertion  
(Station 429+40, Downstream, Video 1)

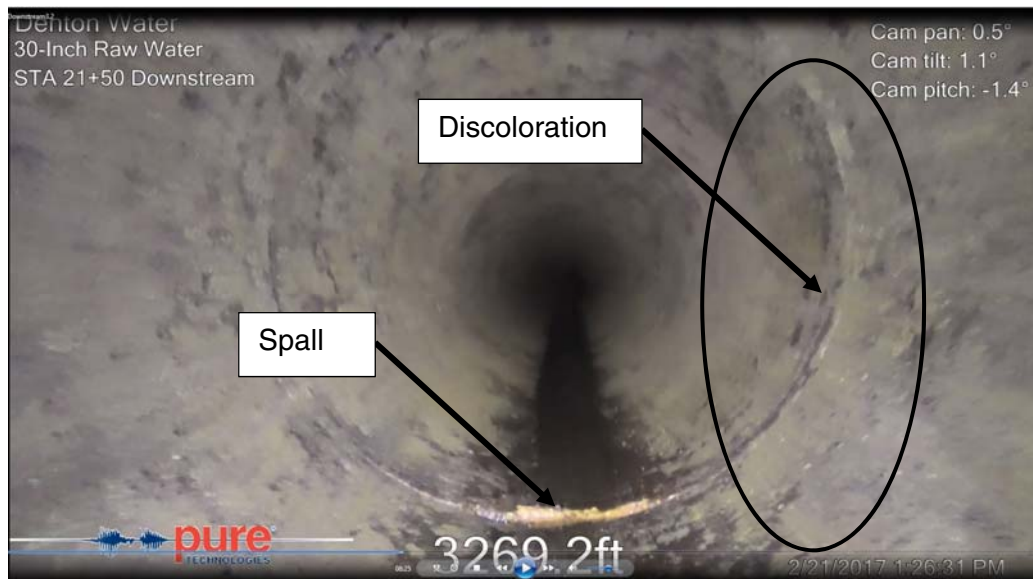
Figure 3.9: Pipe 2102, Discoloration, 2:00 to 5:00 position, 6 feet in length, 3,270 feet from insertion  
Joint spall at invert, (Station 21+50, Downstream, 3.2 Video)

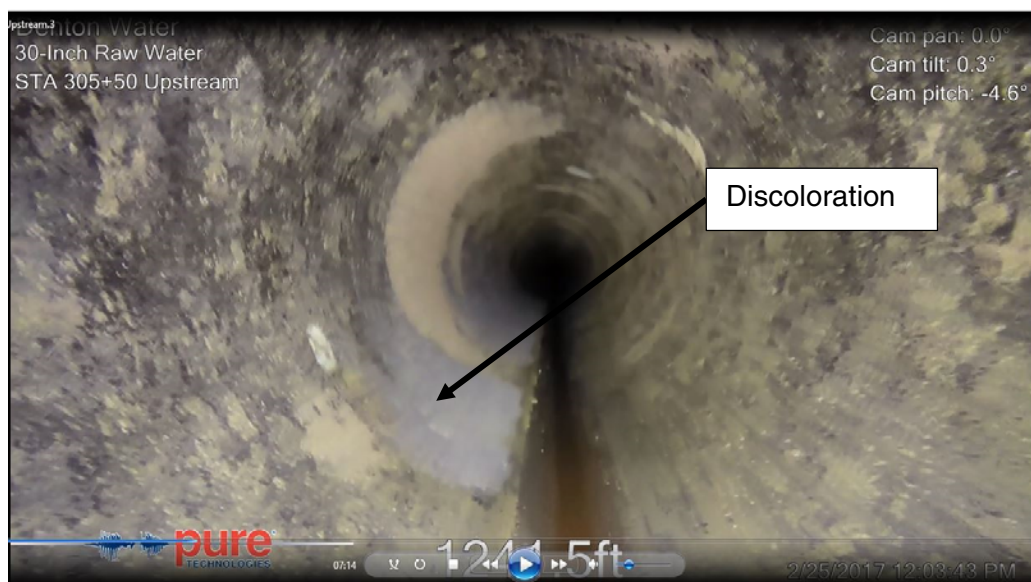
Figure 3.10: Pipe 2812, Large Discoloration, from invert across 9:00 position to crown,  
1,245 feet from insertion (Station 305+50, Upstream, Video 3)

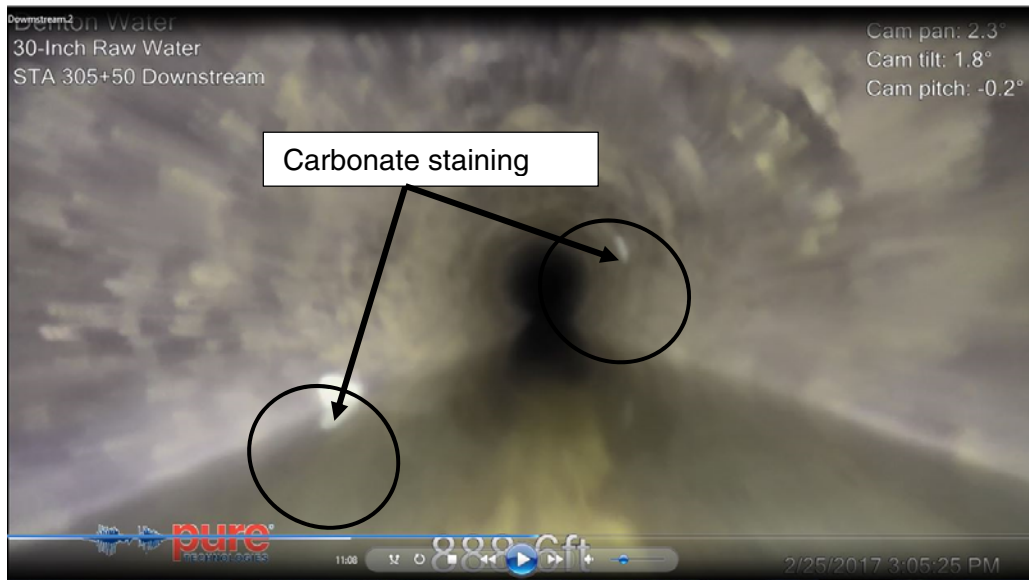
*Figure 3.11: Pipe 2871, Areas of carbonate staining, 2:30 and 8:00 positions,  
895 feet from insertion (Station 305+50, Downstream, Video 2)*

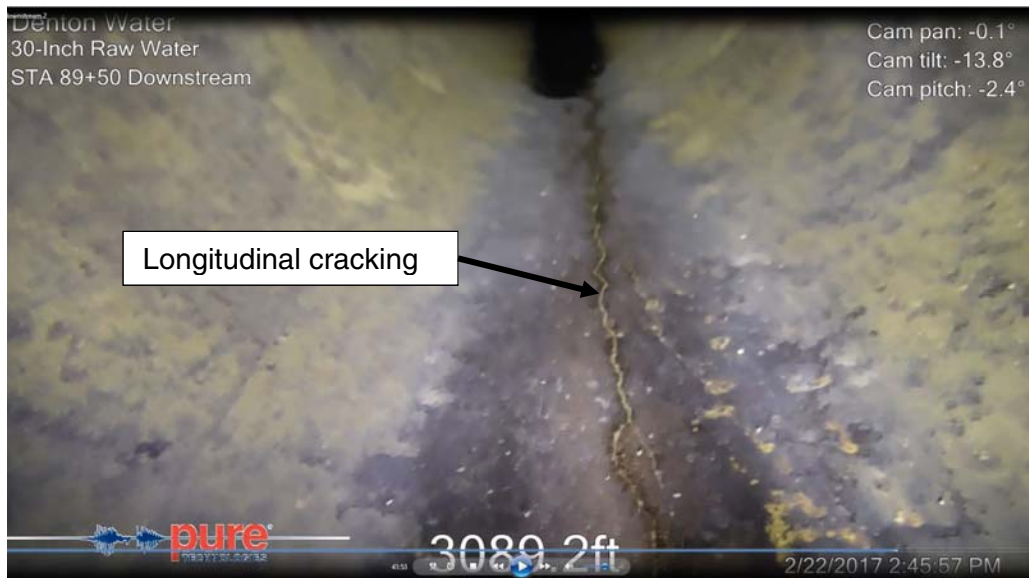
Longitudinal cracking is an indication of advanced deterioration, where in some cases the structural integrity of the pipe may be affected.

Figure 3.12: Pipe 2289, Longitudinal cracking along invert 3090 feet from insertion  
(Station 89+50, Downstream, Video 2)

3. Pipes with wide internal cracks should be thoroughly investigated to determine if repairs are required. If the cracks are greater than 1/16 of an inch (0.0625 inches) this is considered a fracture, and therefore should be point repaired with mortar, grout or approved equivalent in accordance with current bar wrapped pipe manufacturing recommendations. Several pipes exhibited longitudinal cracking. Additional details are provided in Appendix D - Inspection pipe list with visual assessment observations.

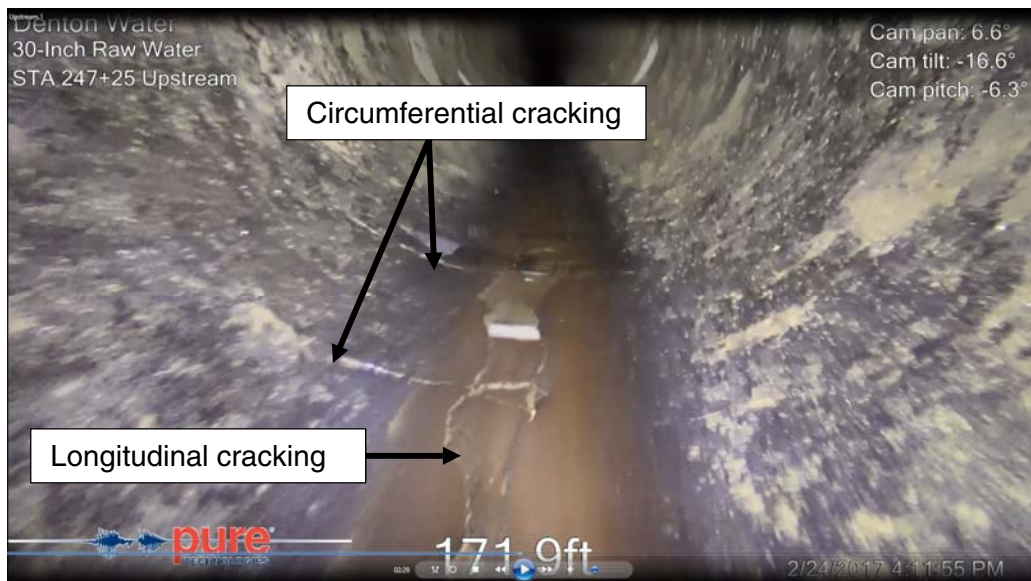
Figure 3.13: Pipe 2652, Longitudinal cracking along invert with intersecting circumferential cracks  
180 feet from insertion (Station 247+25, Upstream, Video 2)

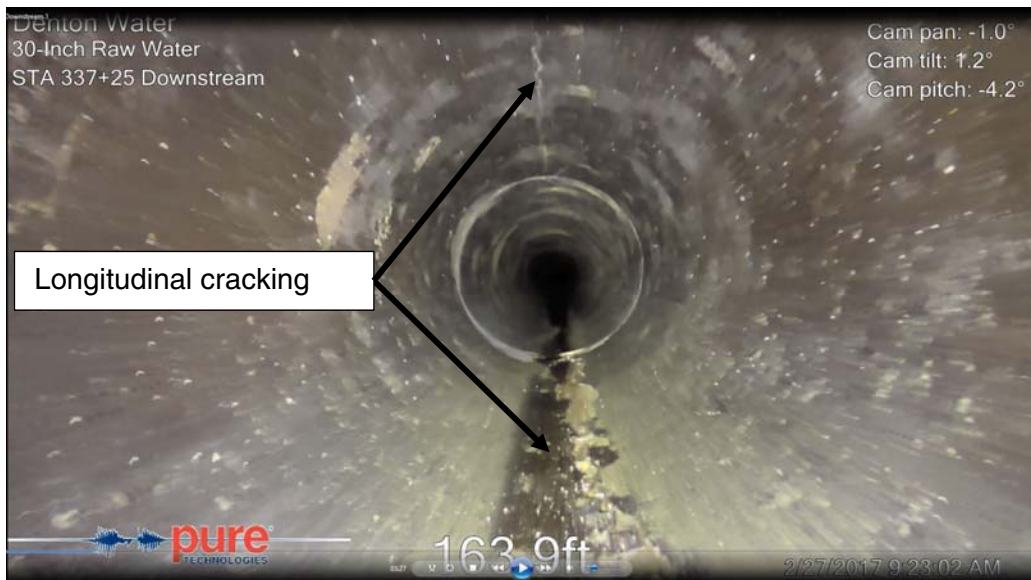
Figure 3.14: Pipe 2652, Longitudinal cracking along invert and crown  
170 feet from insertion (Station 337+25, Downstream, Video 1)

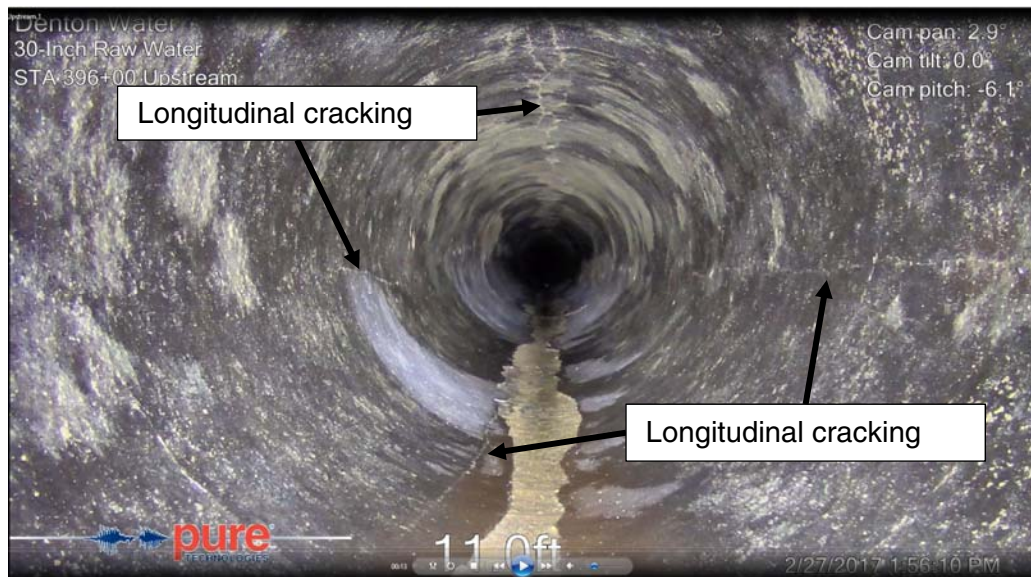
Figure 3.15: Longitudinal cracking along invert, crown and at each springline  
Piece number 156-SP insertion (Station 396+00, Upstream, Video 1)

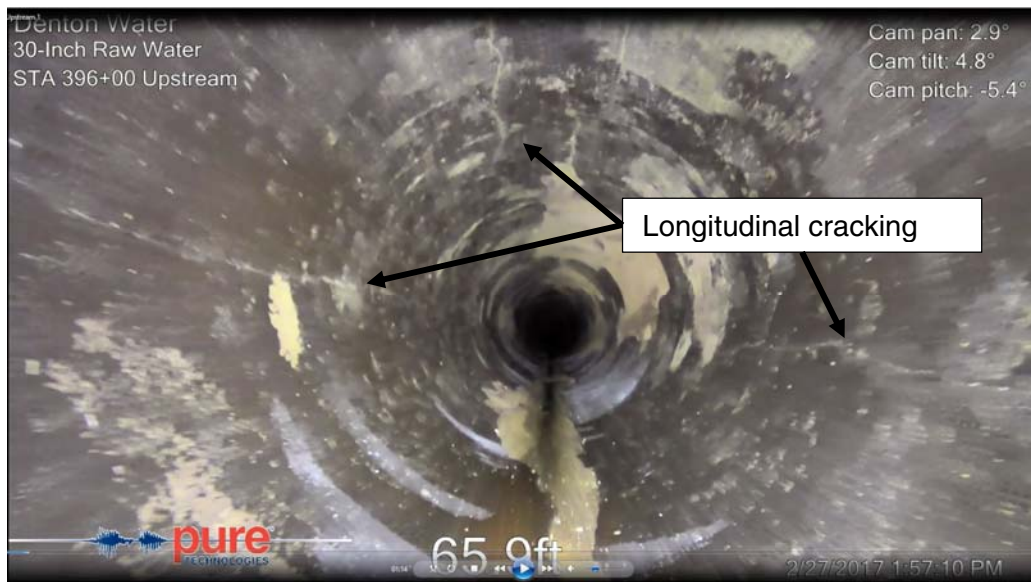
Figure 3.16: Pipe Number 3115, Longitudinal cracking along crown and at each springline  
Located 66 feet from insertion, (Station 396+00, Upstream, Video 1)

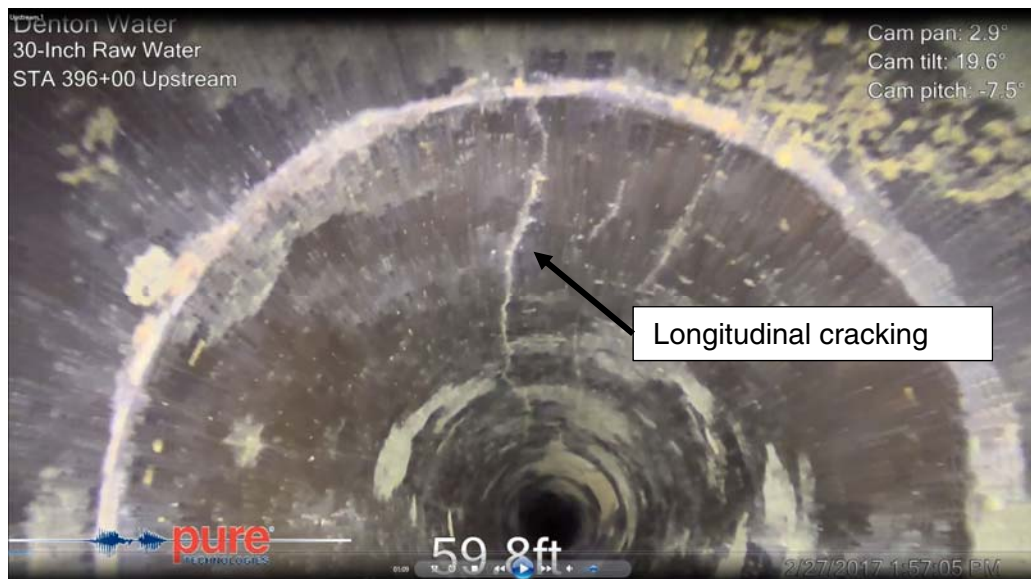
Figure 3.17: Pipe Number 3116, Longitudinal cracking along crown full length of pipe  
Located 60 feet from insertion, (Station 396+00, Upstream, Video 1)

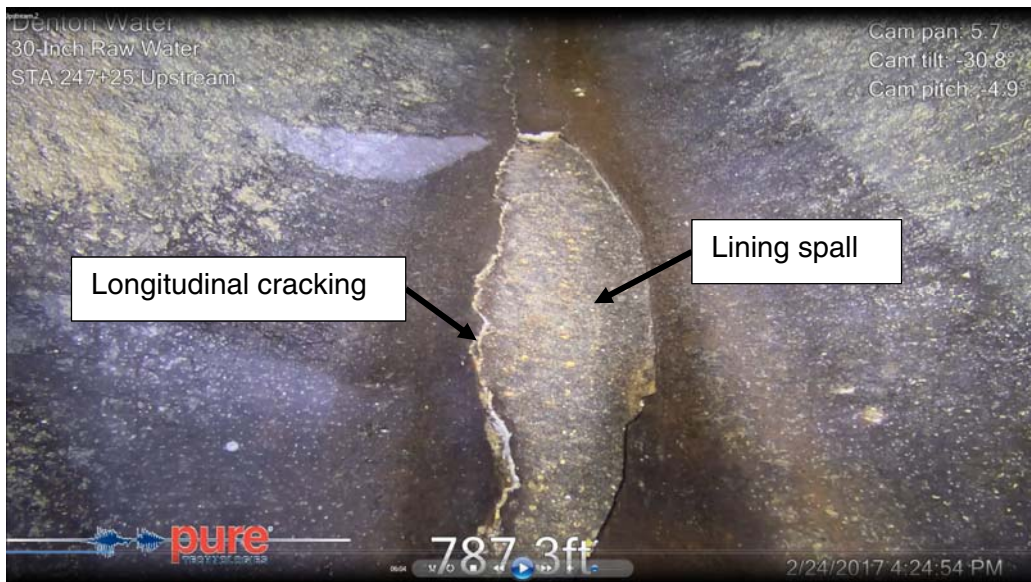
Figure 3.18: Pipe 2506, Longitudinal crack with lining spall at invert, 787 feet from insertion  
(Station 247+25, Upstream, Video 2)

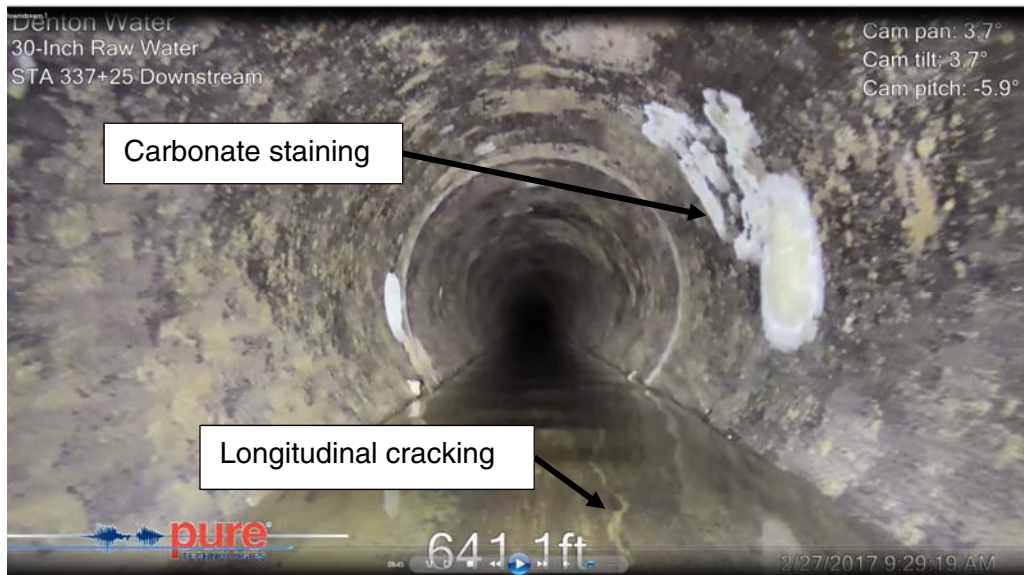
Figure 3.19: Pipe 2955, Longitudinal crack along invert, areas of carbonate staining,  
641 feet from insertion (Station 337+25, Downstream, Video 1)

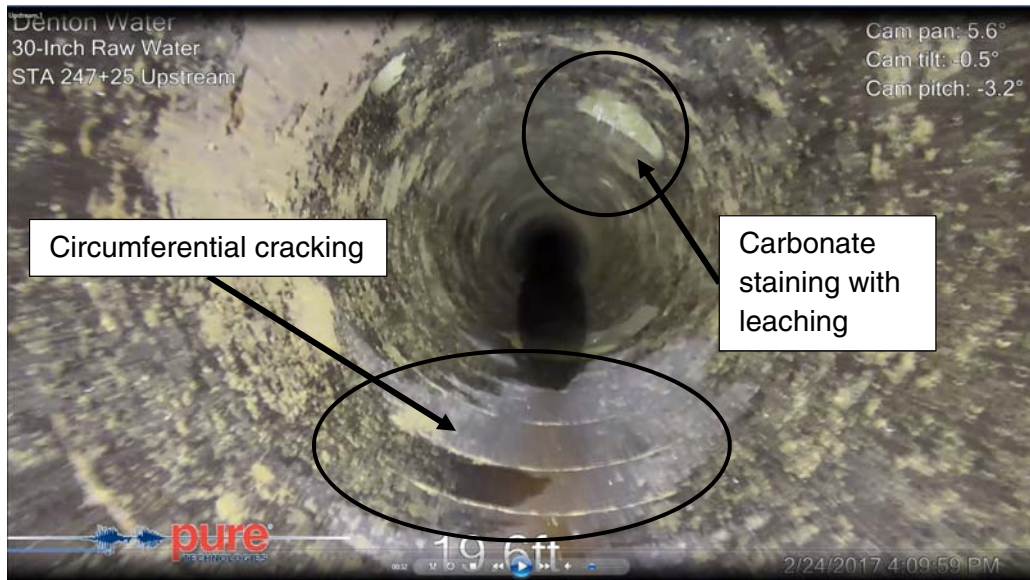
Figure 3.20: Pipe 2655, Circumferential cracking, Carbonate staining with leaching at 2:00 position,  
20 feet from insertion (Station 247+25, Upstream, Video 1)

Typically, circumferential cracking is not of concern, and generally does not relate to the structural integrity of the pipe, unless there is a correlation with the electromagnetic inspection. None of the pipes circumferential cracking correlated to the electromagnetic inspection data. A few pipes had numerous circumferential cracks throughout the pipe length.

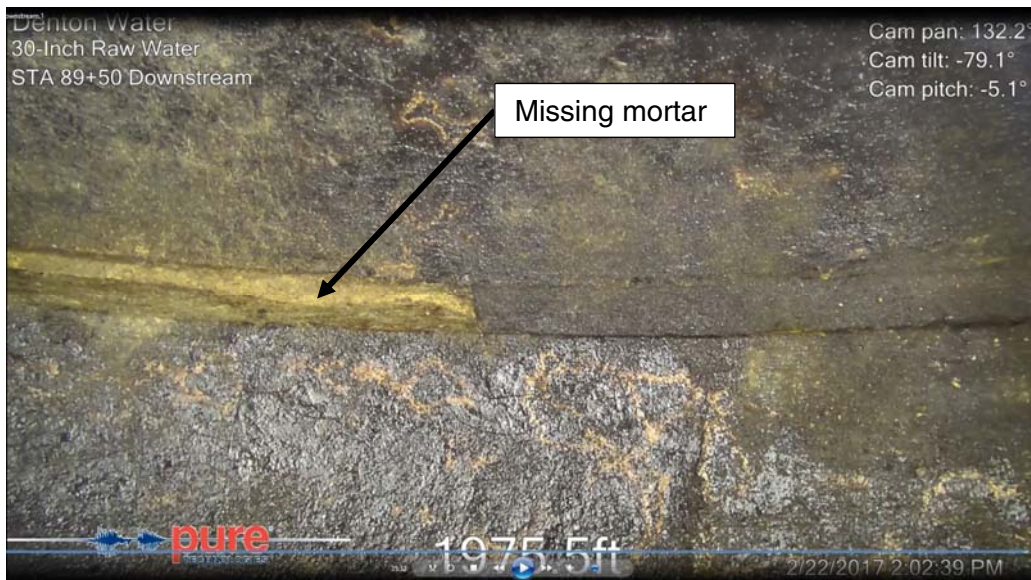
Figure 3.23: Pipe 2255, Joint missing mortar, 1,975 feet from insertion  
(Station 89+50, Downstream, Video 1),

Pure Technologies considers moderate spalling to be when the spall depth is greater than 0.5 inches but the underlying steel joint ring is not exposed. Severe spalls typically expose or nearly expose the joint ring and are considered in need of repair. The joints were not physically measured during the inspection, therefore it not possible to determine the depth and severity of spalls.

4. Joints missing mortar should be repaired with mortar, grout or approved equivalent in accordance with current bar wrapped pipe manufacturing recommendations. The joint of pipe 2255 (Pure reference number), Piece number 971 exhibited areas of missing mortar at the time of the inspection. Additional details are provided in Appendix D - Inspection pipe list with visual assessment observations.

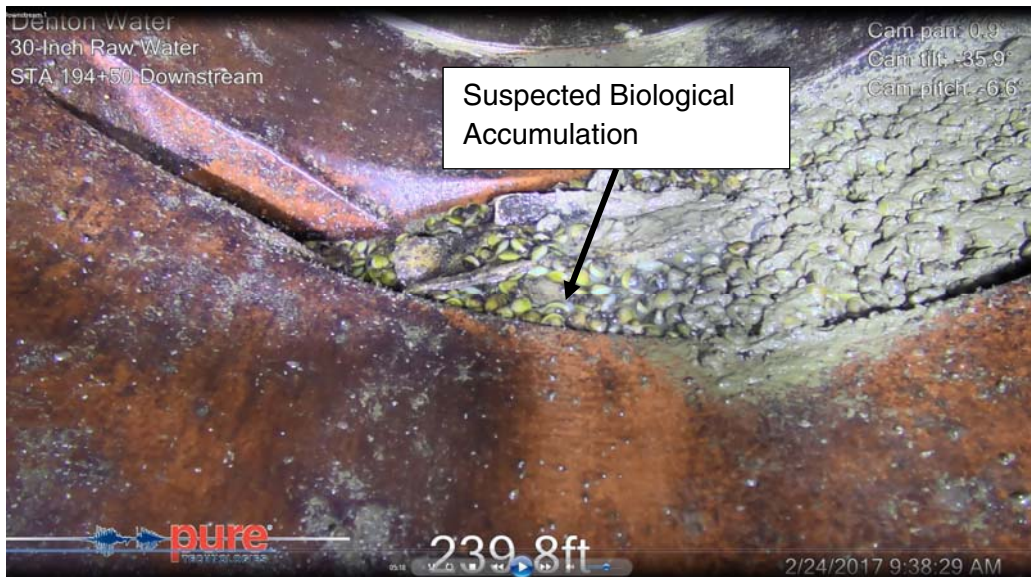
Figure 3.24: Pipe 2506, Gate valve, Suspected biological accumulation at invert,  
240 feet from insertion (Station 194+50, Downstream, Video 1)

5. The origin of the suspected biological accumulation should be further investigated.
6. Based on the level of distress detected during the electromagnetic inspection, Pure Technologies recommends that another inspection of the pipeline be conducted in five (5) years to determine if pipes with existing deficiencies exhibited an increase in distress (broken bar wraps or cylinder anomalies) or if new distress developed.

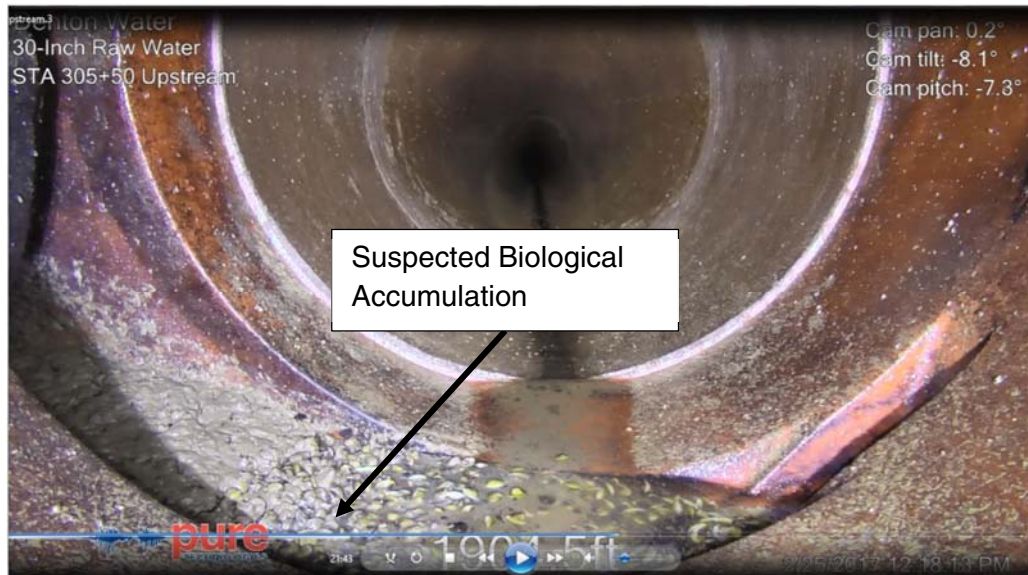
Figure 3.25: Pipe Number N/A, Gate valve, suspected biological accumulation at invert, 1,902 feet from insertion (Station 305+50, Upstream, Video 3), Laying schedules unavailable

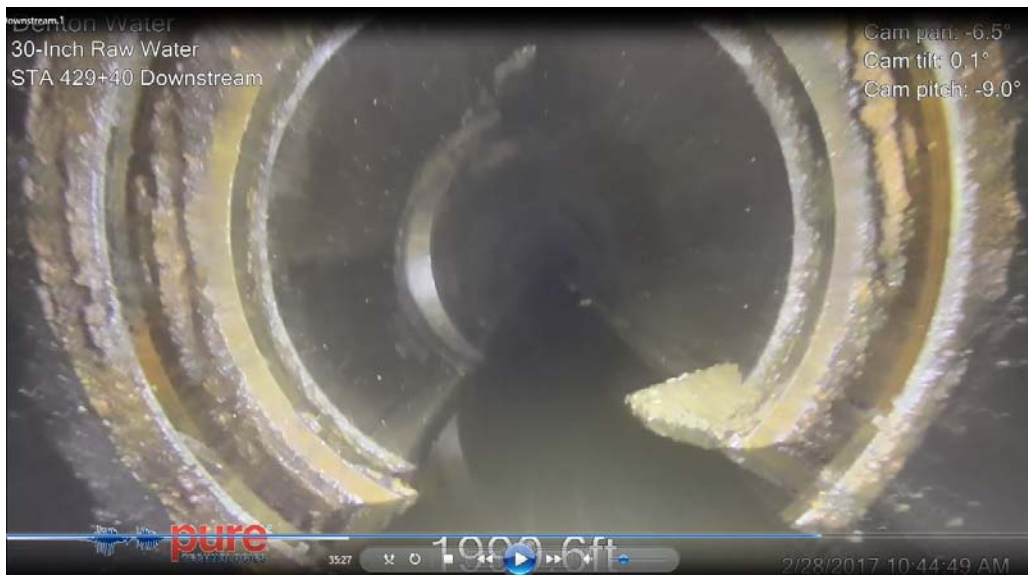
Figure 3.26: Pipe 3272, Gate valve, accumulation of debris, side outlet, 2,000 feet from insertion (Station 429+40, Downstream, Video 1)
