Assessing the Condition of a 30-inch Bar Wrapped Pipe Water Transmission Main

Presented by: Brian Ellis, P.E.

Pure Technologies

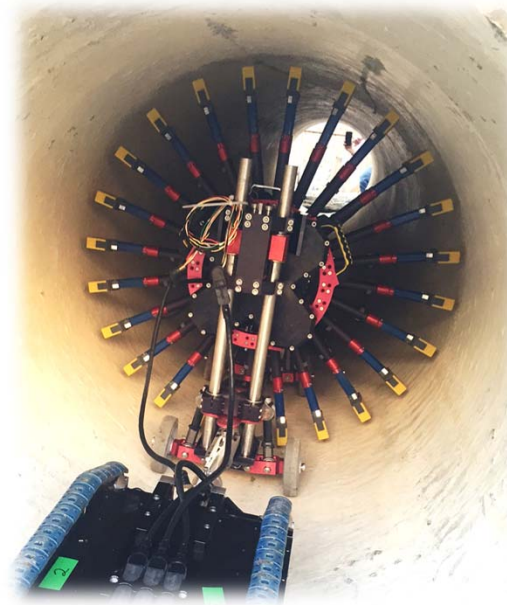
24D Array
used for Inspection
of Denton 30-inch BWP

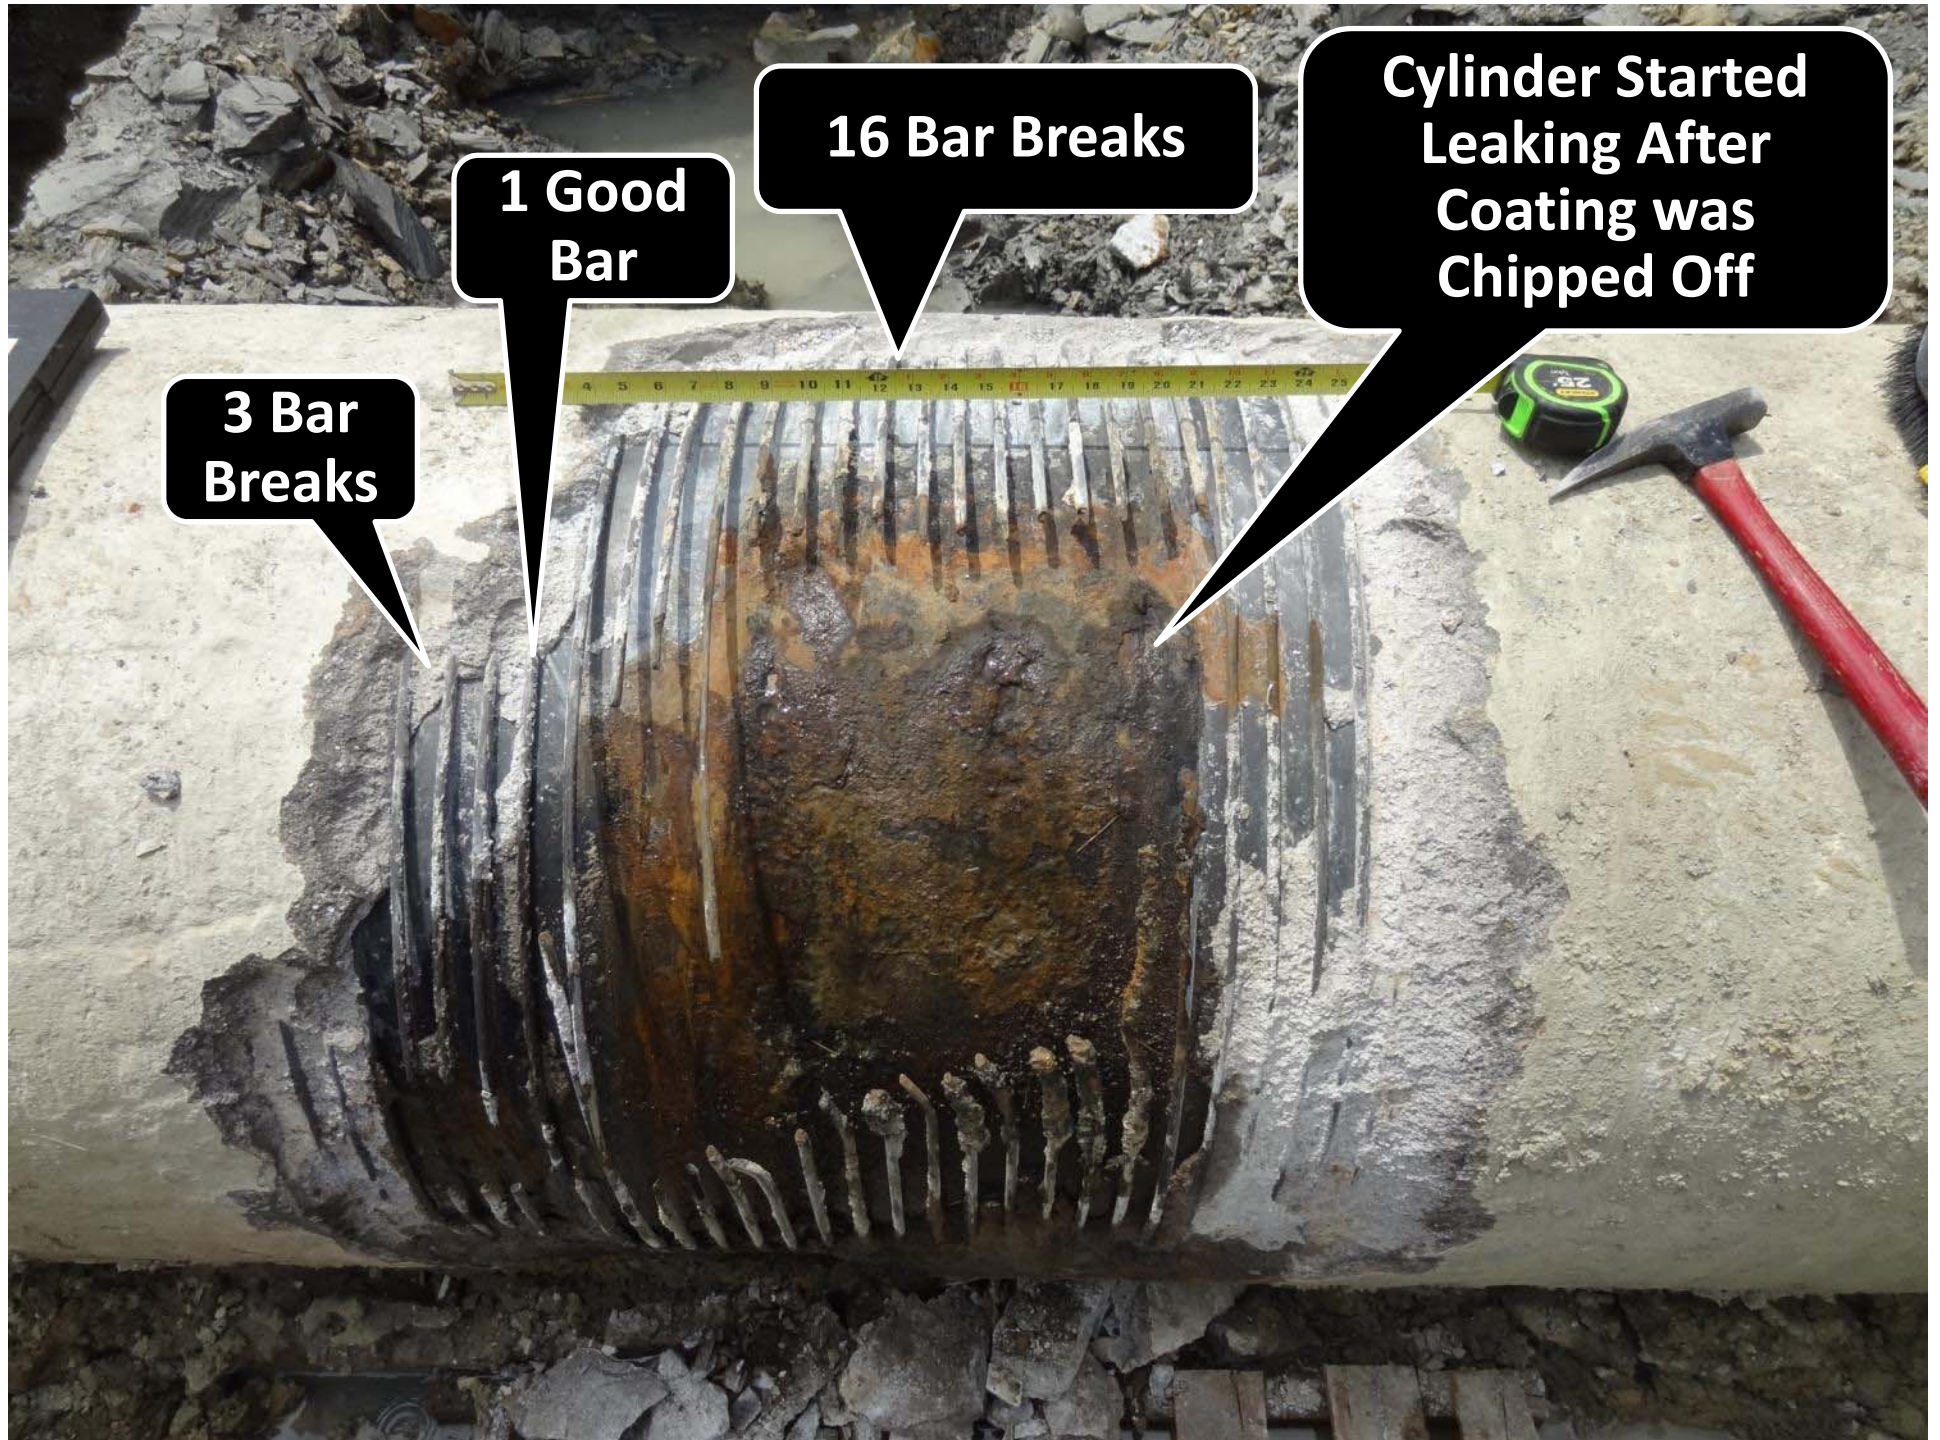
**3 Bar
Breaks**

**1 Good
Bar**

16 Bar Breaks
