MEMORANDUM

SUBJECT: ESA24-0001 Hunter Ranch Sewer

Riparian Buffer ESA Assessment Form

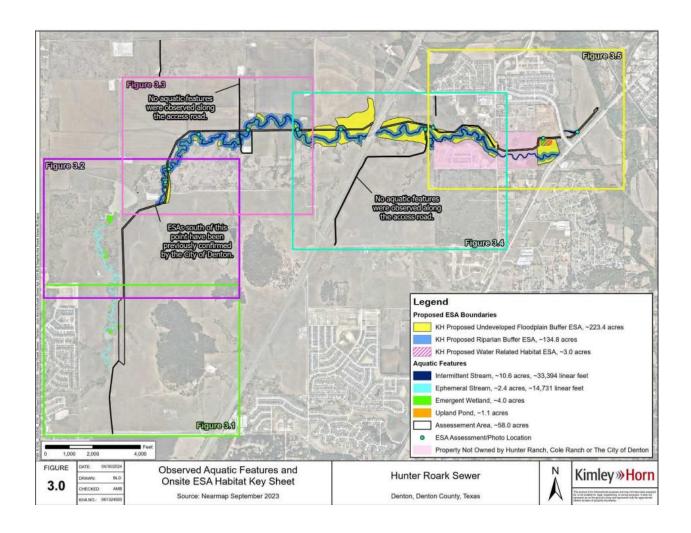
A wetland was found to have developed on the former Birch property south of the Vintage Village development.

Per a request from Hillwood Development for a sanitary sewer project serving the area, the Official ESA Map will be updated to reflect the current conditions found in the field.
