12 July 2022

RE: City Hall West Selective Demolition (1927 Old Denton City Hall)

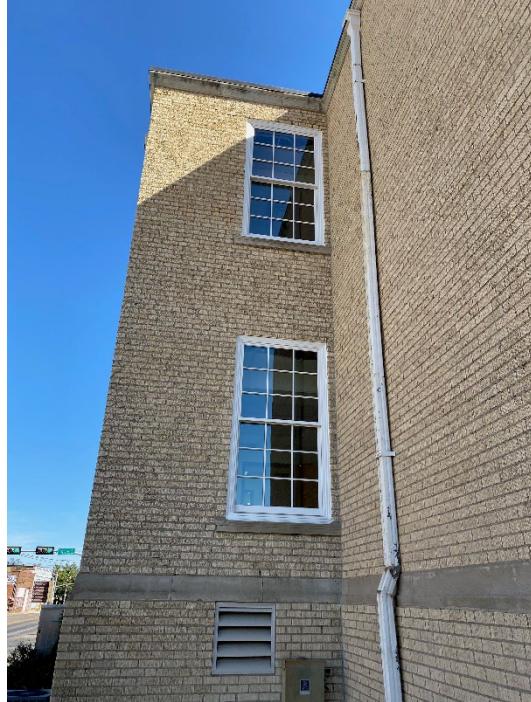
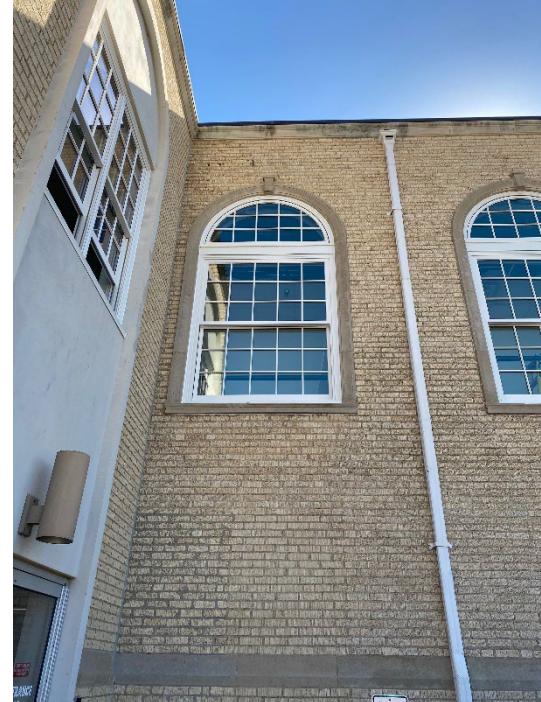
Existing Type F and cast stone surround

New windows and doors are limited to the removal of the north elevator addition. Windows will match the previously approved metal clad wood product used in the 2020 full exterior window replacement scope of work. Cast stone panels and water table will be reconstructed to match existing panels at window type E

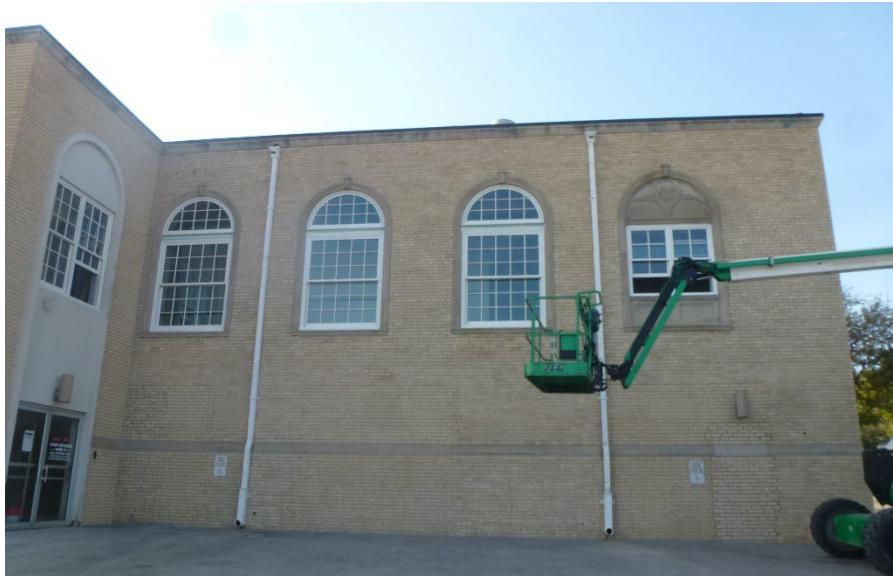
North Elevation, non-original elevator tower at left of photo

The scope of work includes the removal of interior infill structure to return the building's original auditorium space and offices. Levels D & F added within the original auditorium will be removed in anticipation of a full interior restoration of the building. The north elevator addition will be removed including the removal of the elevator shaft and floors at levels B & D. The original exterior wall remains with damage to cast stone water table and window surrounds. The original exterior wall will be restored and original masonry openings and windows reconstructed. Windows and the exterior door will be metal clad wood of the same manufacturer and line installed in 2020. Significantly damaged cast concrete balustrade at the tower will be restored through crack injection and patching. We request the Texas Historical Commission's review and approval of the proposed scope of work.

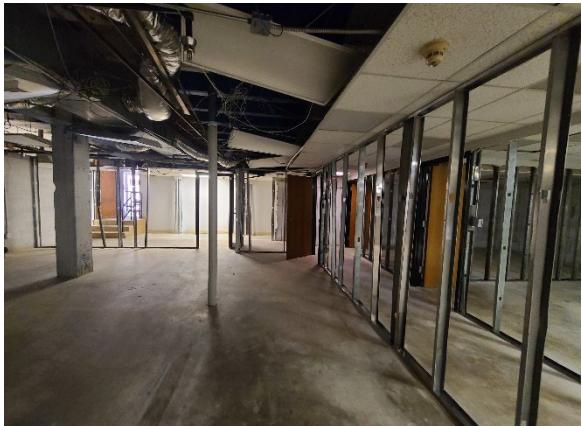
Level B looking south, former fire station

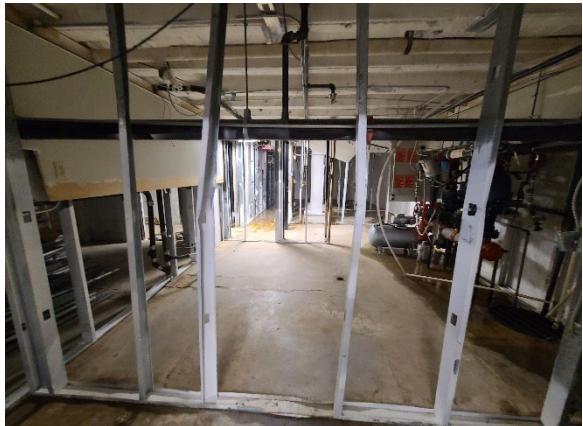
Level A looking north, basement and utilities

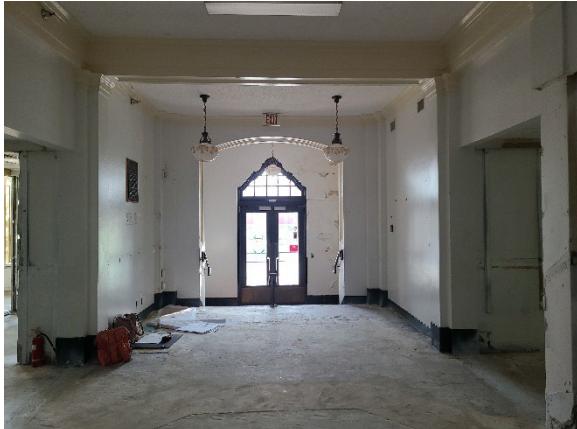
Level C Lobby looking east, original finishes

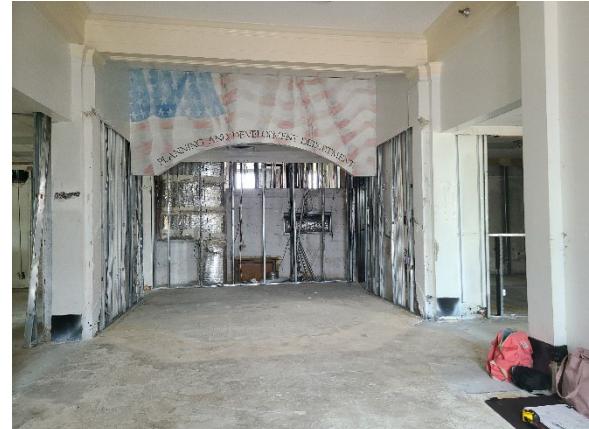
Level C Lobby looking west, floor removal for stair

Future phases will reconstruct the grand stair from level C to the back of the auditorium. The concrete infill floor will be removed during this scope of work with temporary protection installed. The building will remain unoccupiable until direction on future use is determined and approved by the City of Denton. A current "Vision Plan" process is underway to determine future use with community involvement.

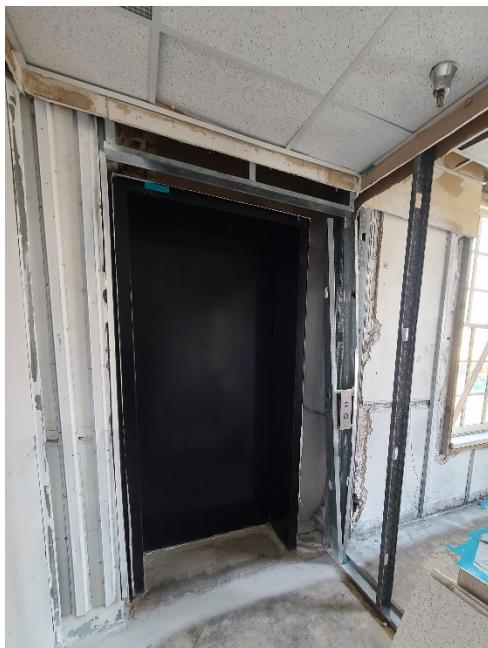
Level C North elev. Door in former window opening

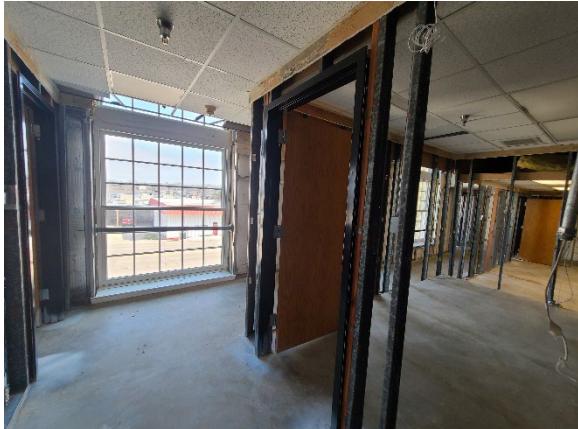
Level D looking at north auditorium wall

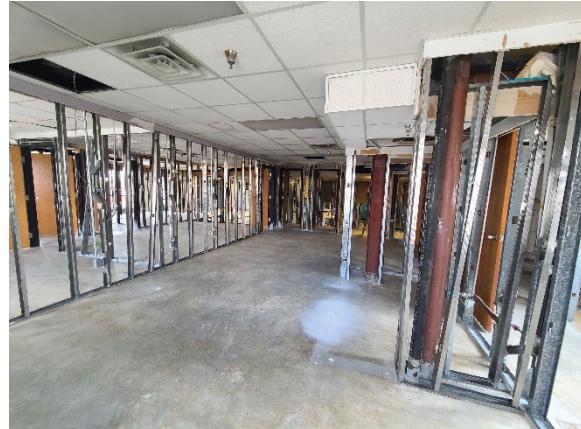
Level D original steel columns

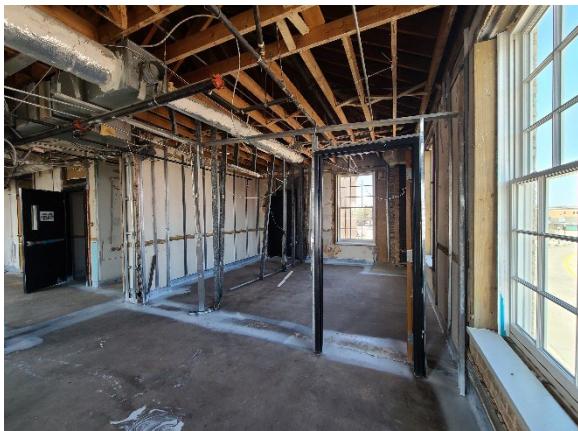
Level E looking at north elevator door

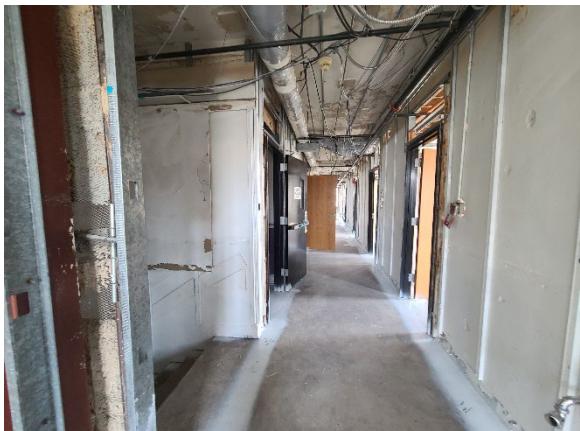
Level E original stair & hall walls

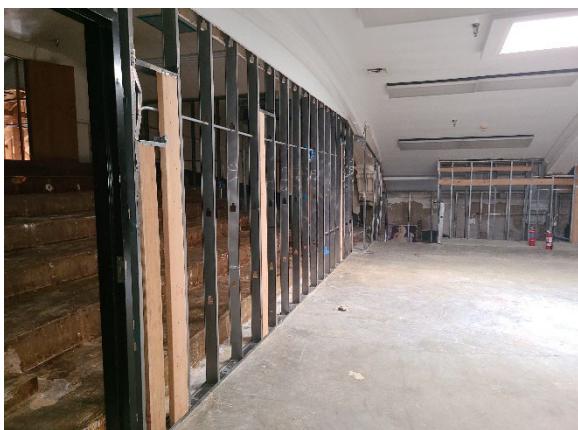
Level F looking south, partial balcony remains

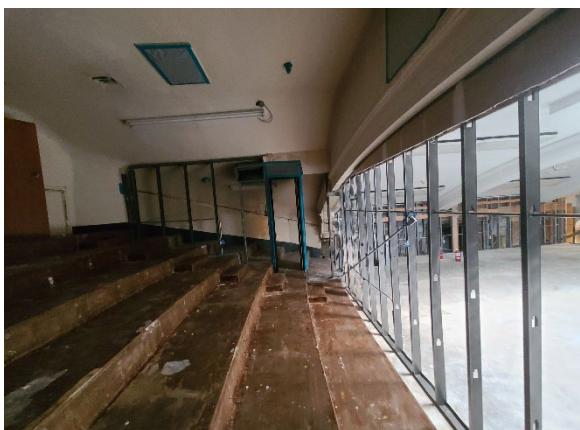
Level F remaining portion of balcony

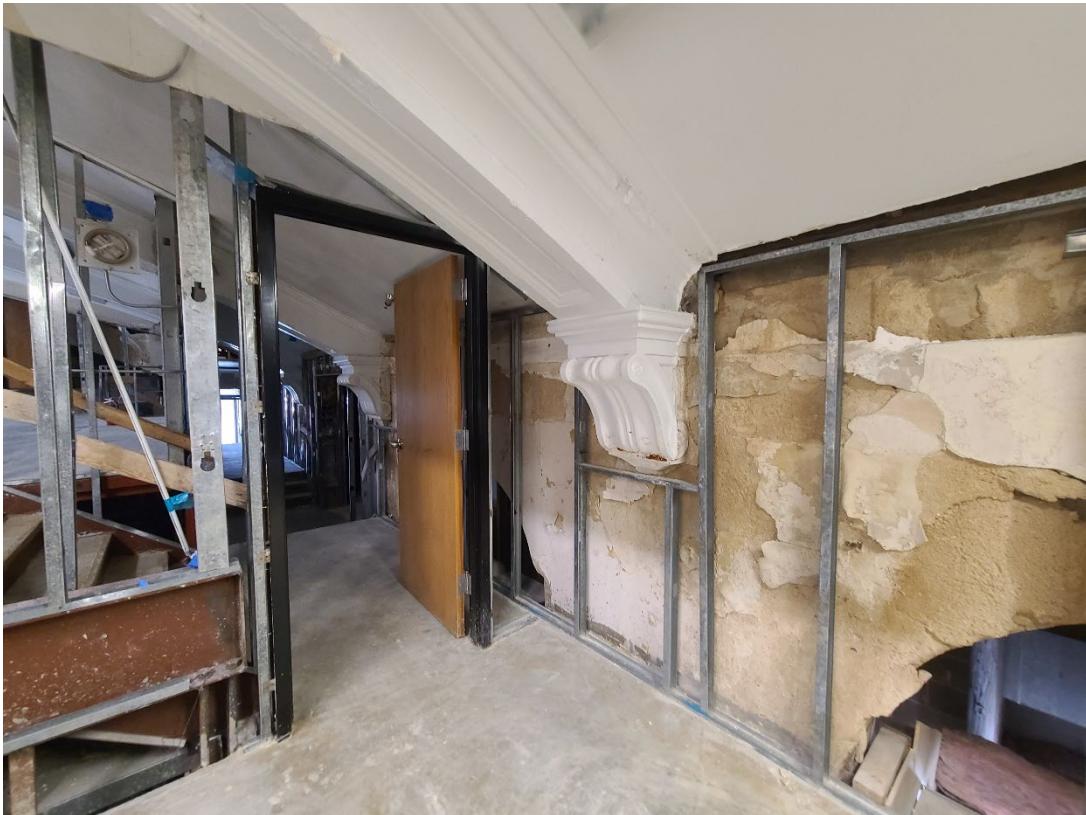
Level F original south wall, masonry opening, ceiling plaster work, infill floor

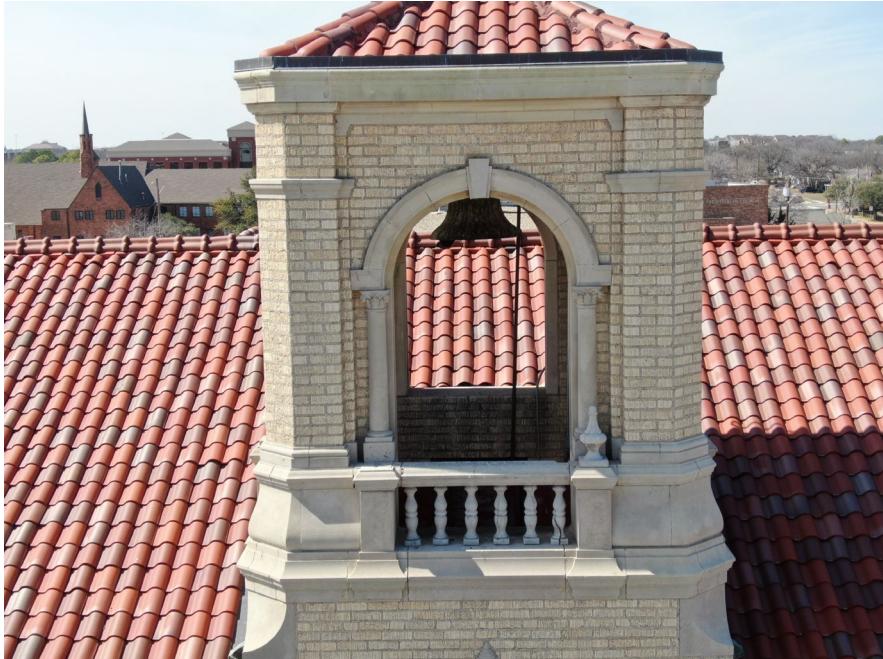
Cast stone balustrade at the clock tower has significant cracking and detached pieces. The loose pieces present a life safety hazard to pedestrians below. Restoration of the cast stone balustrade is limited to the clock tower and will inject cracks and dutchman patch the existing material.

Bell tower cast stone balustrade, east elevation, missing urn

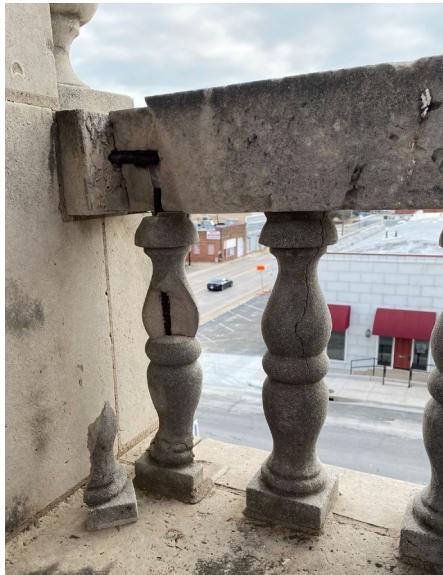
East balustrade interior

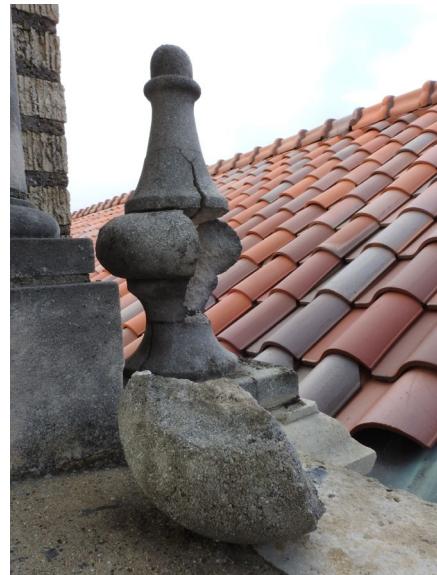
West urn damage
