ALTERNATIVE ENVIRONMENTALLY SENSITIVE AREA REPORT

IDI Logistics

Spencer Road Industrial Project Site

City of Denton Environmentally Sensitive Areas Assessment
(ESA# 25-0001)

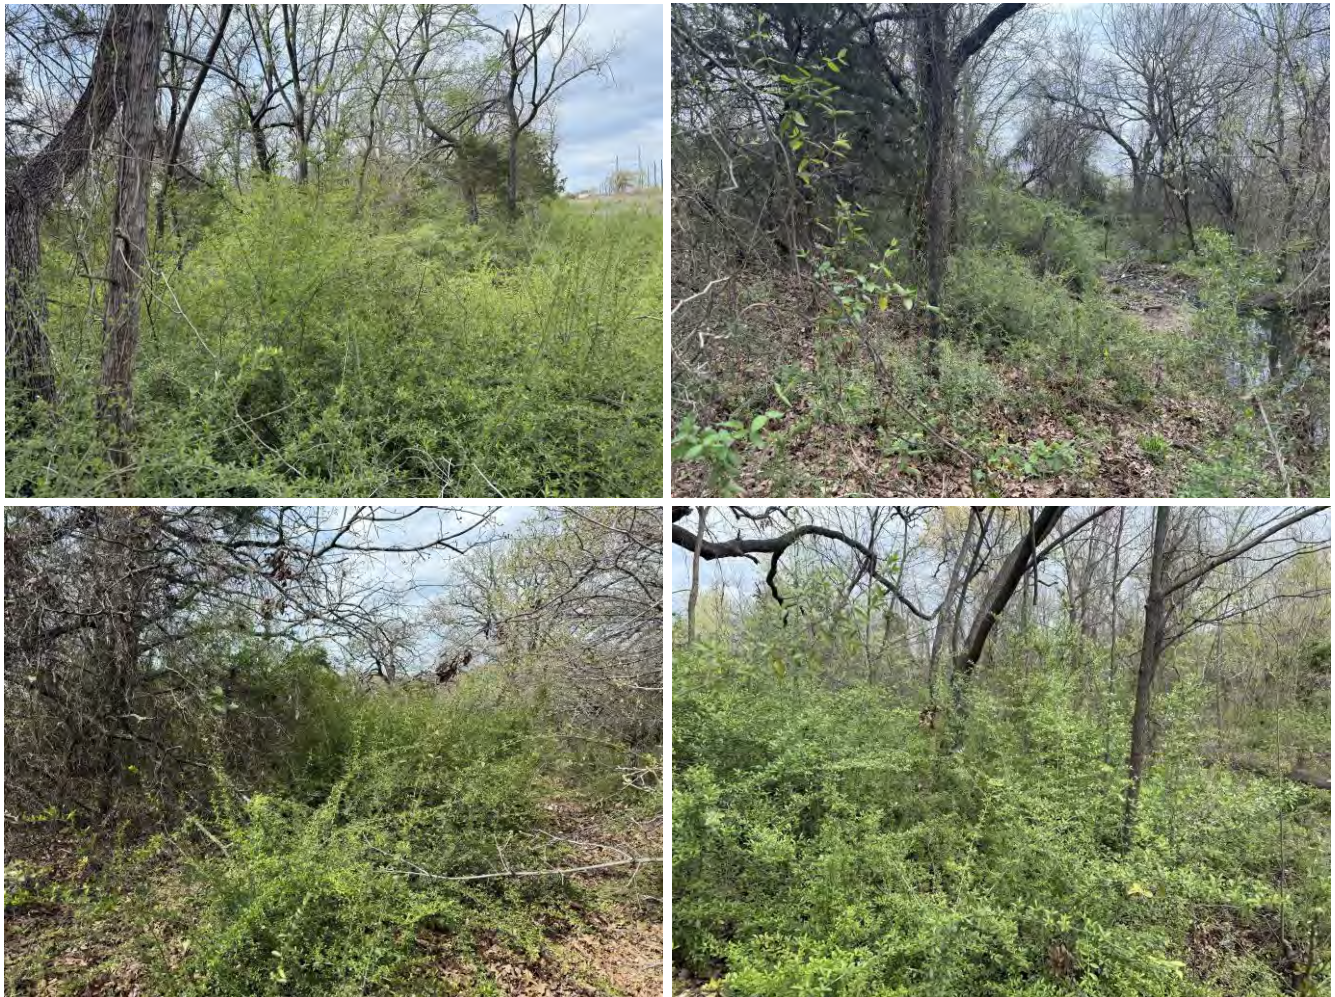
Figure 1 illustrates that invasive Chinese privet currently dominates the canopy understory within the ESA. Mechanical removal will consist of the use of a hydro-axe for most of the area, supplemented with hand clearing to remove Chinese privet immediately surrounding existing trees. The hydro-axe will remove the aboveground portion of the Chinese privet plant but does not remove the root system and sprouting will occur. The regrowth will be spot treated with triclopyr, a pesticide from the City's Integrated Pest Management list, the following spring at the recommended label rate. An additional spot treatment of seedlings will be conducted, if necessary. Debris from the privet removal will be mulched and spread within the mitigation area. The eradication of Chinese privet will open the understory and improve opportunities for diverse native species to thrive with limited invasive competition. A successful eradication will allow for no more than 5 percent of remaining Chinese privet understory cover. Seedlings and regrowth will be monitored and removed seasonally during the 3-year monitoring period within the mitigation area as needed to ensure Chinese privet remains eradicated.

Figure 1. The photographs illustrated above depict the understory of invasive Chinese Privet throughout the mitigation area.

A mitigation plan executed over a year-long period is proposed to effectively restore and improve the unimpacted Riparian Buffer and Undeveloped Floodplain ESAs. A contractor, such as IES, will be contracted to complete the privet removal and monitoring. The developer is proposing to mechanically remove Chinese privet, an invasive species, from the understory of the unimpacted Riparian Buffer and Undeveloped Floodplain ESAs as well as from non-graded areas immediately surrounding the ESA to help prevent the reintroduction of Chinese privet. The removal approach is a targeted mechanism to eliminate invasive species and will result in no ground disturbing activities that could harm overstory trees. The initial privet removal will occur the first winter after construction has commenced to reduce sprouting.

A seed mixture will be seeded throughout the unimpacted Riparian Buffer and Undeveloped Floodplain ESA regions once the understory has been cleared of Chinese privet to provide a protective ground cover and functional understory strata. The seed mix is intended to aid in rebuilding the stream bank buffer zone. The seed mix will include native species such as Virginia wildrye (*Elymus virginicus*), Canada wildrye (*Elymus canadensis*), inland sea oats (*Chasmanthium latifolium*), purpletop tridens (*Tridens flavus*), purple coneflower (*Echinacea purpurea*), bergamont (*Monarda fistulosa*), red columbine (*Aquilegia canadensis*), black-eyed Susan (*Rudbeckia hirta*), swamp sunflower (*Helianthus angustifolius*), American beautyberry (*Callicarpa americana*), butterfly weed (*Asclepias tuberosa*), frostweed (*Verbesina virginica*), and blue mistflower (*Conoclinium coelestinum*). The native seed mix will contain no more than 20 percent of a single species. The proposed seeding goal is to develop an AESA with a quality, diverse, functioning habitat that will not need additional maintenance beyond the initial seeding.

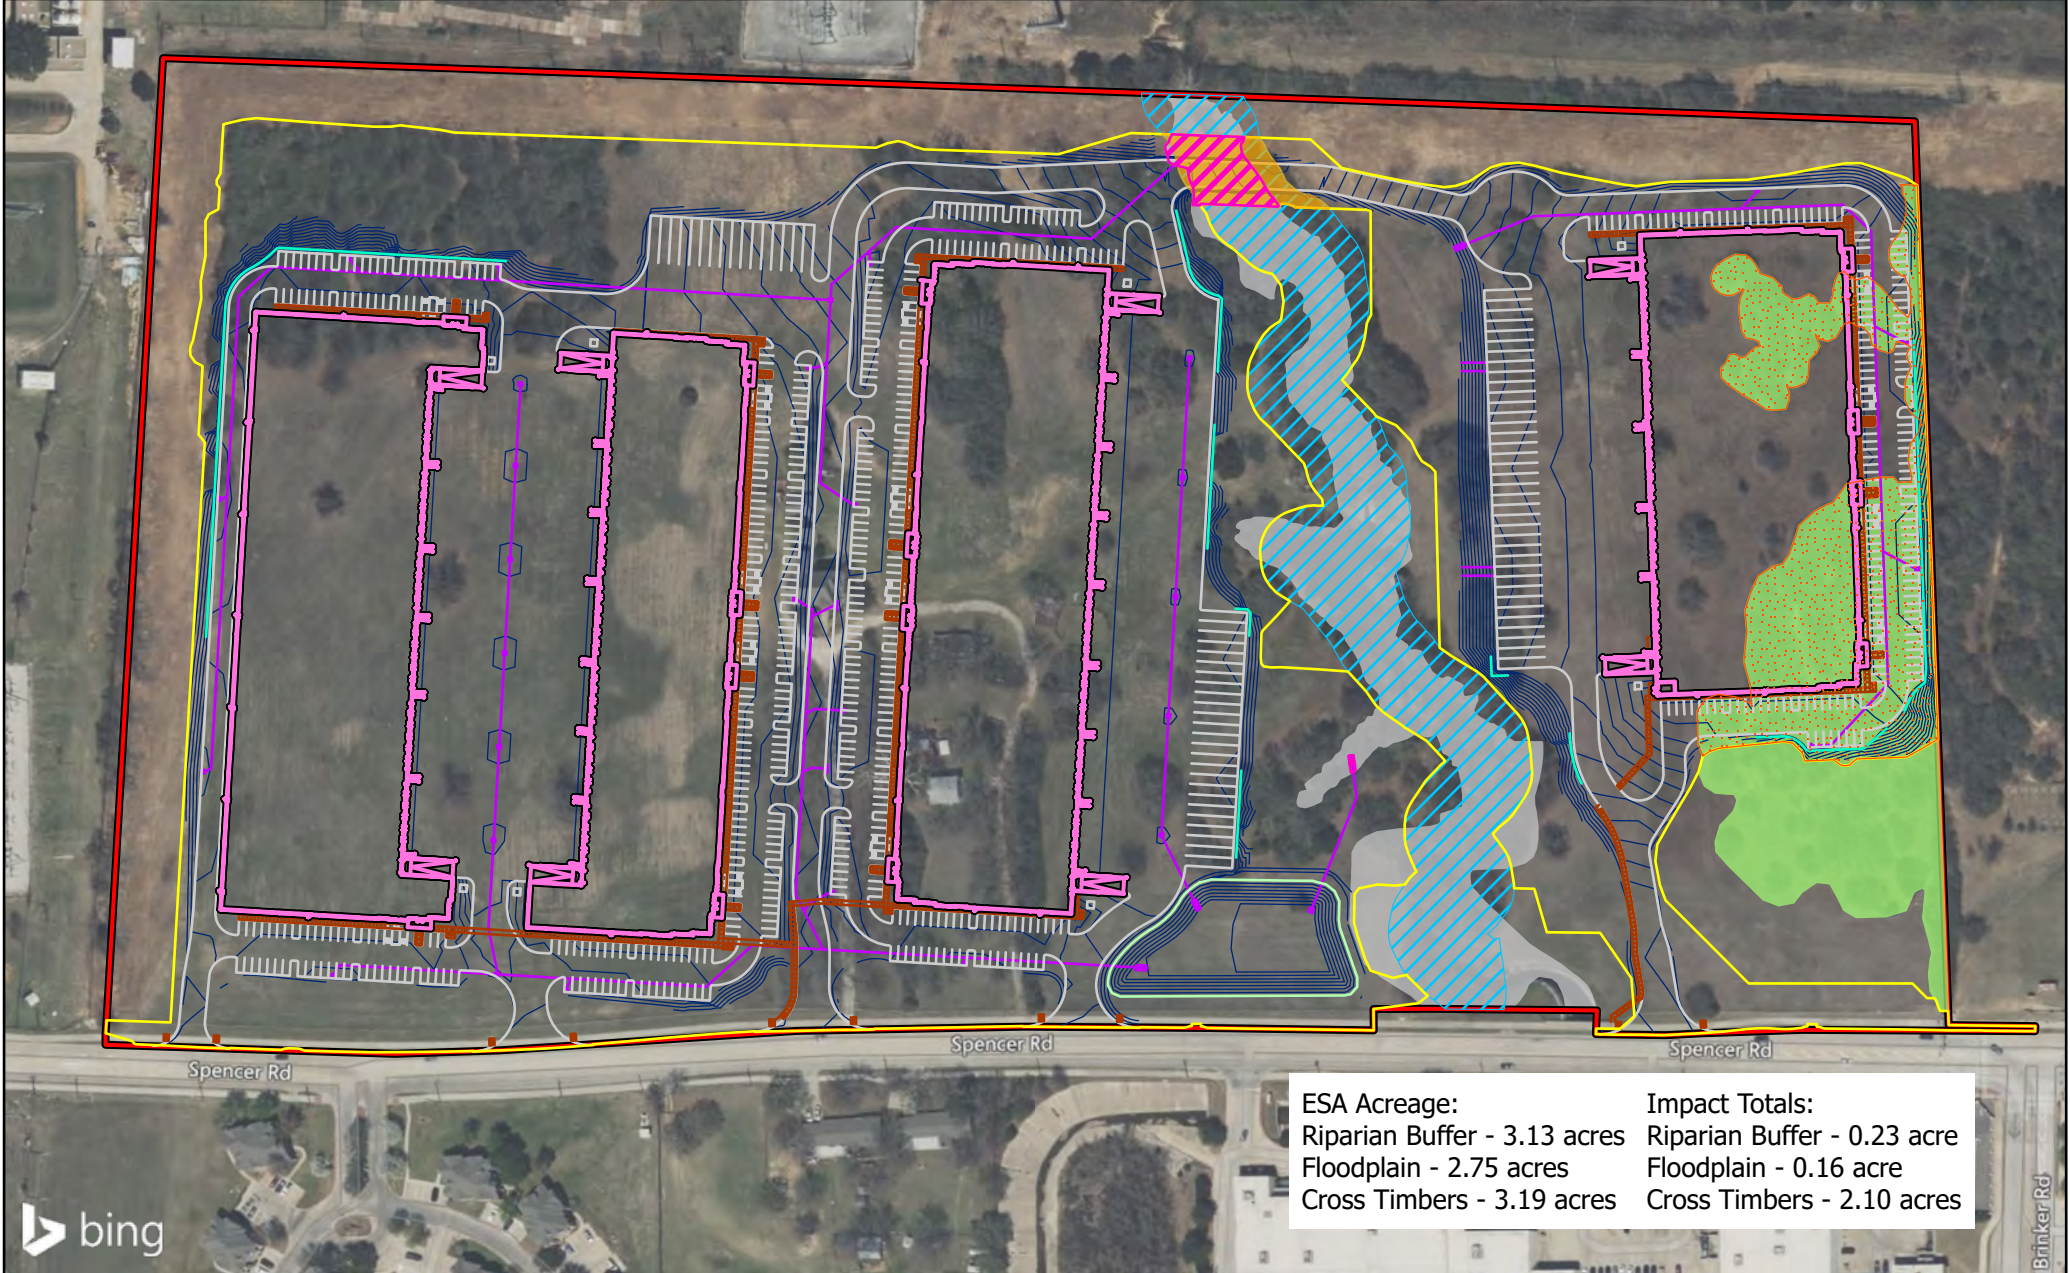
Figure 5.
Site Plan and Impacts Map

Appendix A, Figure 5 shows the observed Riparian Buffer and Undeveloped Floodplain associated with the stream channel through the central region. The total Riparian Buffer ESA covers 3.13 acres, and the Undeveloped Floodplain ESA covers 2.75 acre within the property boundary.
