**BOND**  
**PROGRAM 2023**

# Fire Stations 5 & 6

Meeting # 2

June 1, 2023

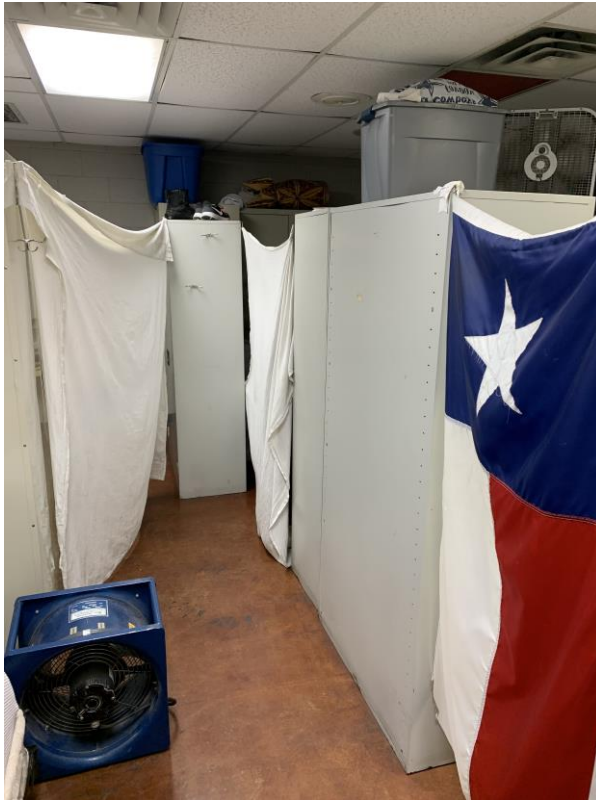
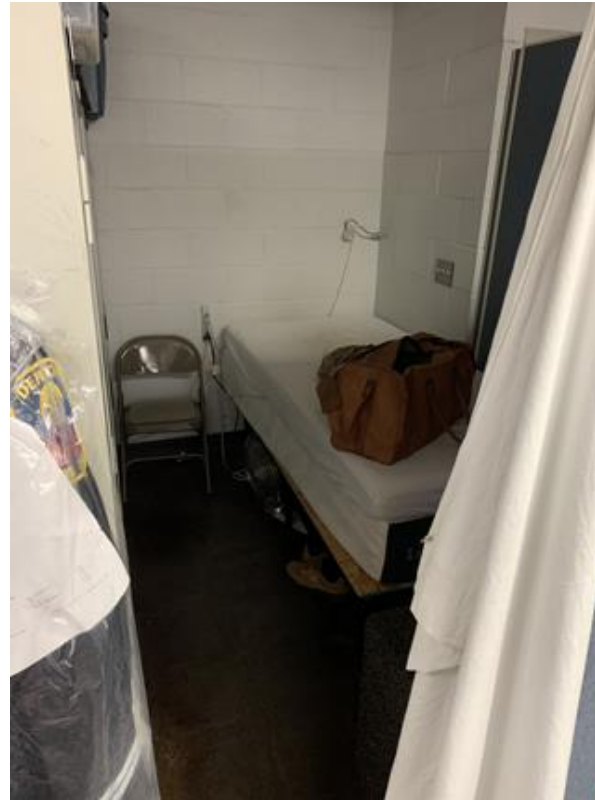
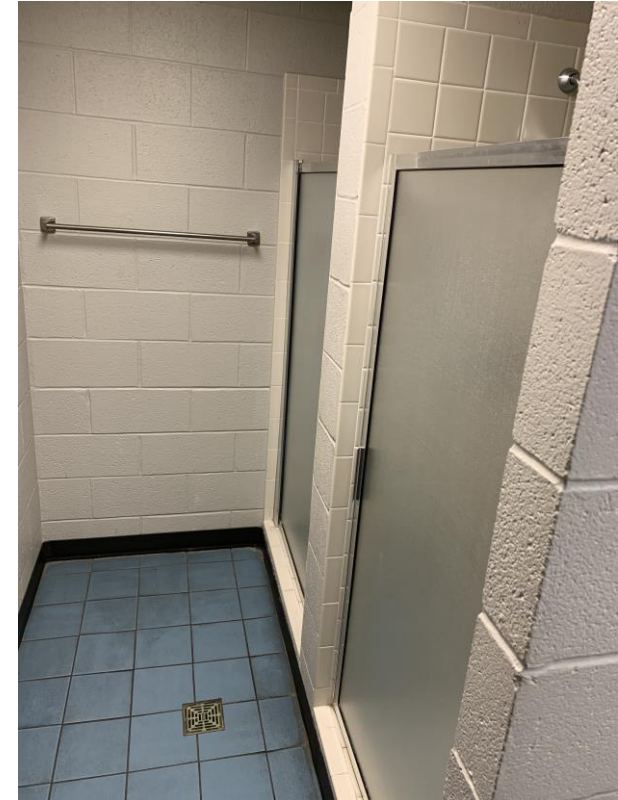
## Inadequate Employee Amenities

Barrack Style Sleeping and Hygiene areas

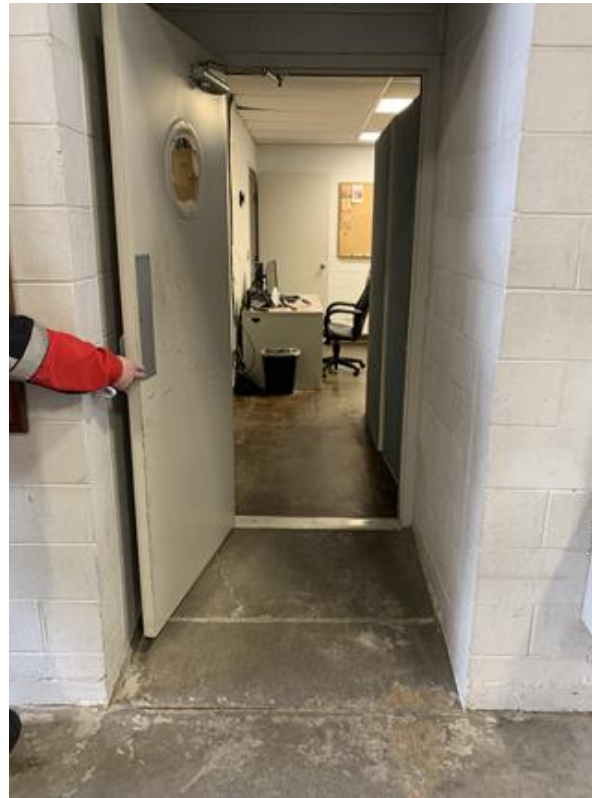
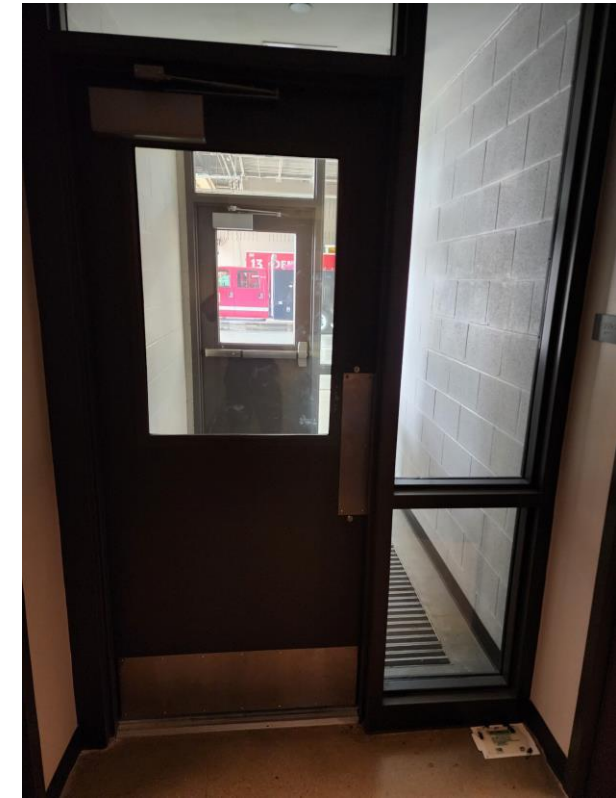
Lack of carcinogen and biohazard reduction zones (hot/warm/cold)\*\*

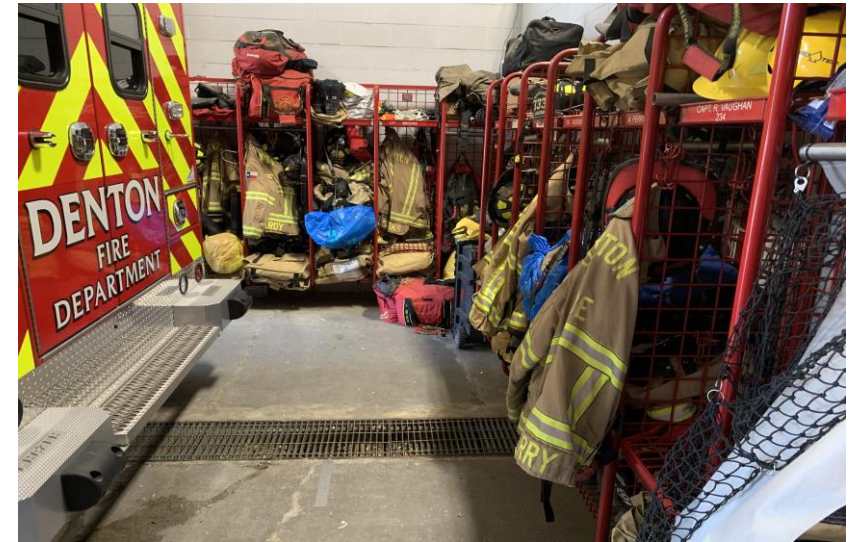
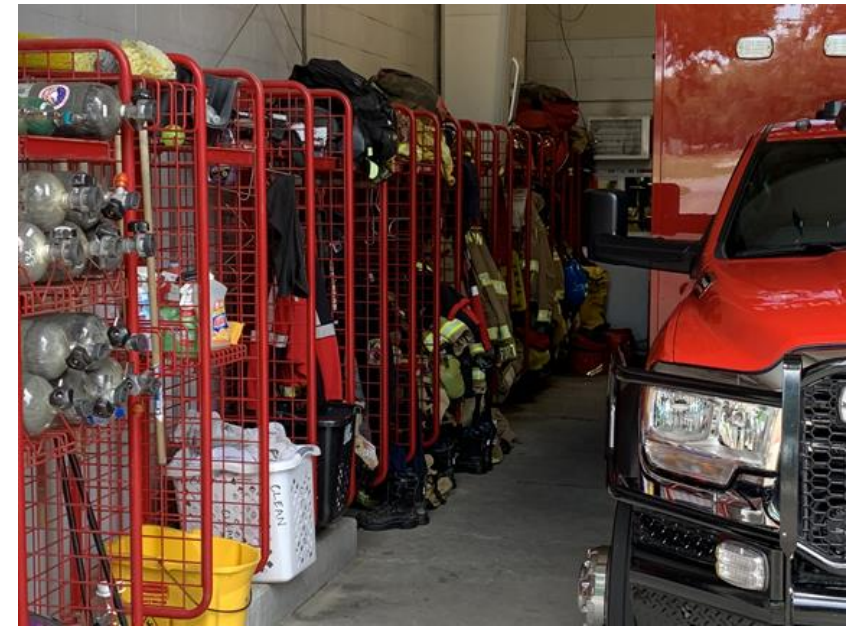
## PPE Storage\*\*

Insufficient space, exposure to vehicle exhaust and UV rays

- UV damaged gear in past 7 years- \$40,000
- NFPA 1851 non compliant

## Ineffective exhaust ventilation in apparatus bays\*\*

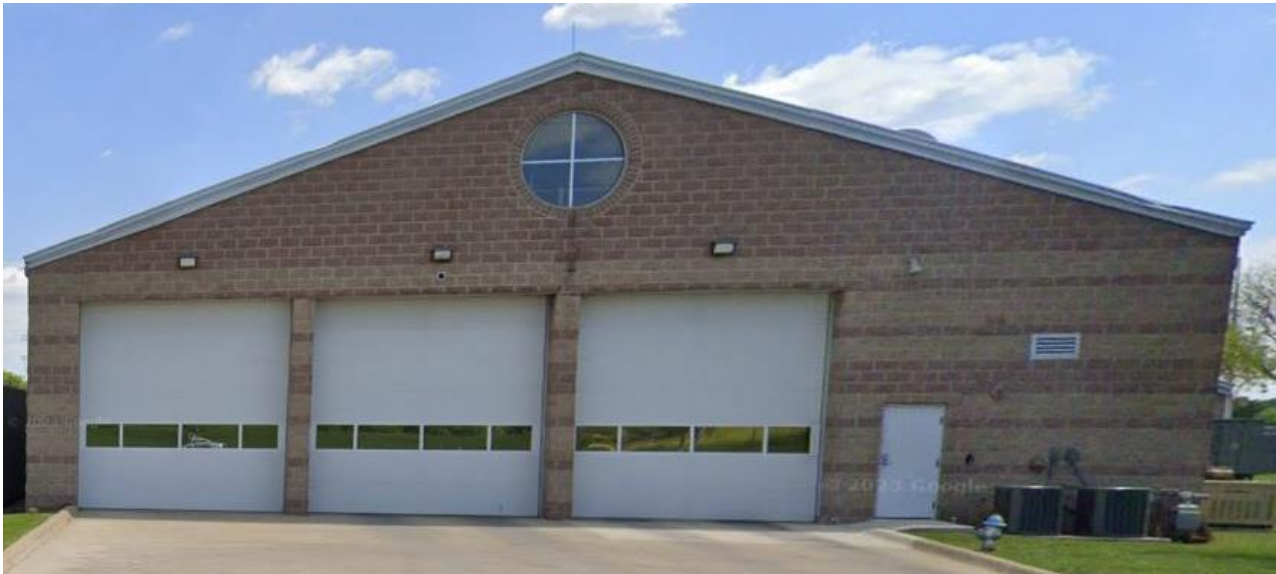
Station 5 & 6 Bay Doors

- Existing Horizontal Doors increase response times  
(DFD 2020 Strategic Plan)

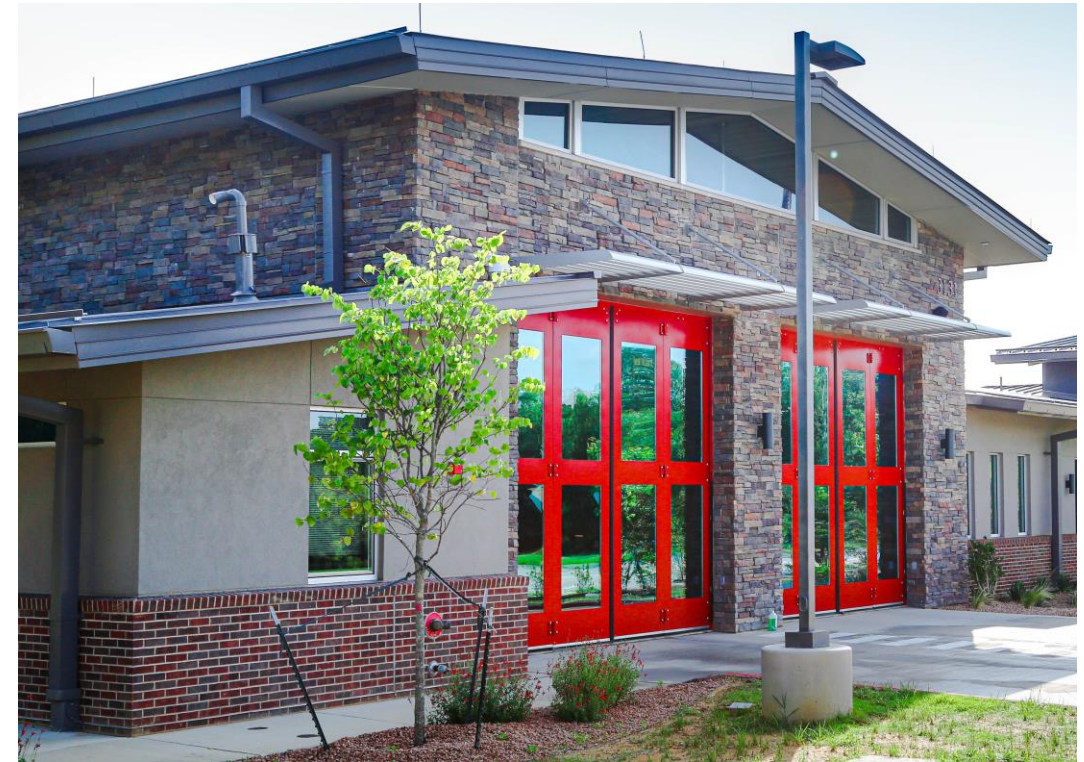
New doors open in <7 seconds

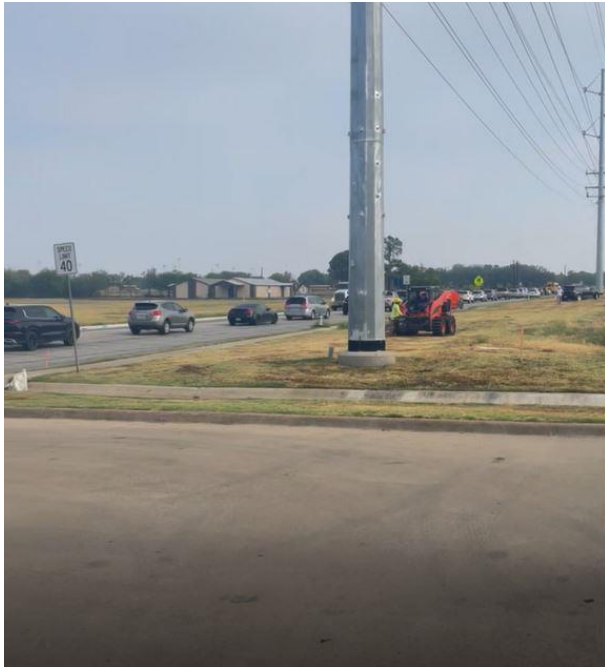
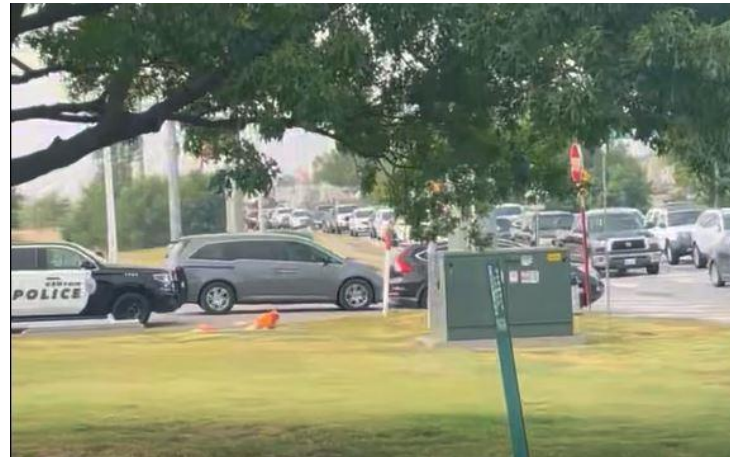
## Station 5

- Traffic stack from Denton High School on Bonnie Brae impacting apparatus response

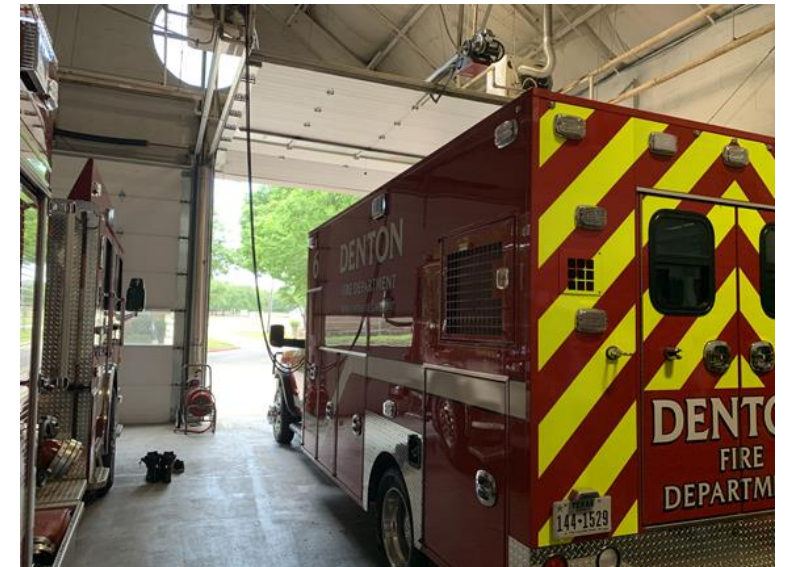
## Station 6

- Limited visibility for Traffic and Emergency Apparatus entering Teasley
- Absence of Drive Through bays for Apparatus (Requires Backing)

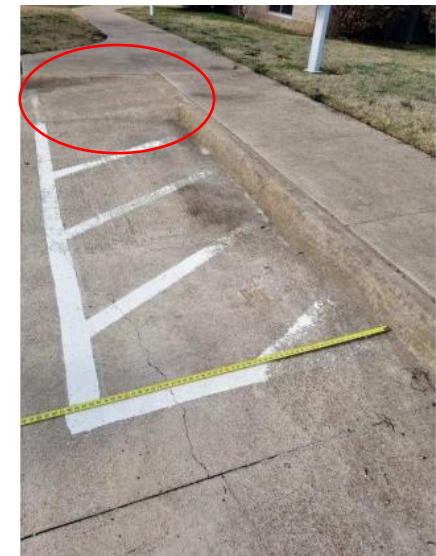
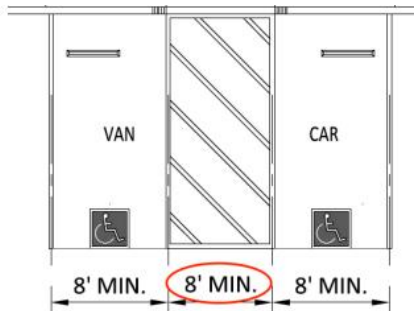
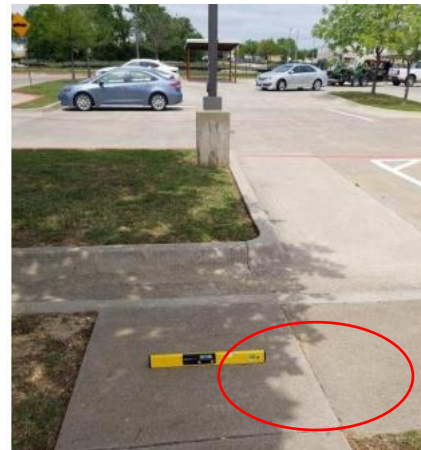
- The ADA Assessment identified 103 barriers at Fire 5 & 6, of that, 10 barriers fall within the high priority category.

• Parking	High Priority 3	There are no van accessible parking stalls. Severely out of compliance.
• Parking	High Priority 2	The access aisle is not located on an accessible route of travel to the accessible building entrance. Severely out of compliance.

• Parking	High Priority 4	The access aisle is not a minimum 8 feet to the centerline of the stripe. Moderately out of compliance.
• Parking	High Priority 2	The access aisle contains a built-up curb ramp. Severely out of compliance.

• Parking	High Priority 2	The cross slope (short dimension) of the access aisle exceeds 2 percent. Severely out of compliance.
• Path of Travel (2)	High Priority 4	The concrete expansion joint is spaced greater than 1/2 inch. Moderately out of compliance.

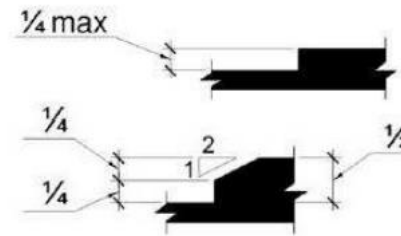
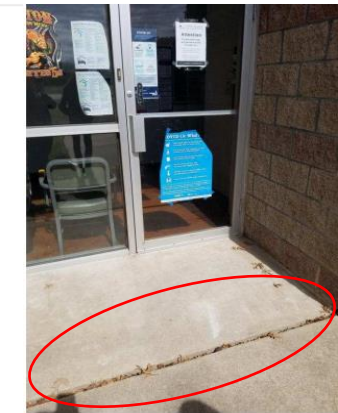
• Path of Travel	High Priority 4	The walkway contains abrupt vertical edges and/or variations over 1/4 inch. Moderately out of compliance.
• Engine bay	High Priority 4	The grate openings are greater than 1/2 inch and are parallel to the direction of travel. Moderately out of compliance.
