City of Denton Historic Landmark Commission Tax Exemption Application for Designated Historic Sites

Name of Owner	TJD Holdings, LLC									
Property Address	1314 N Locust St., Denton, Texas 76201									
Telephone/Email	940-387-0512									
Start/Completion Dates start: 01/27/2323 - finish: 03/09/2023										
	f Completed Improvements and/or Restoration Work:									
Circumferential water	drainage system, foundation repair and electrical (for water pumps).									
Please also attach t	the following with your application:									
receipts for	proof of payment for completed improvements and/or restoration work. (Please note all work completed must total a minimum of \$10,000 in order to be considered for the Historic Sites Tax Exemption.);

THIS IS TO CERTIFY THAT ON THIS DATE, I MADE AN ON-SITE INSPECTION OF THE FOUNDATION AND DRAINAGE PERFORMANCE FOR THE ADDRESSED PROPERTY. THE SUBJECT IS A ONE STORY, DENTAL OFFICE, SIDING VENEER DWELLING, SUPPORTED ON A PIER-AND-BEAM FOUNDATION. FOR ORIENTATION PURPOSES, IT IS ASSUMED THAT THE PROPERTY FACES WEST. THIS INSPECTION MEETS THE REQUIREMENTS OF A "LEVEL B" EXAMINATION AS DEFINED BY THE TEXAS BOARD OF PROFESSIONAL ENGINEERS. (Pi

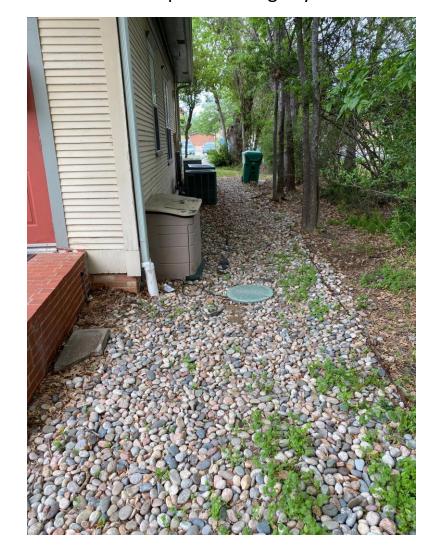
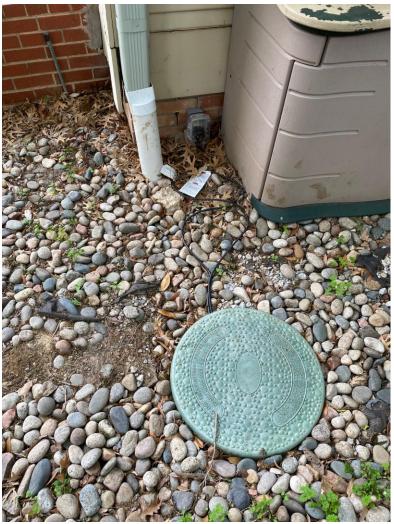
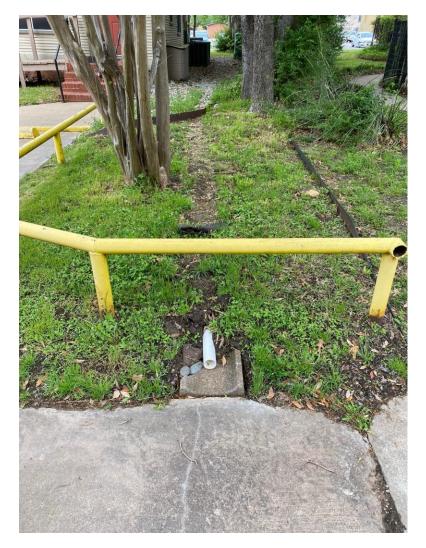
New Water Pumps & Drainage System

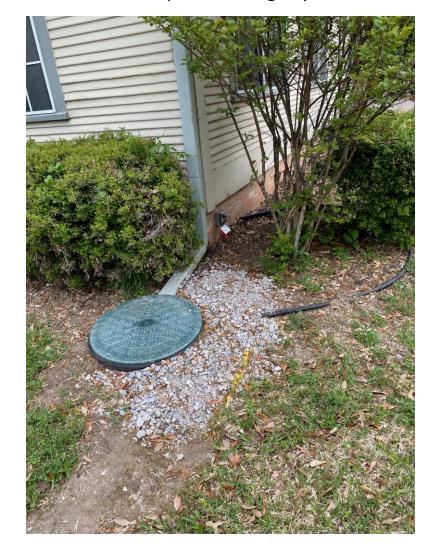
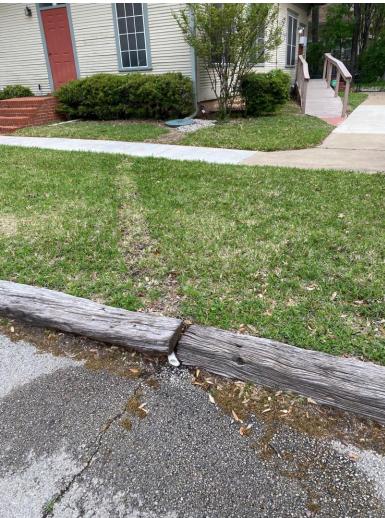
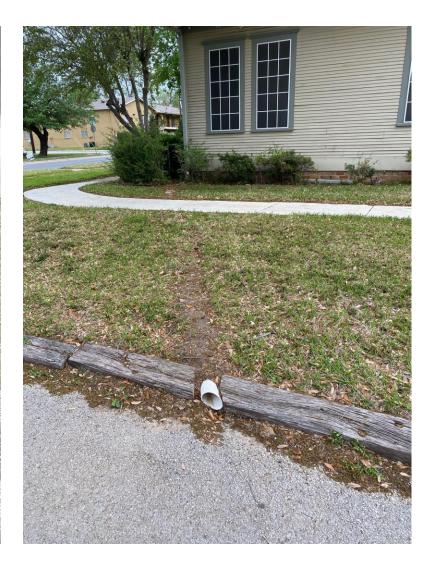
New Water Pumps & Drainage System

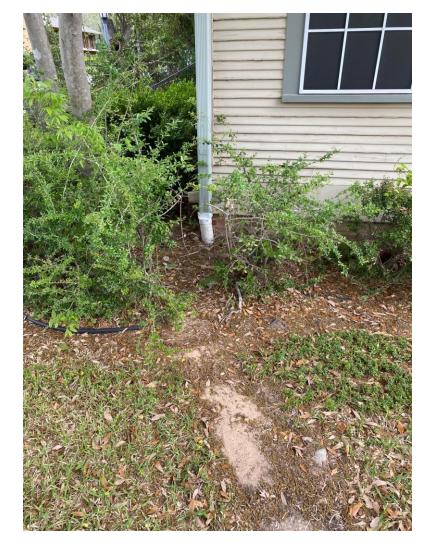
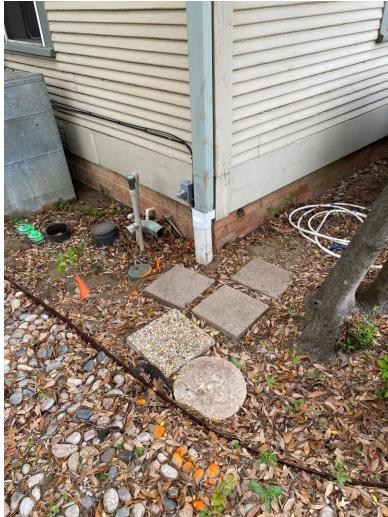
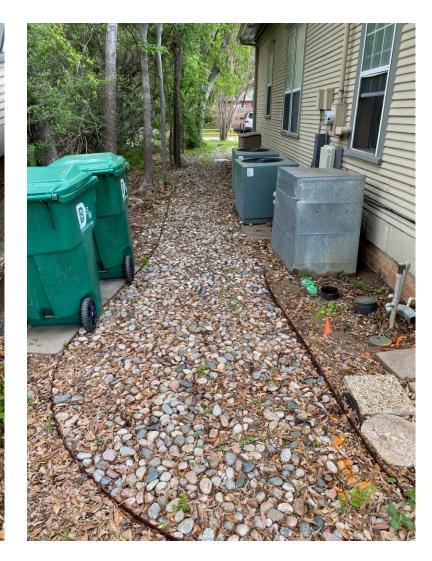
New Drainage System
