Denton's use of Quick Cam and Quick Lock to meet CMOM goals

PUB Presentation
December 14, 2015

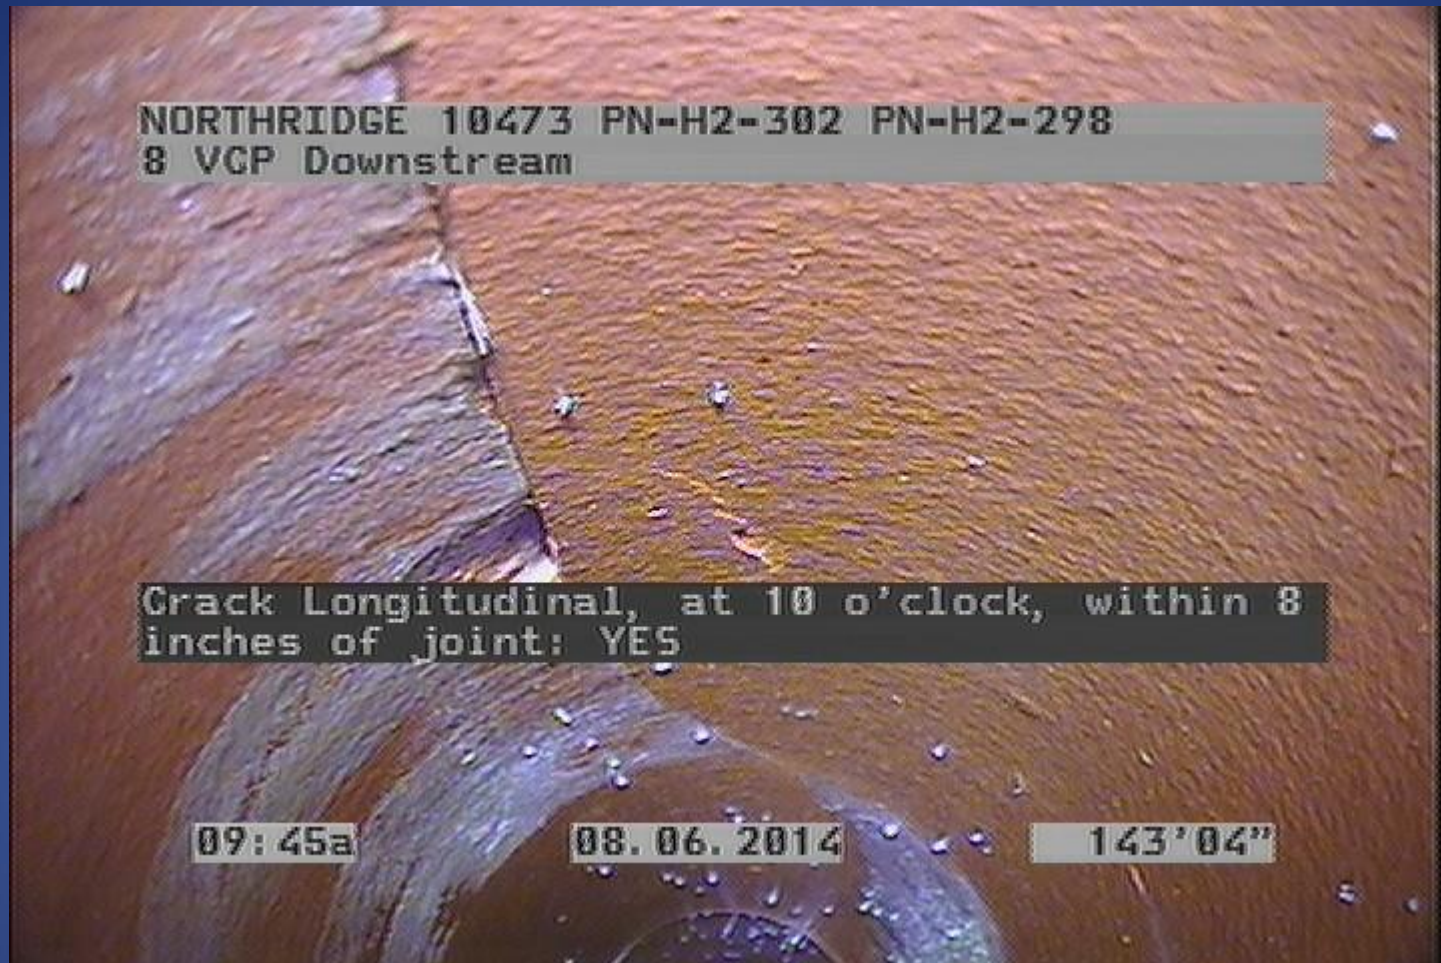
CCTV picture of fracture allowing infiltration.

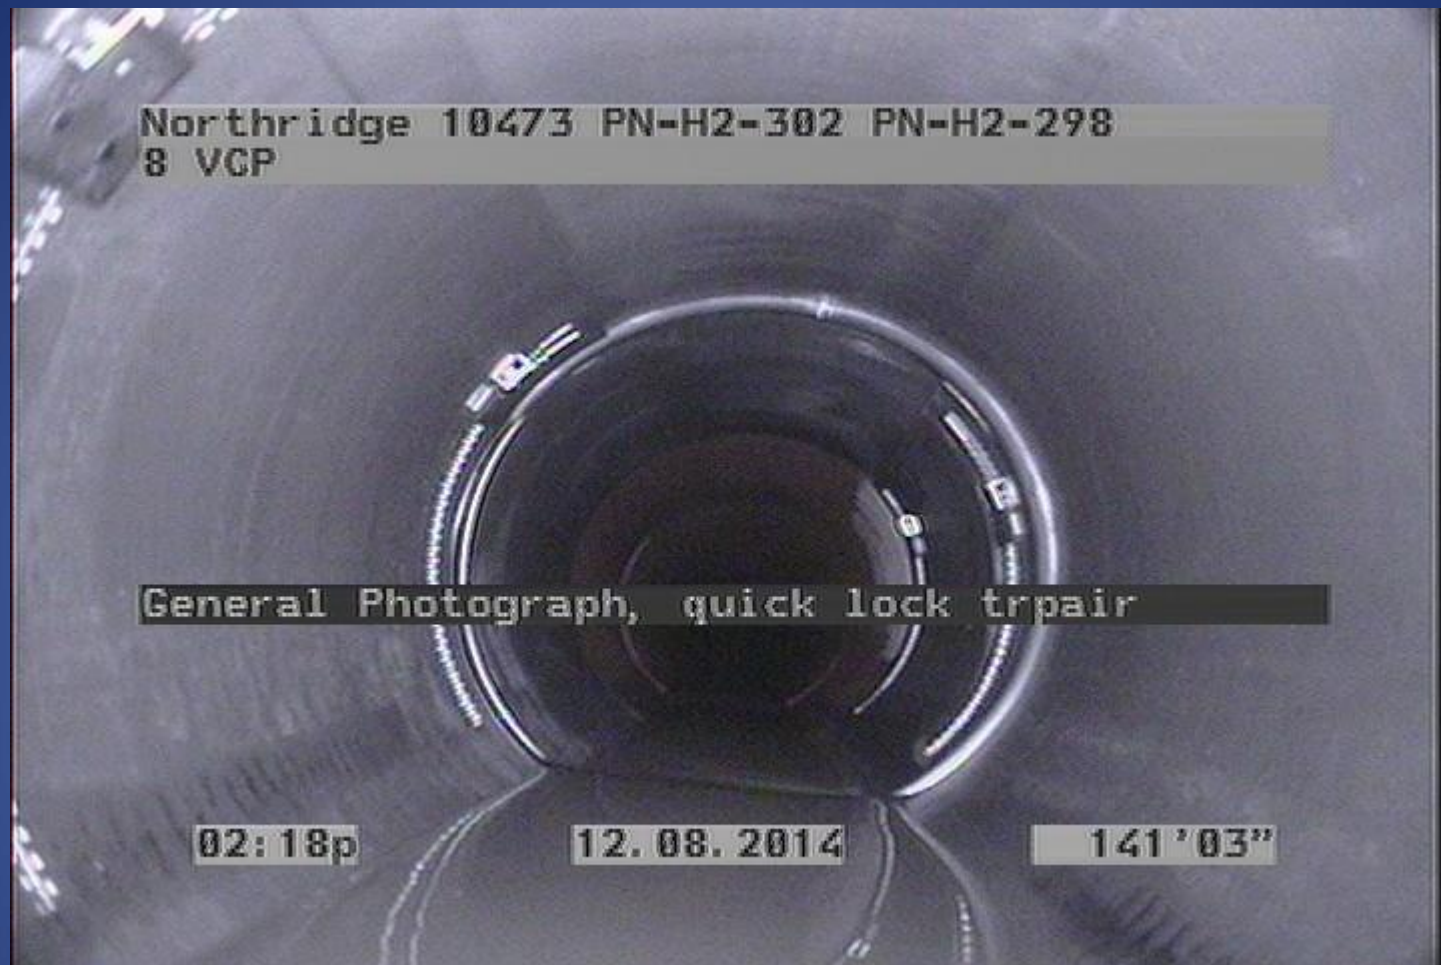
After 1st repair

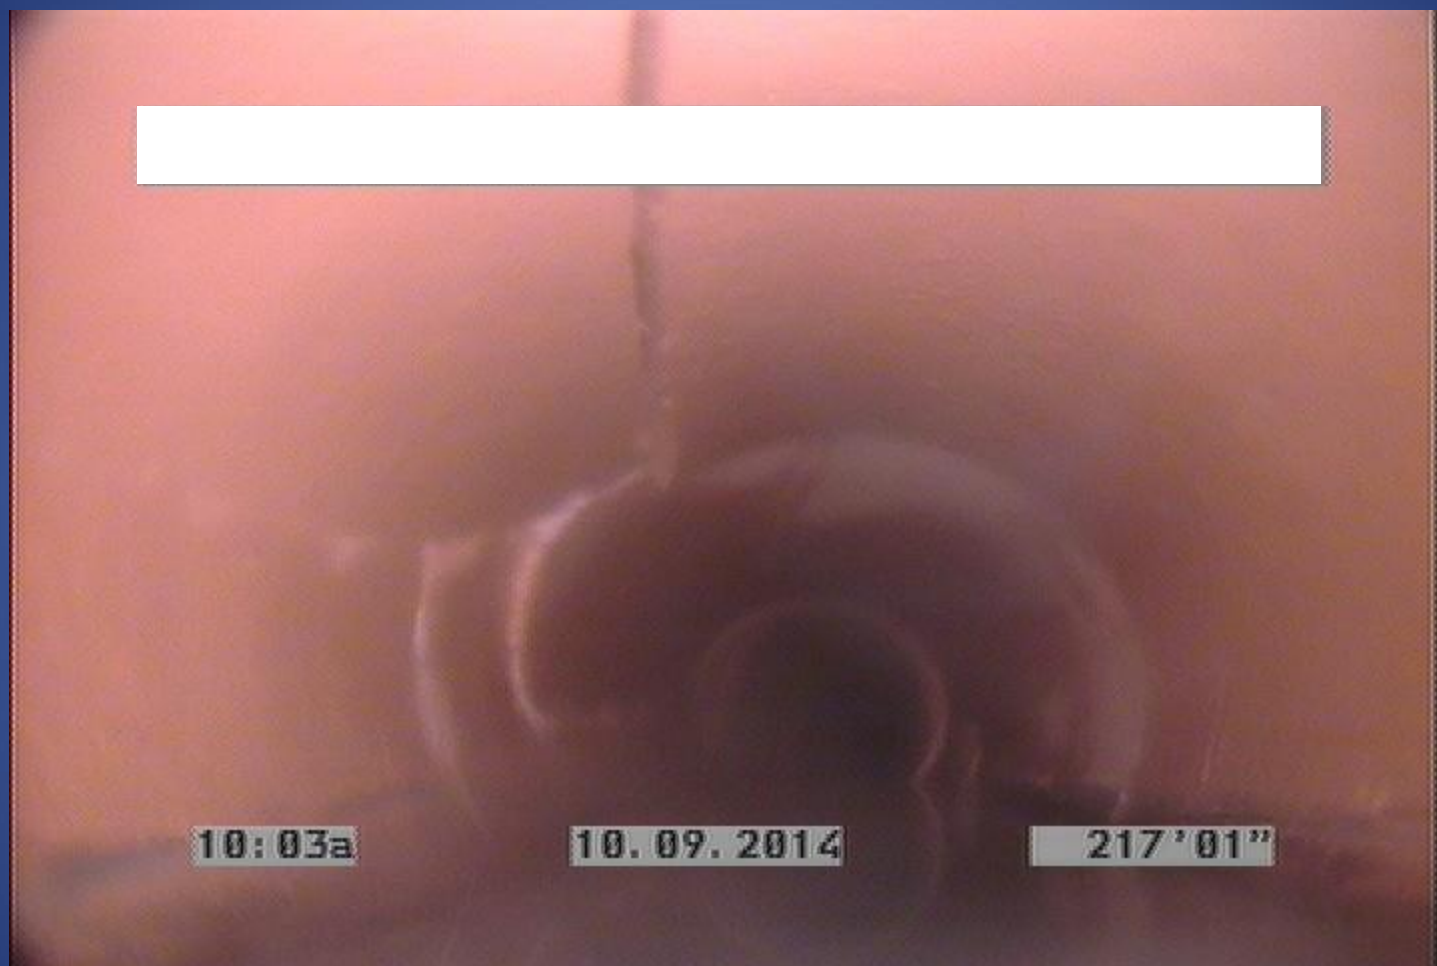
Before Repair

Quick Lock Internal Repair
8" VCP
Spiral Fracture at Joint
Upstream

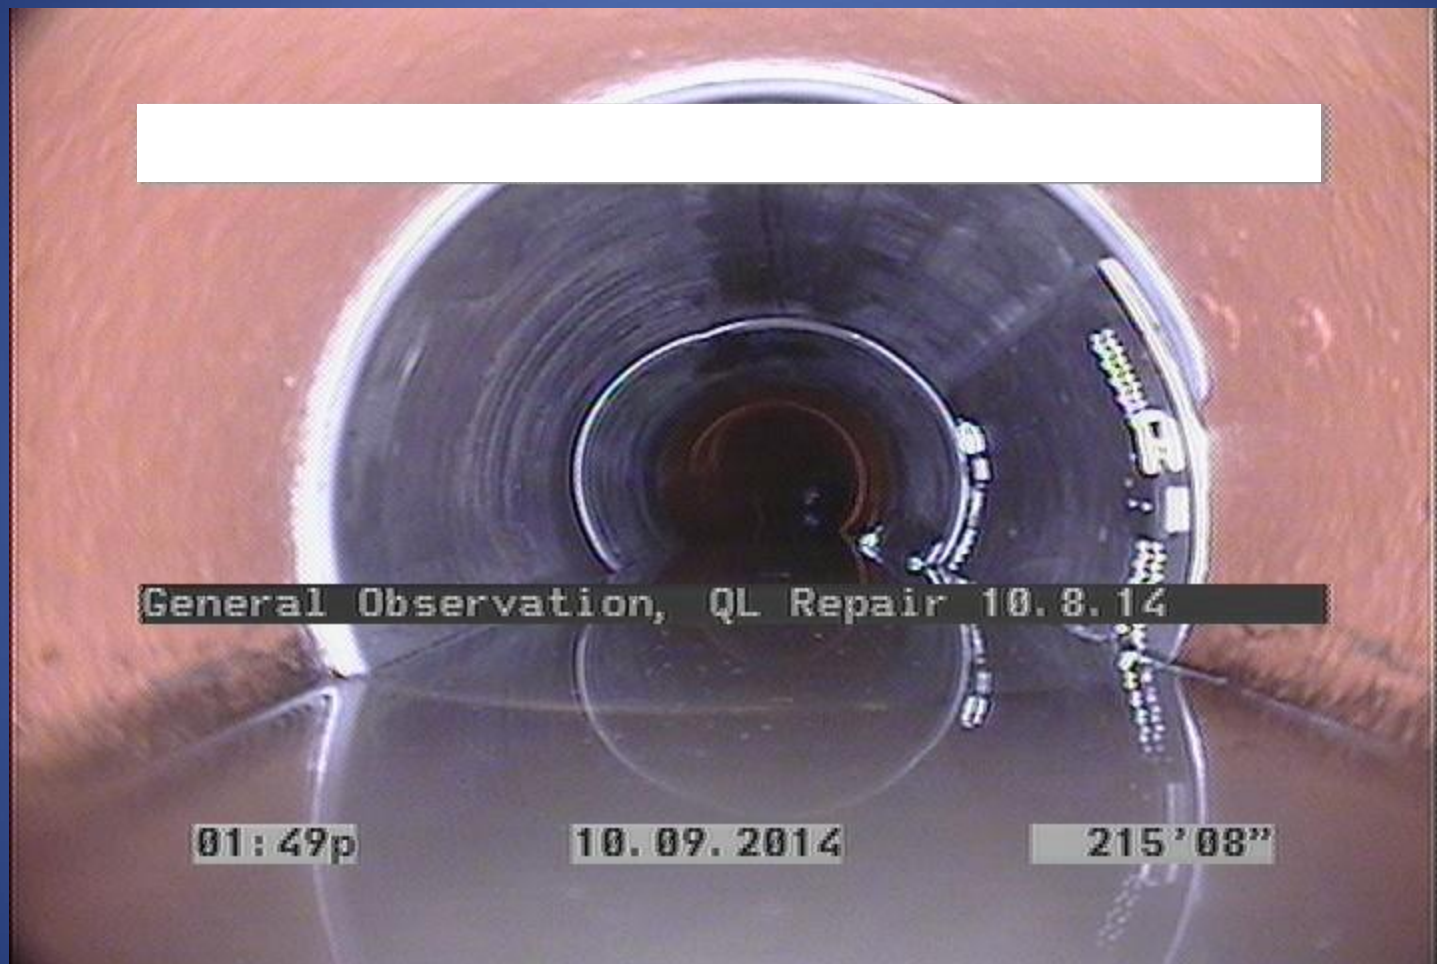
After Repair
