**Dangerous Buildings Hearing for
1415 Meadow St, Denton, TX
76205 HBS26-003**

Dangerous Building Application of Standards 17-182 (Ord. No. 24-1647, § 3(Exh. A), 10-15-24) The main structure at 1415 Meadow St qualifies for 12 of the 15 dangerous structure standards :

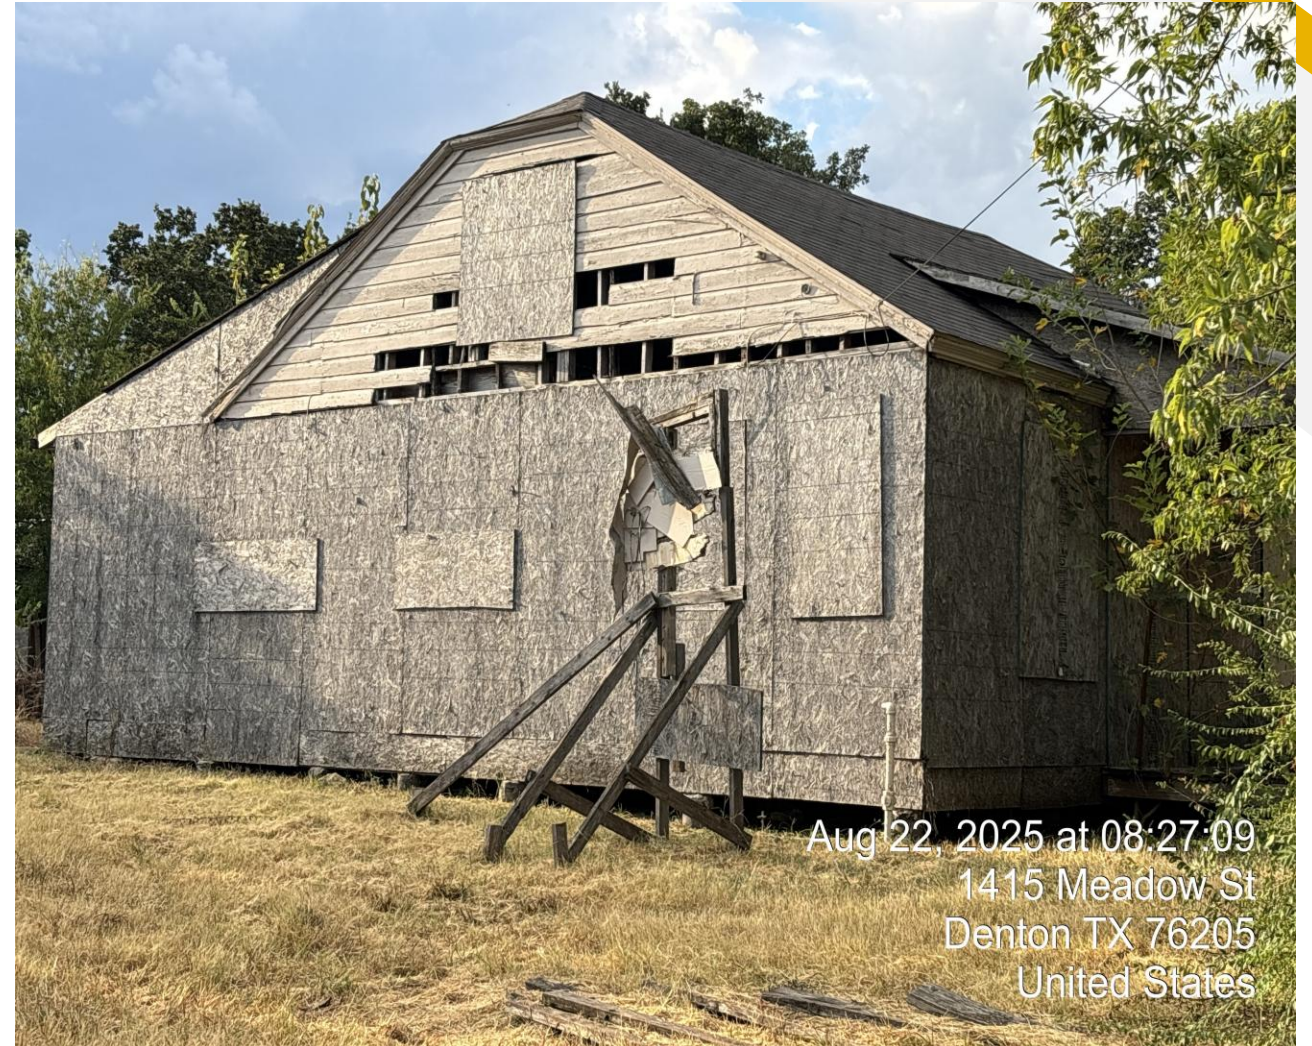
- (1) The building or structure was constructed or maintained in violation of any provision of the city's building codes, fire code or any other applicable ordinance or law of the city, county, state, or federal government and such violation renders the building or structure dangerous to the life, limb, health, property, safety, or welfare of the general public or the occupants of the building or structure.
 - The building has not been maintained in some time, the exterior sheathing is extremely weathered, and siding is missing from the gable.
- (3) The foundation or the vertical or horizontal supporting members are so damaged or deteriorated as to create a hazard or safety concern.
 - The roof framing and exterior walls have suffered a fair amount of weathering as well due to water infiltration.

- Based on the information outlined in this presentation, and the lack of improvement from 2019 to now, Staff recommends that HABSCo find the structures to be dangerous.
- City staff recommends **the owner be ordered to demolish** these structures within 30 days. If more than thirty days is requested by the owner, it is recommended that the board require compliance with a time schedule for the work and the site must be kept reasonably secure from unauthorized entry.

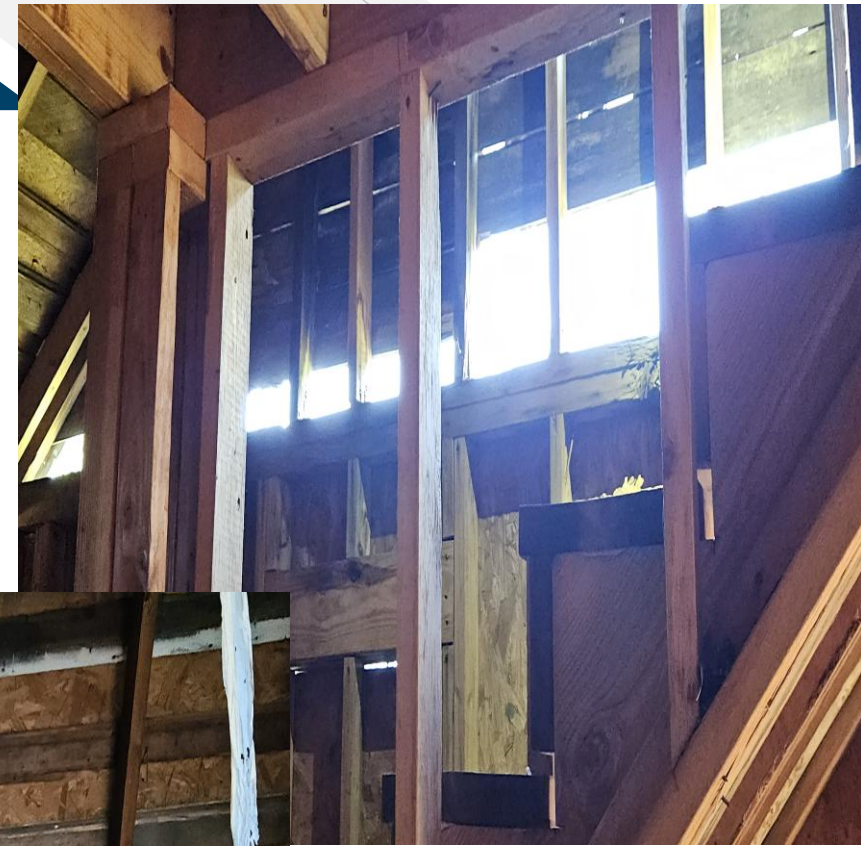
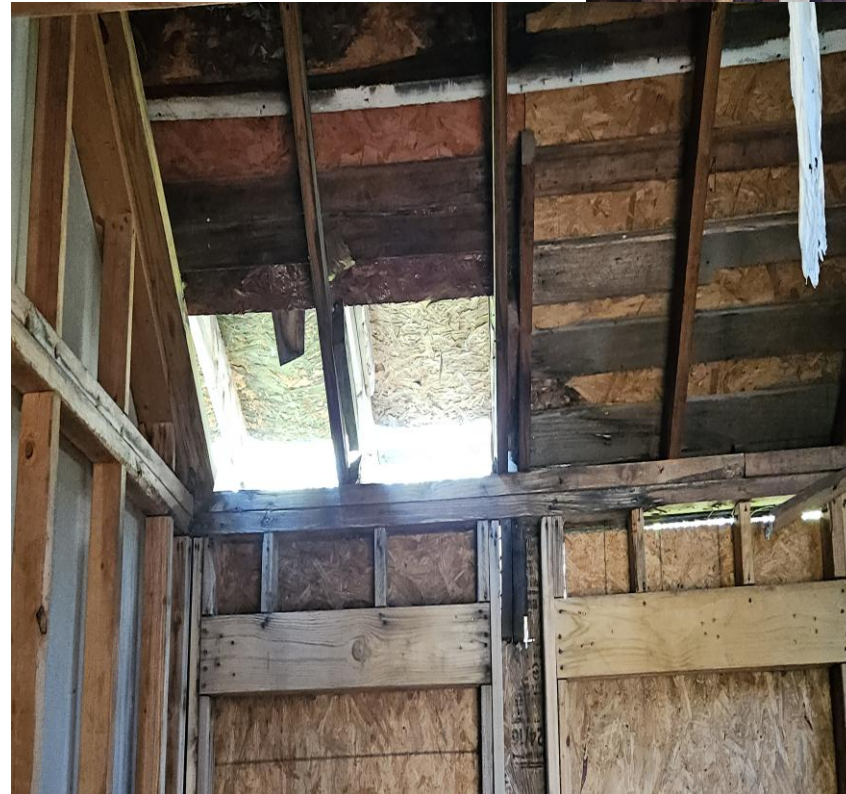
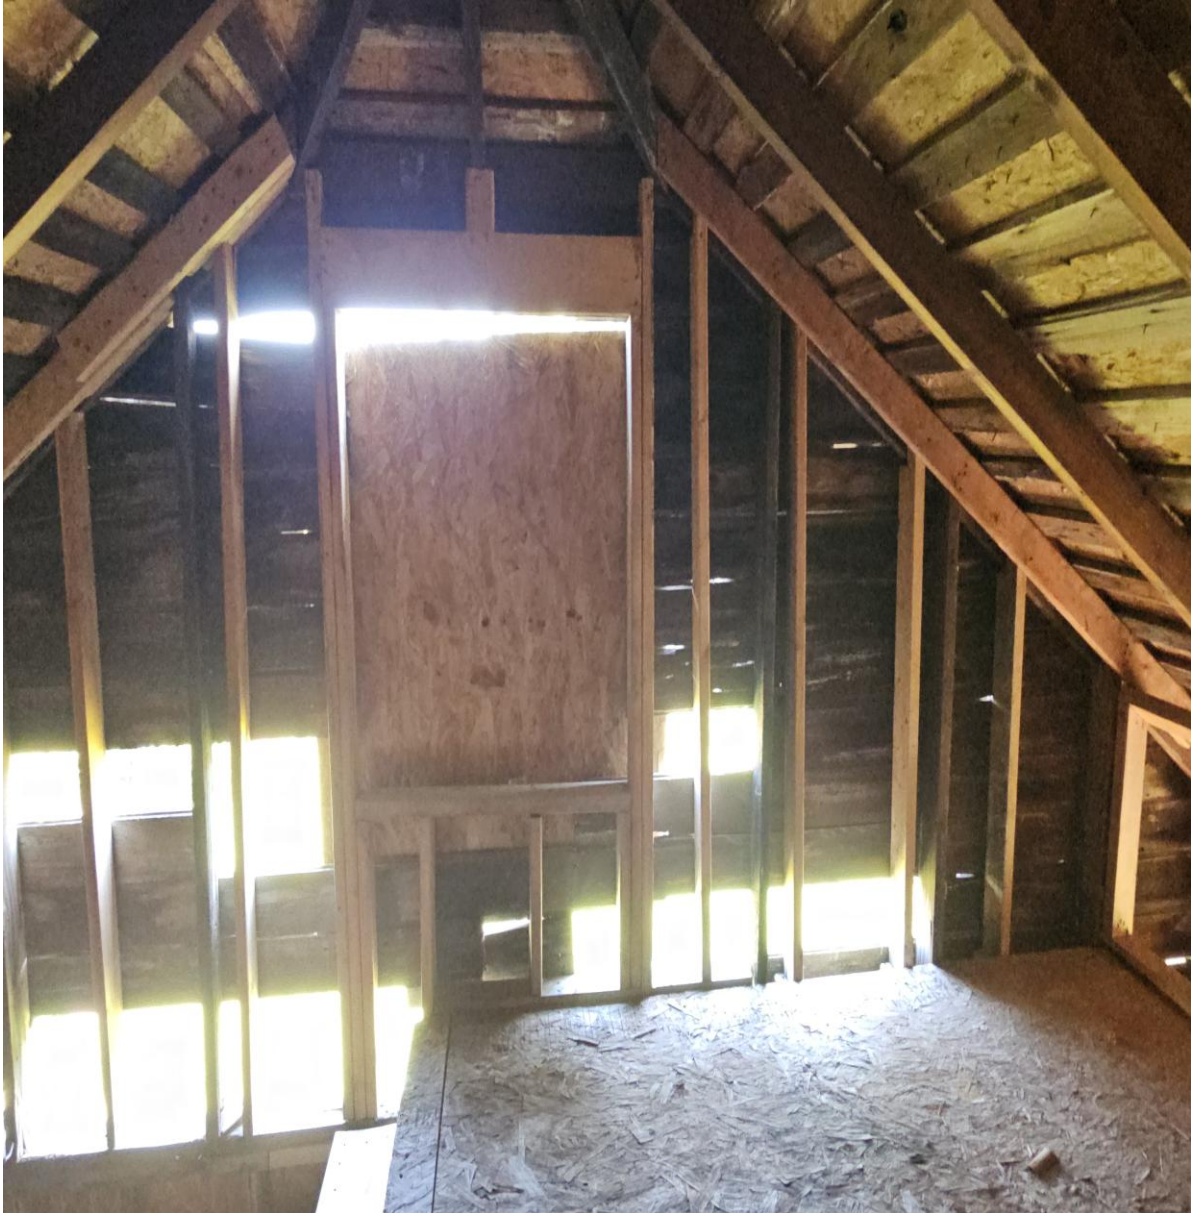
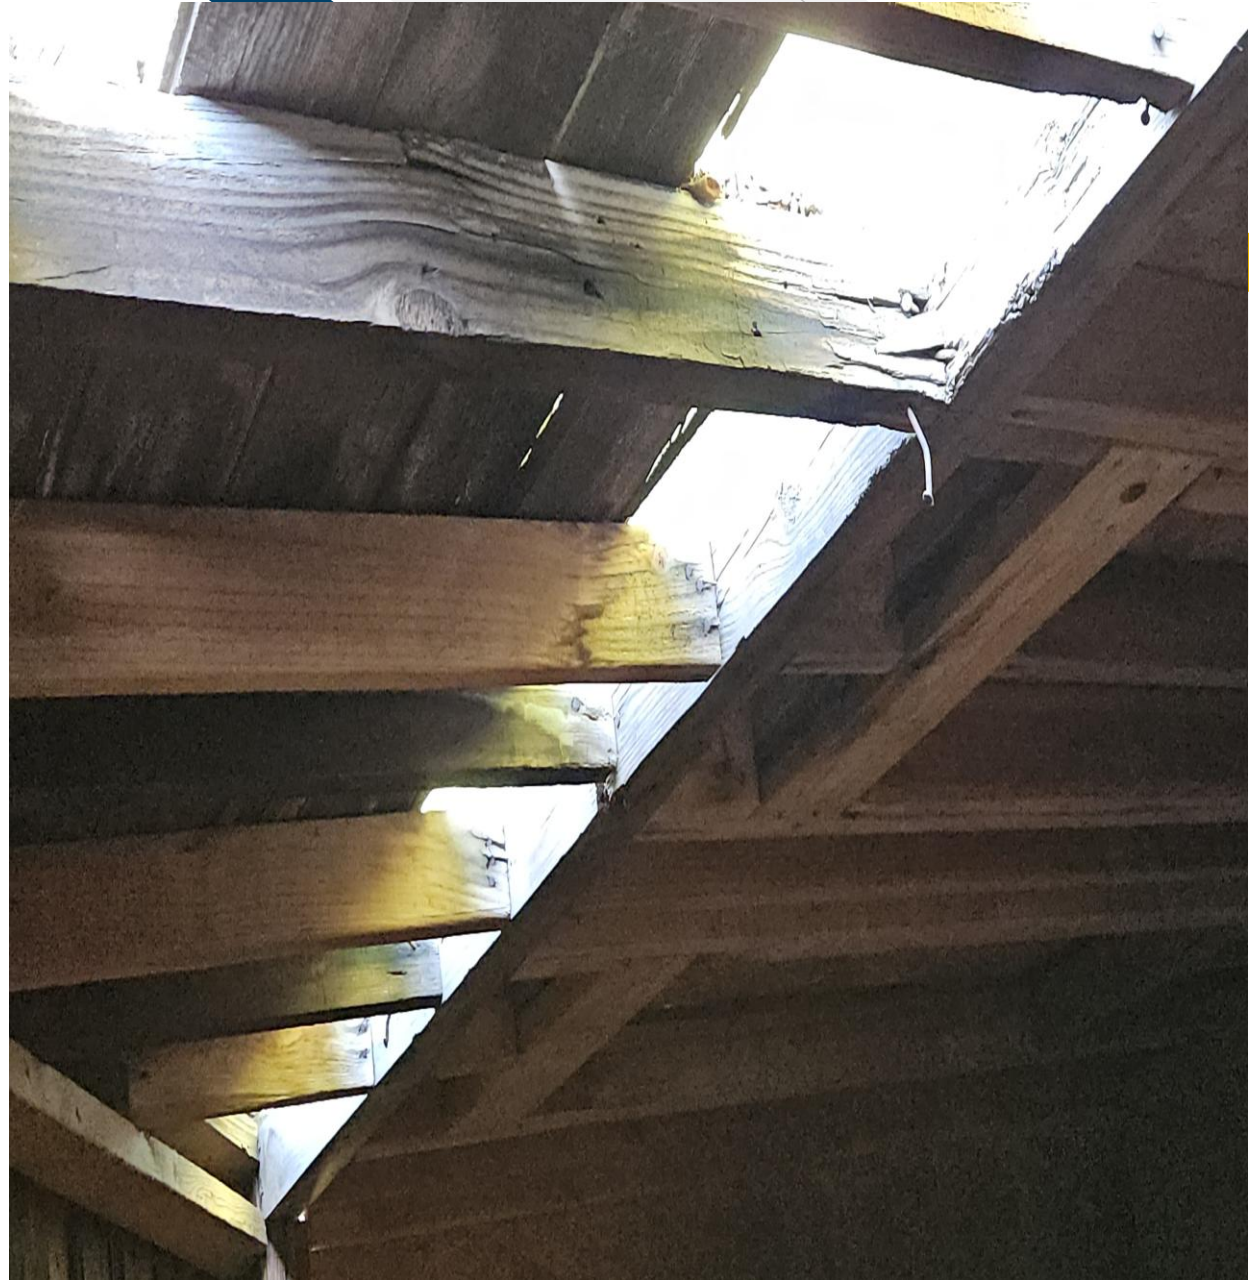
- (4) The non-supporting coverings of walls, ceilings, roofs, or floors are so damaged or deteriorated as to create a hazard or safety concern.
 - All interior and exterior sheeting has deteriorated from the lack of weatherproofing over the years.
- (6) The structure or any part thereof has been damaged by fire, water, earthquake, wind, tornado, vandalism, or other causes to such an extent that it has become dangerous to the public health, safety and welfare.
 - The structure has suffered water damage due to the lack of weatherproofing/proper exterior wall and roof coverings, as well as vandalism from being an unsecure structure over the years.

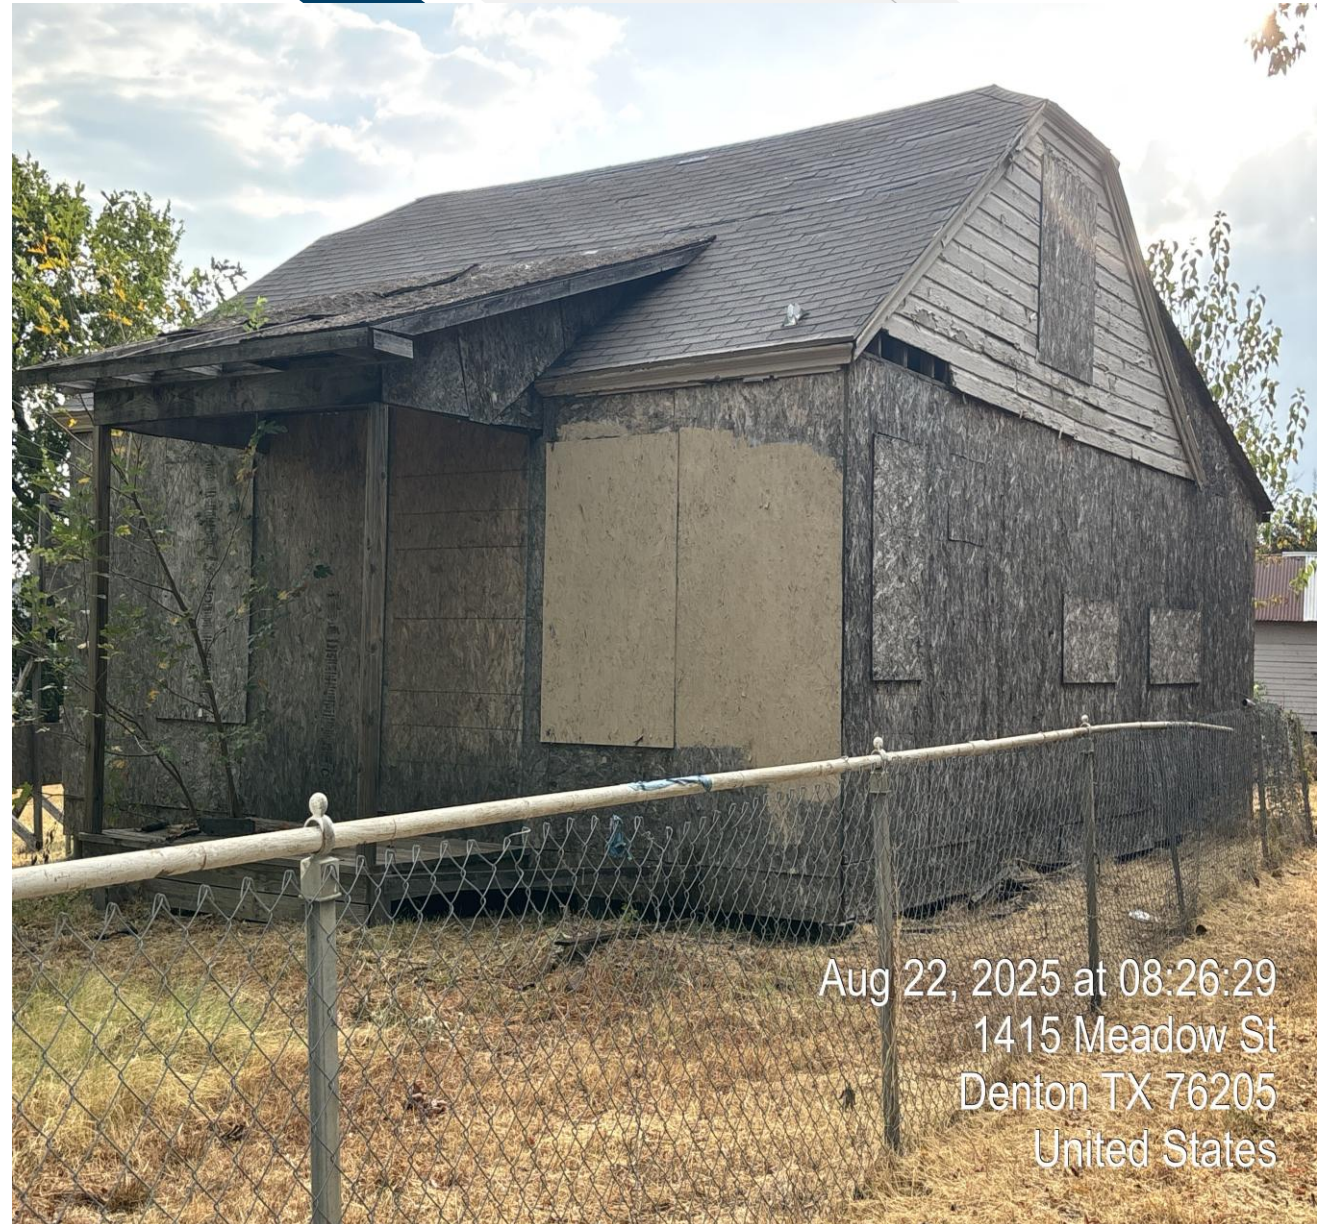
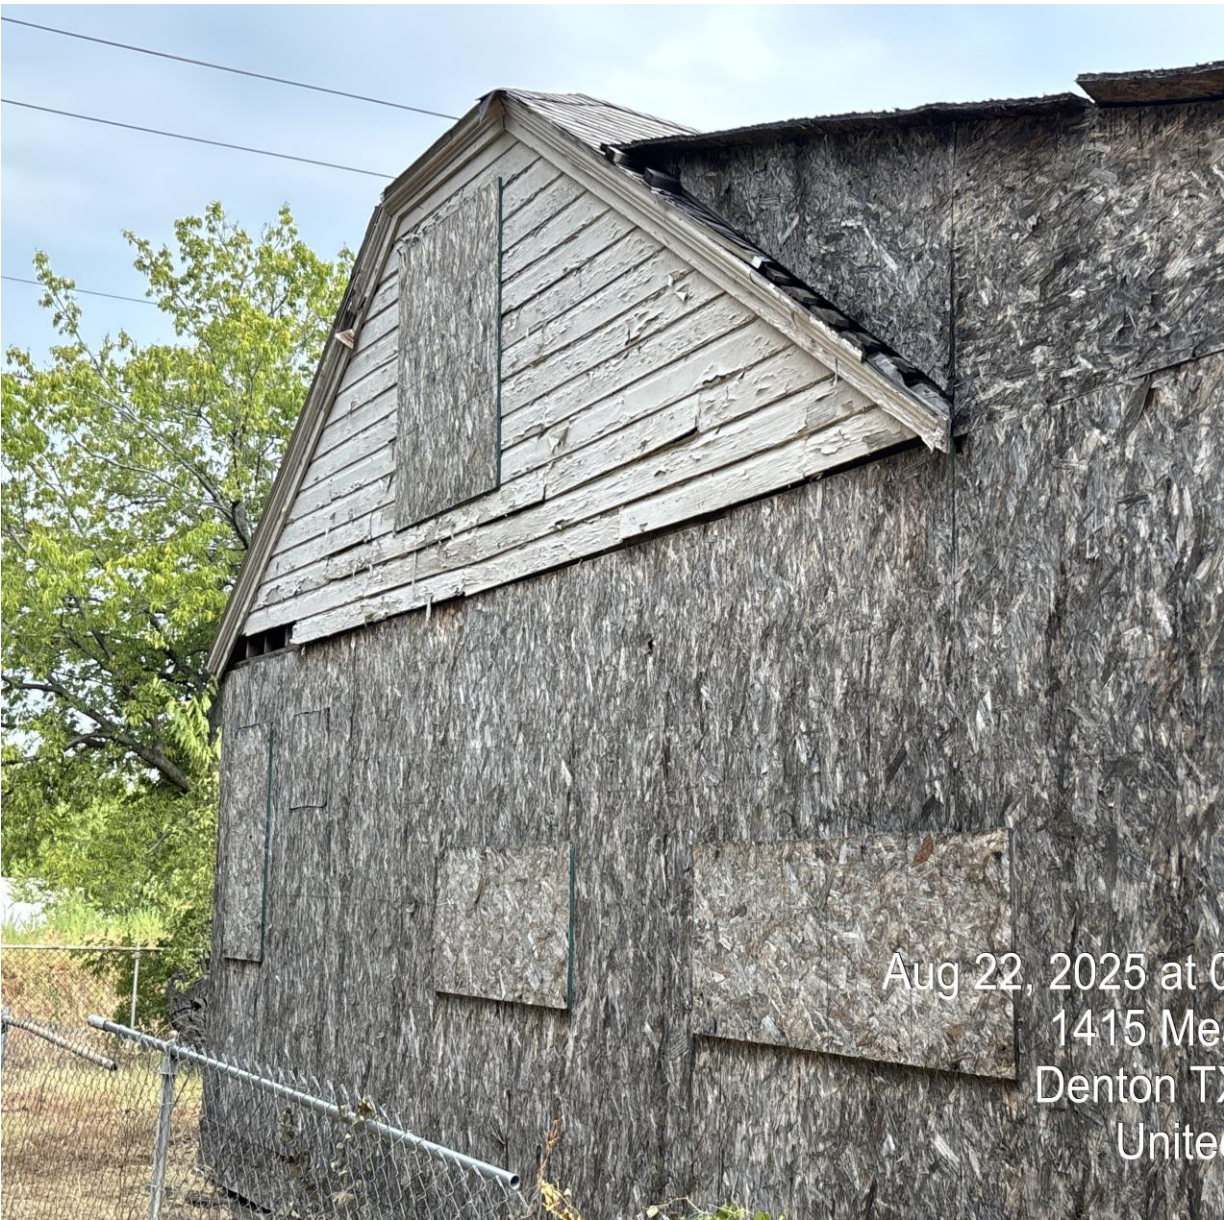
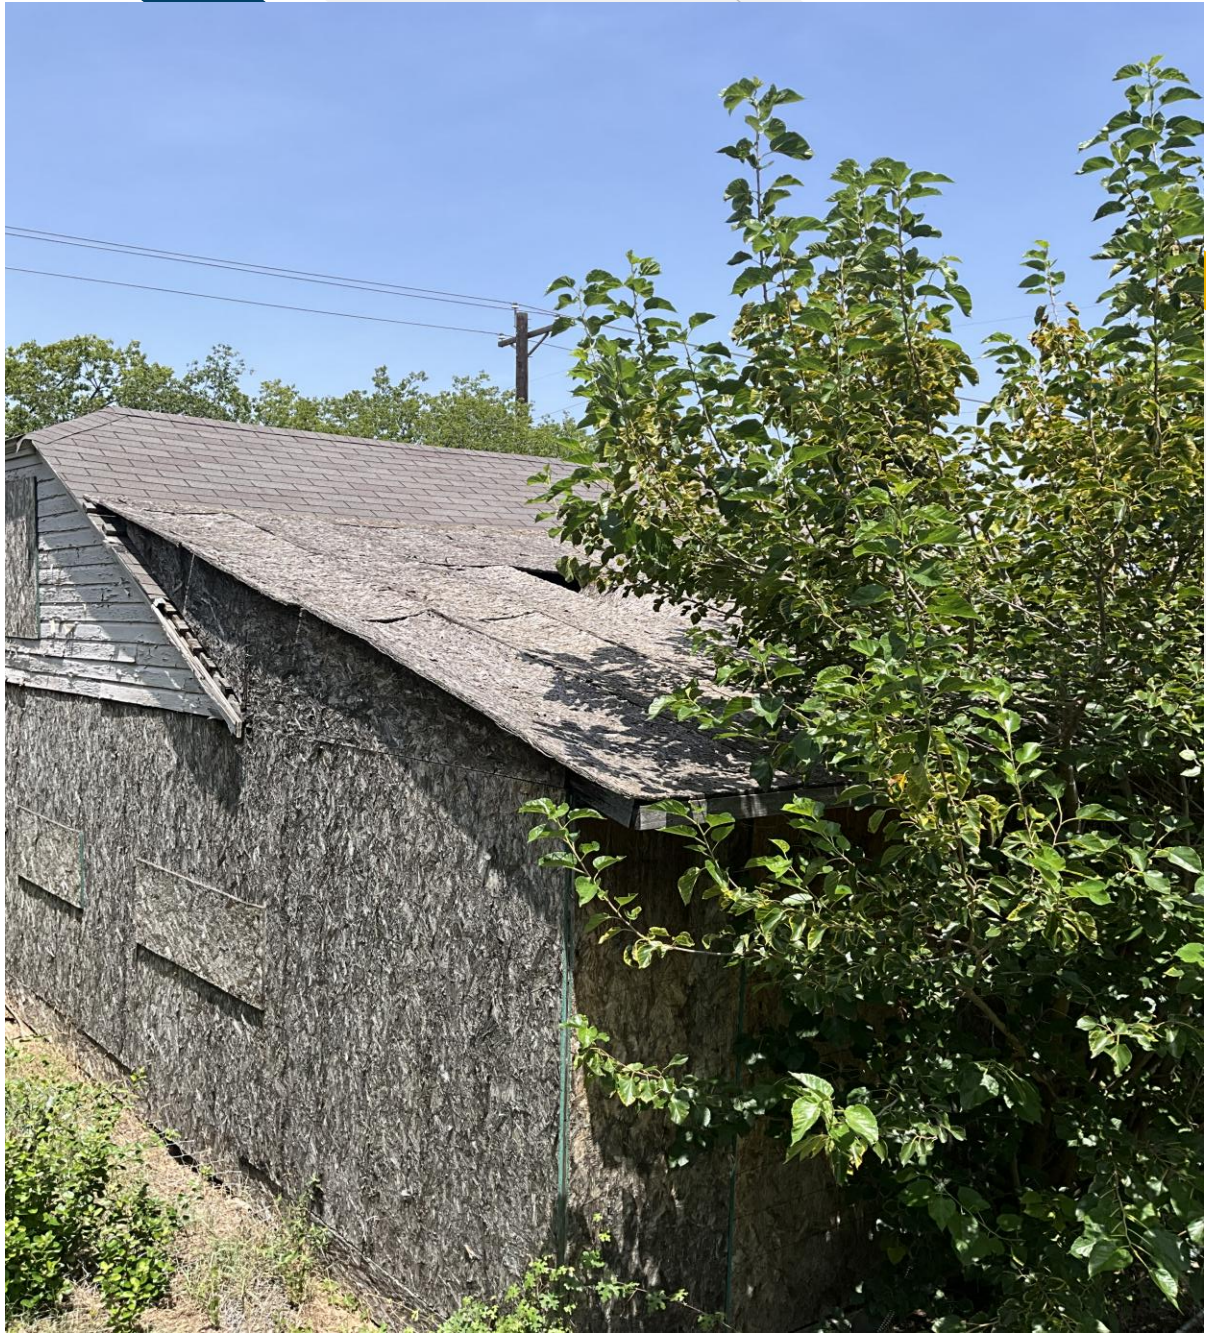
Aug 22, 2025 at 0
1415 Me
Denton TX
Unite

- (7) A portion of a building or structure remains on a site when construction or demolition work is abandoned.
 - Renovations work started in 2019, no permits were ever secured for the work and the project was abandoned.
- (8) A door, aisle, passageway, stairway, fire escape or other means of egress is not of sufficient width or size, or is damaged, dilapidated, obstructed or otherwise unusable, or so arranged so as not to provide safe and adequate means of egress in case of emergency or need.
 - All windows and doors are missing and currently boarded over with plywood to discourage illegal occupancy.

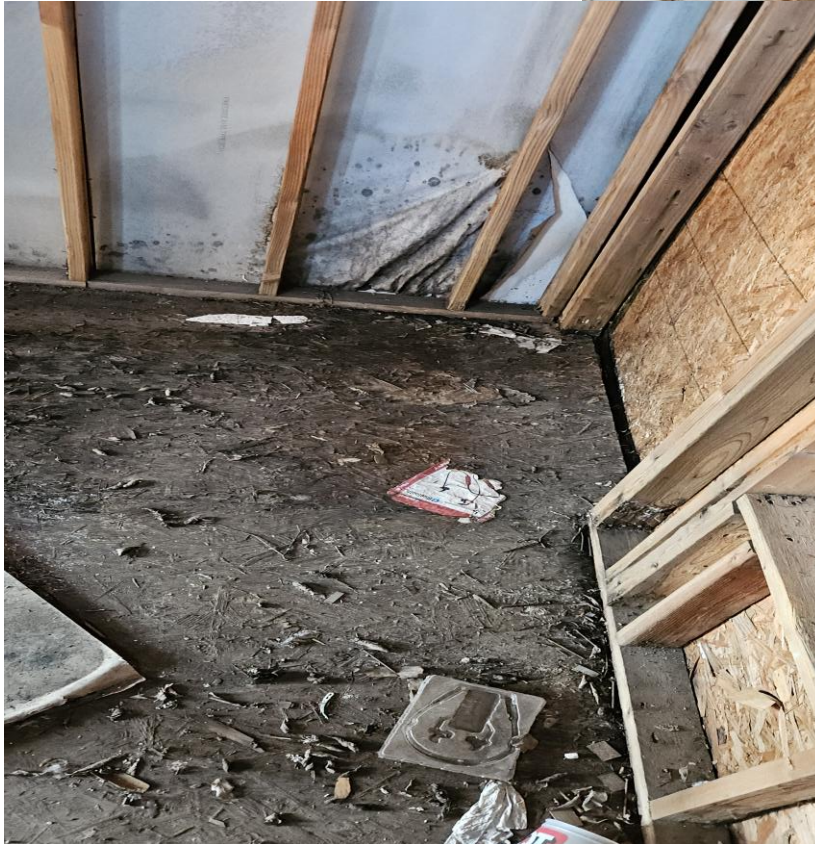
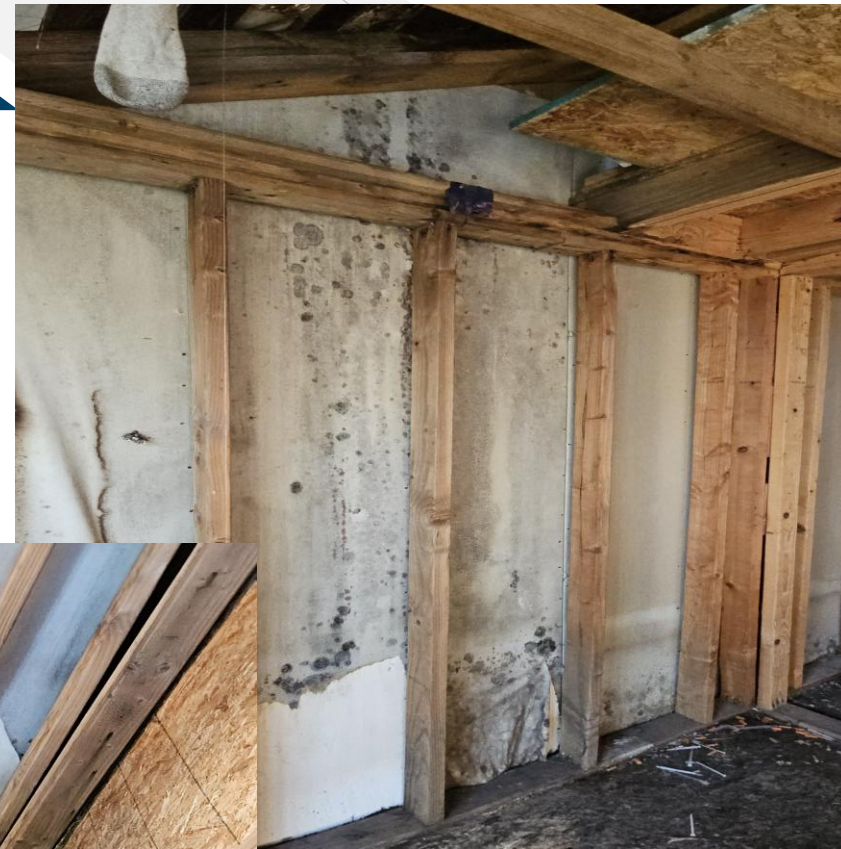
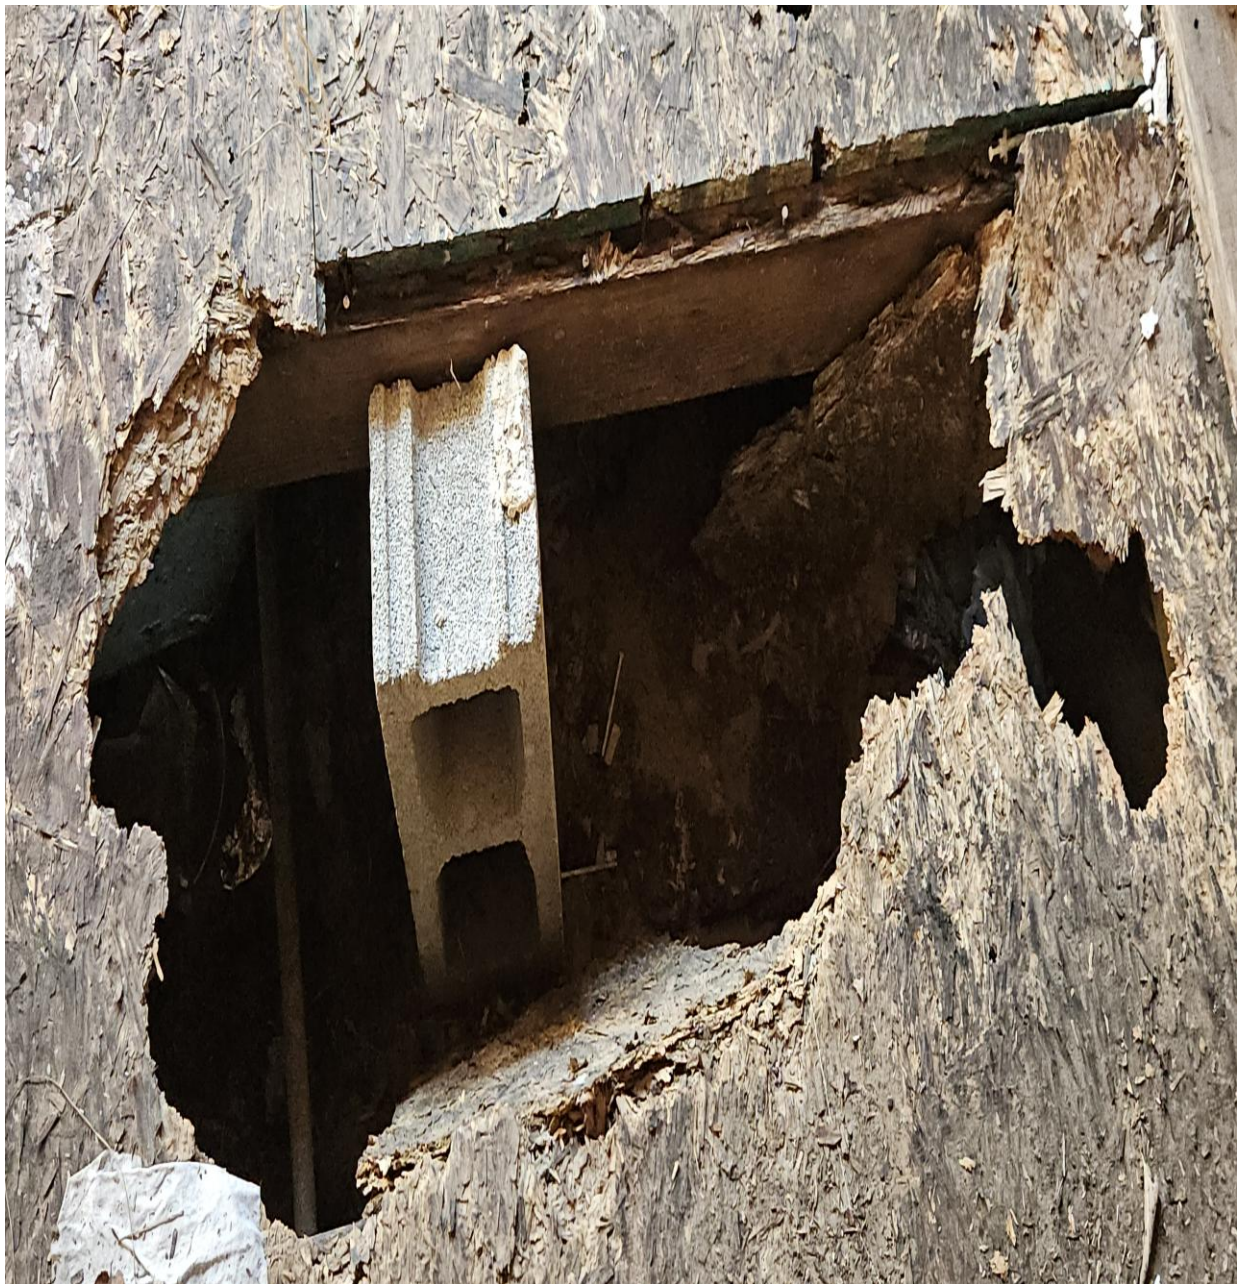
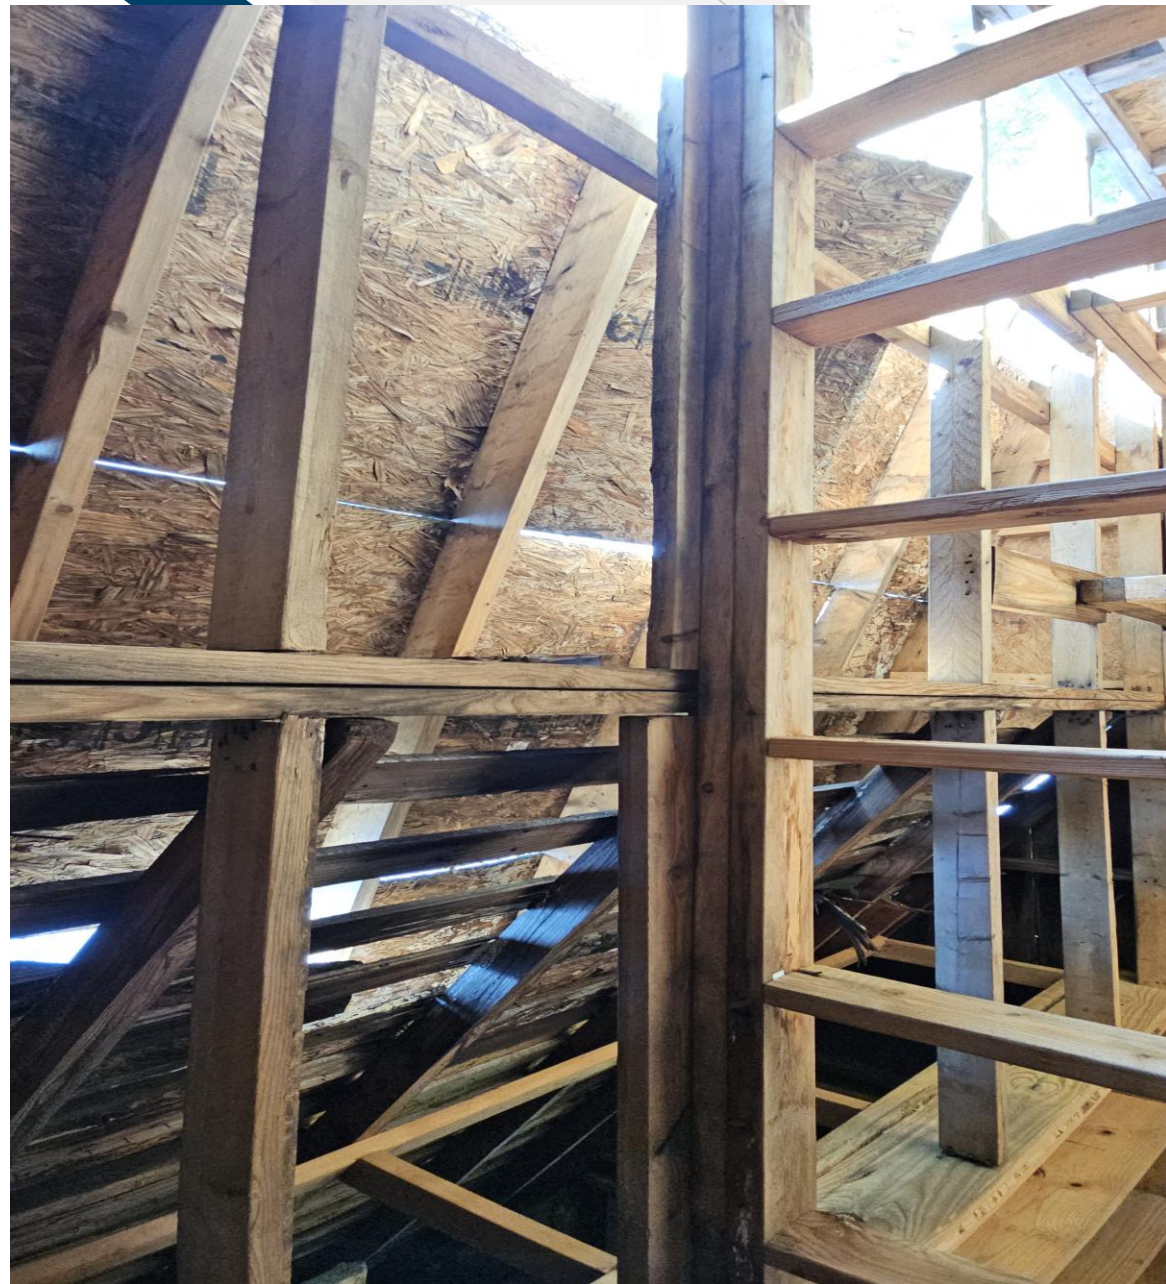
- (9) The structure, because of its condition, is unsafe, unsanitary, or dangerous to the health, safety or general welfare of the city's citizens including but not limited to all conditions conducive to the harboring of rats or mice or other disease carrying animals or insects reasonably known to spread disease.
 - Holes in the roof, floor, and walls make this structure an easy target for rodents, pests, and insects.
- (10) The structure has been found to contain visually apparent mold growth of greater than one hundred (100) square feet in the dwelling unit and will require demolition if the remediation of such mold growth would exceed fifty (50) percent of the value of the structure.
 - The walls and floor have several areas of mold from the exterior wall and roof coverings allowing the infiltration of water.

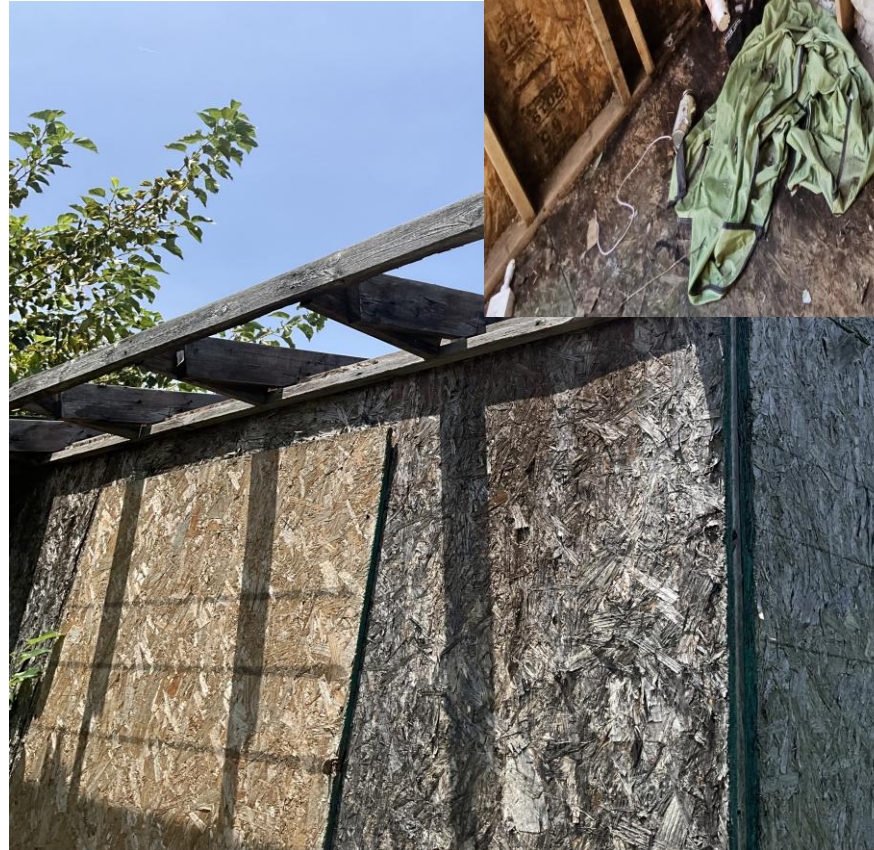
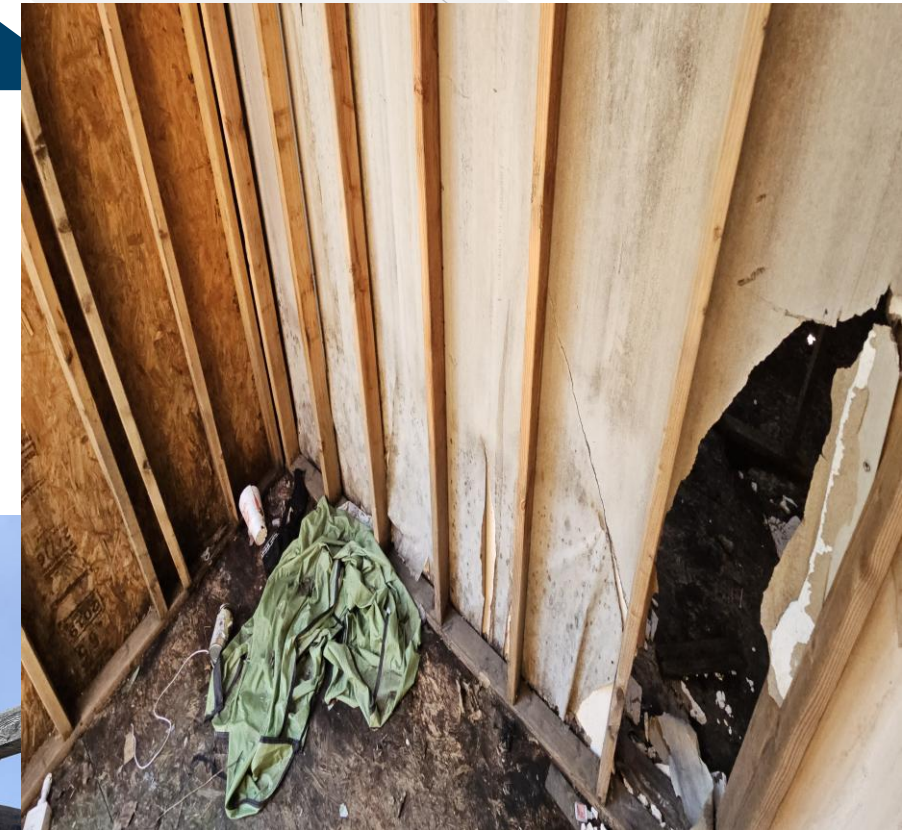
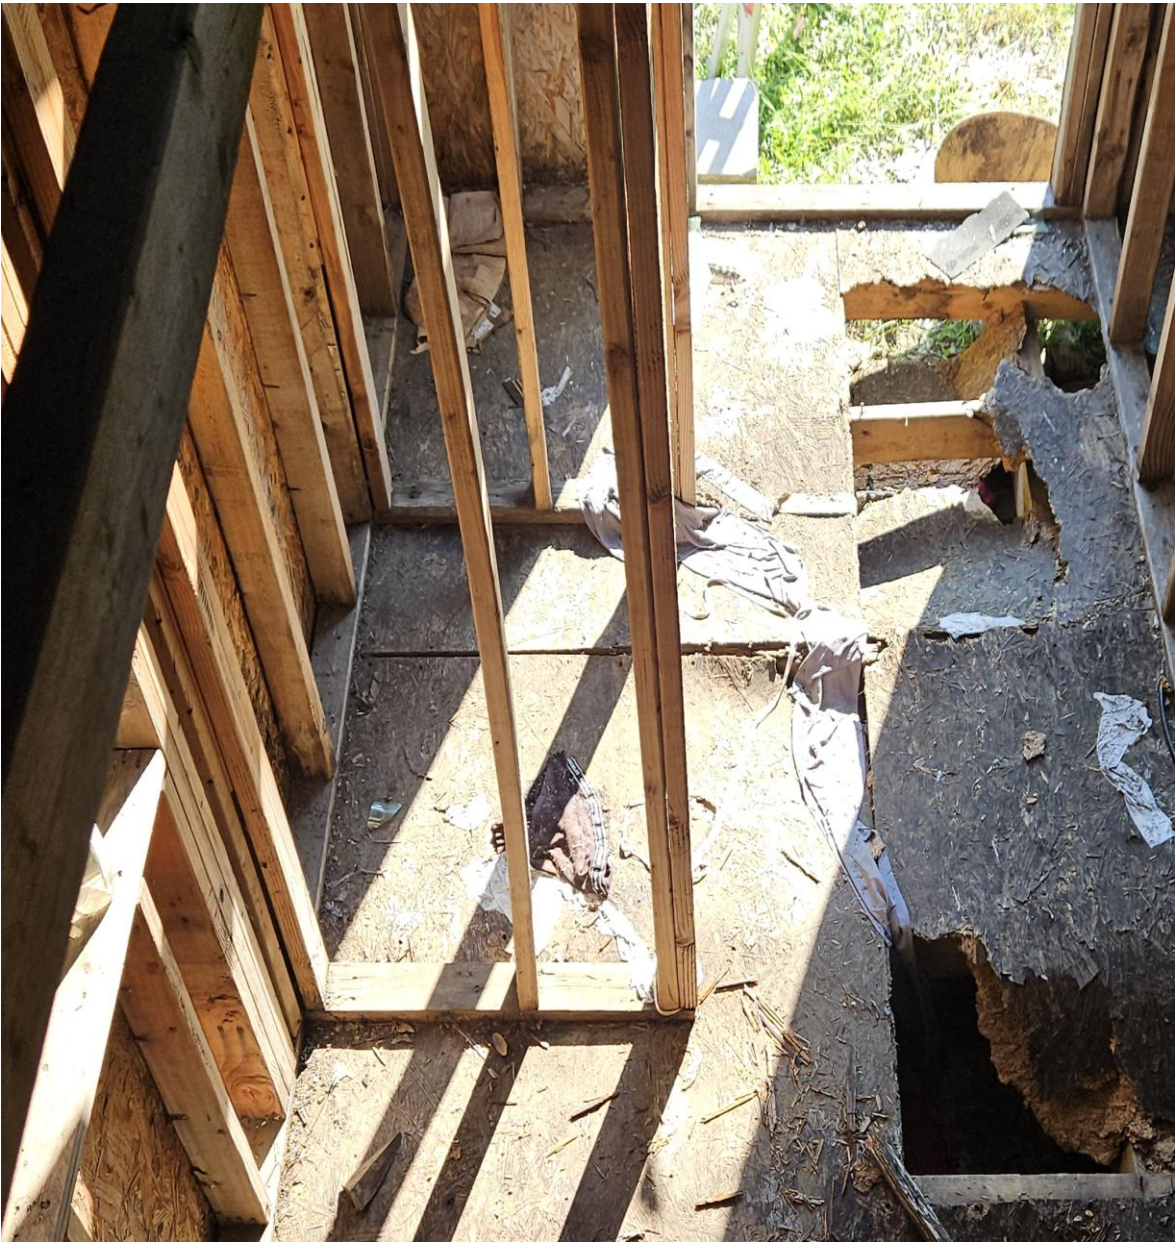
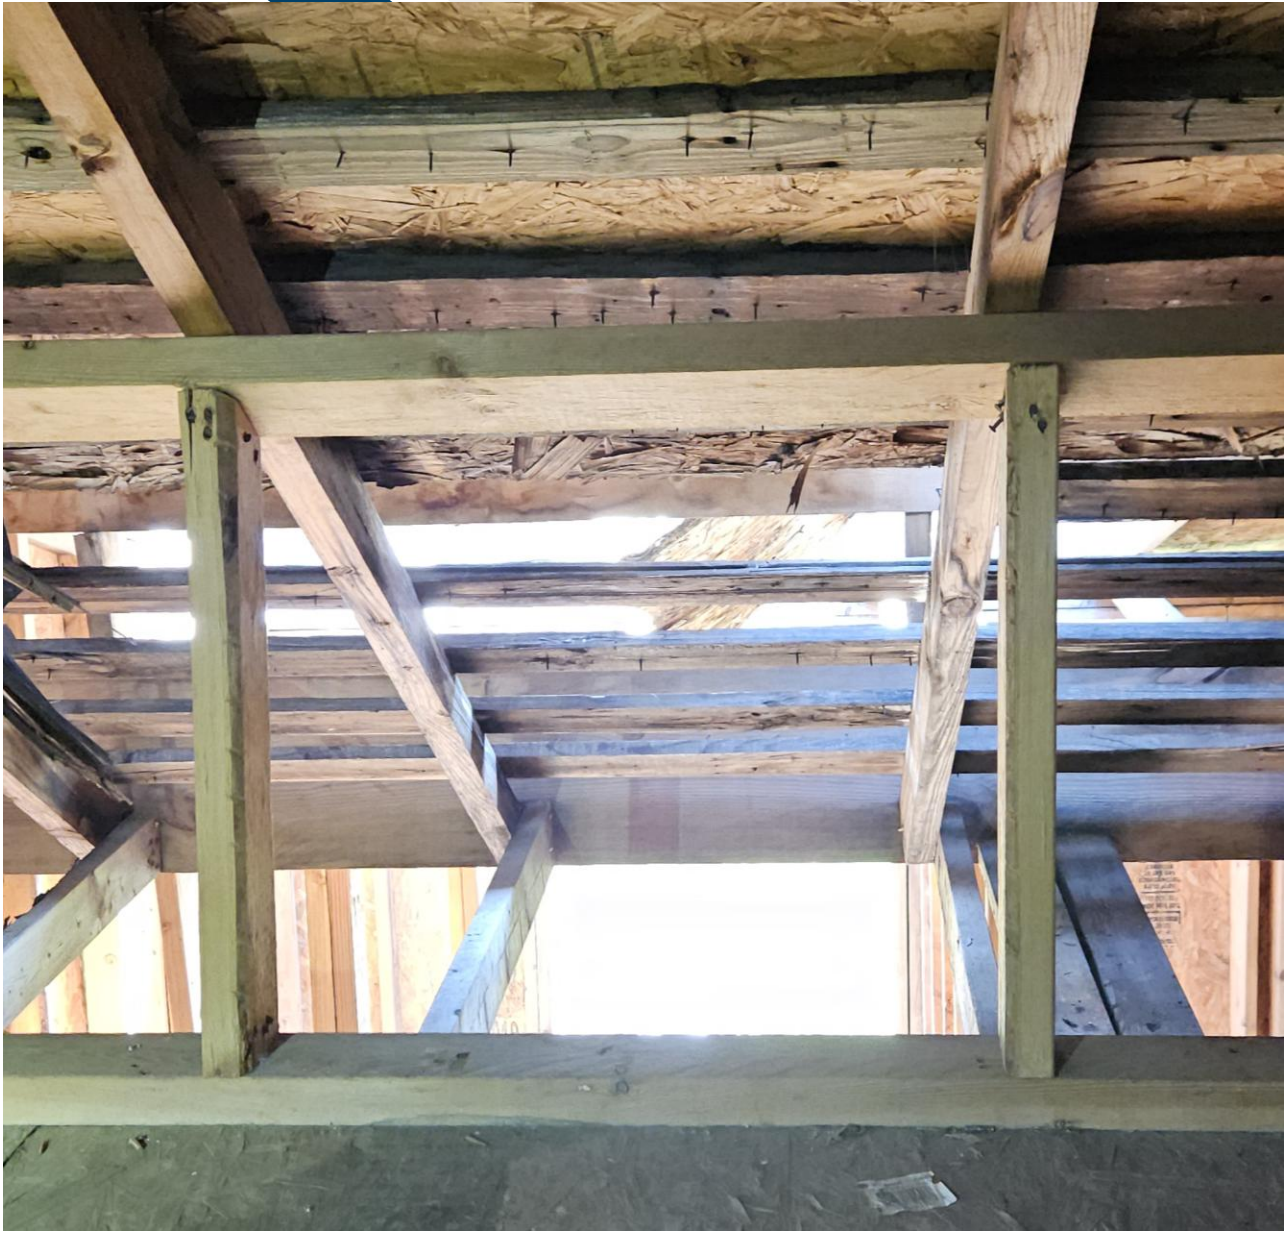
- (11) Whenever the building or structure has been so damaged by fire, wind, tornado, earthquake, or flood, or has become so dilapidated or deteriorated as to become:
 - An attractive nuisance to children;
 - A harbor for unauthorized occupants, criminals, or trespassers; **or** as to
 - Enable persons to resort thereto for the purpose of committing unlawful acts.
- Trash and debris left behind from unauthorized occupants can be seen in the top picture
- (13) The building or structure has any portion, member or appurtenance, ornamentation on the exterior thereof which is not of sufficient strength or stability, or is not so anchored, attached or fastened in place to be capable of safely resisting wind pressure, snow, ice, or other loads.
 - The structures would not be capable of providing resistance to ice, snow, or rain. Sections of the roof are missing.

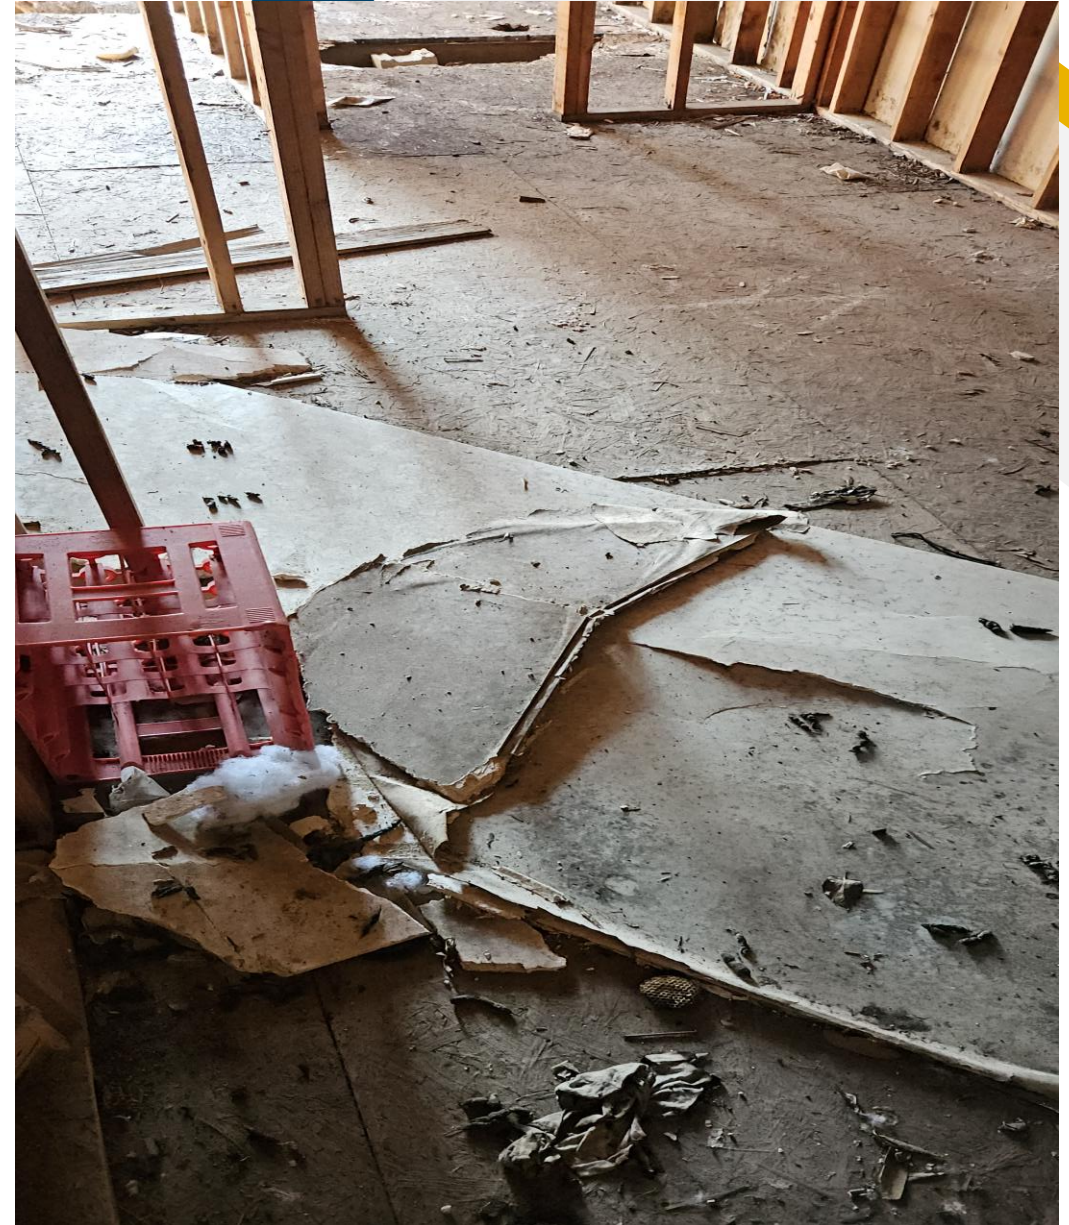
- The electrical, plumbing, and mechanical systems were removed from the main structure.
- (15) The building or structure has been determined to be vacant, using the following factors: the percentage of overall square footage of any building on the property or floor to the occupied space, the condition and value of any items in the property and the presence of rental or for sale signs on the property; provided that multi-family residential property containing three (3) or more dwelling units shall be considered vacant when the majority of all of the dwelling units become unoccupied and a majority remain unoccupied. A property shall not be considered vacant which is being currently marketed by the owner or a licensed real estate professional hired by the former or current occupant of the property, and to which the water service has not been shut off.

- The structure is vacant and has been for several years.
