**Dangerous Buildings Hearing for
1415 Meadow St, Denton, TX
76205 HBS26-003**

Dangerous Building Application of Standards 17-182 (Ord. No. 24-1647, § 3(Exh. A), 10-15-24) The main structure at 1415 Meadow St qualifies for 12 of the 15 dangerous structure standards :

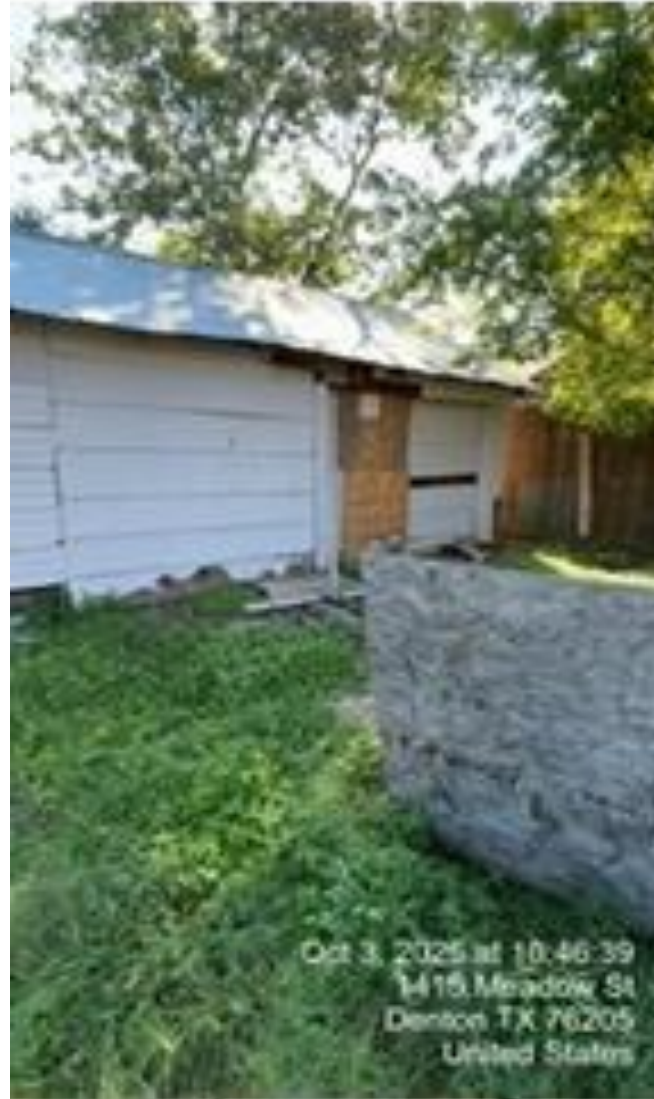
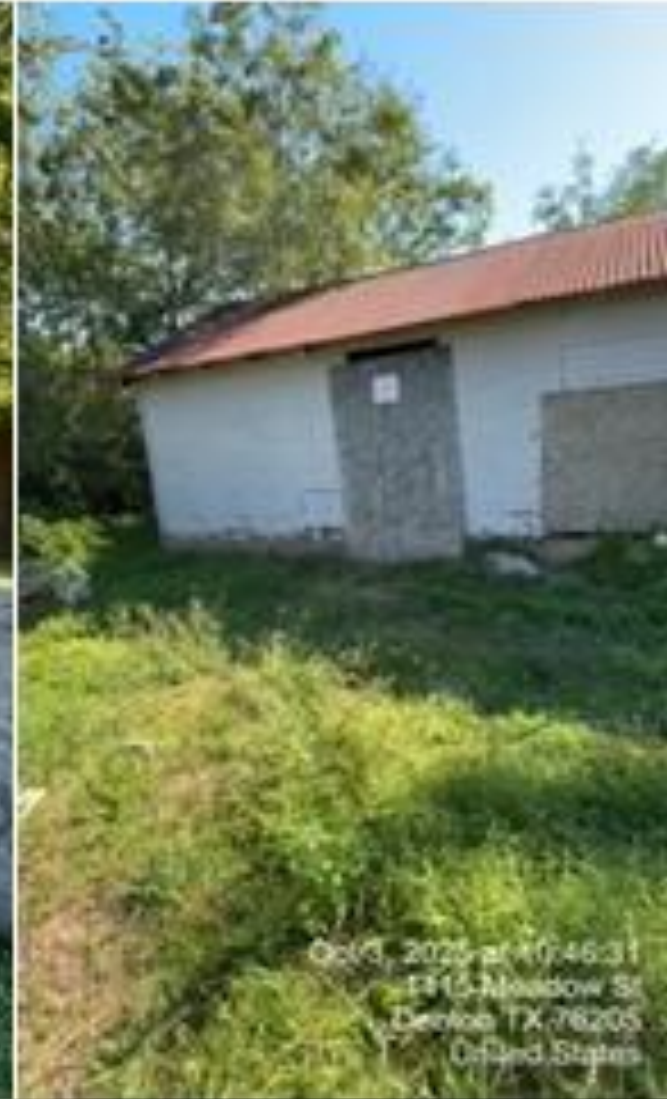
- The accessory structure has not been maintained in some time; it is boarded up due to missing windows/doors and/or holes in the exterior.
- (11) Whenever the building or structure has been so damaged by fire, wind, tornado, earthquake, or flood, or has become so dilapidated or deteriorated as to become:

- Trash and debris left behind from unauthorized occupants can be seen in the pictures on the next slide.

- Based on the information outlined in this presentation, and the lack of improvement from 2019 to now, Staff recommends that HABSCo find the structures to be dangerous.
- City staff recommends **the owner be ordered to demolish** these structures within 30 days. If more than thirty days is requested by the owner, it is recommended that the board require compliance with a time schedule for the work and the site must be kept reasonably secure from unauthorized entry.

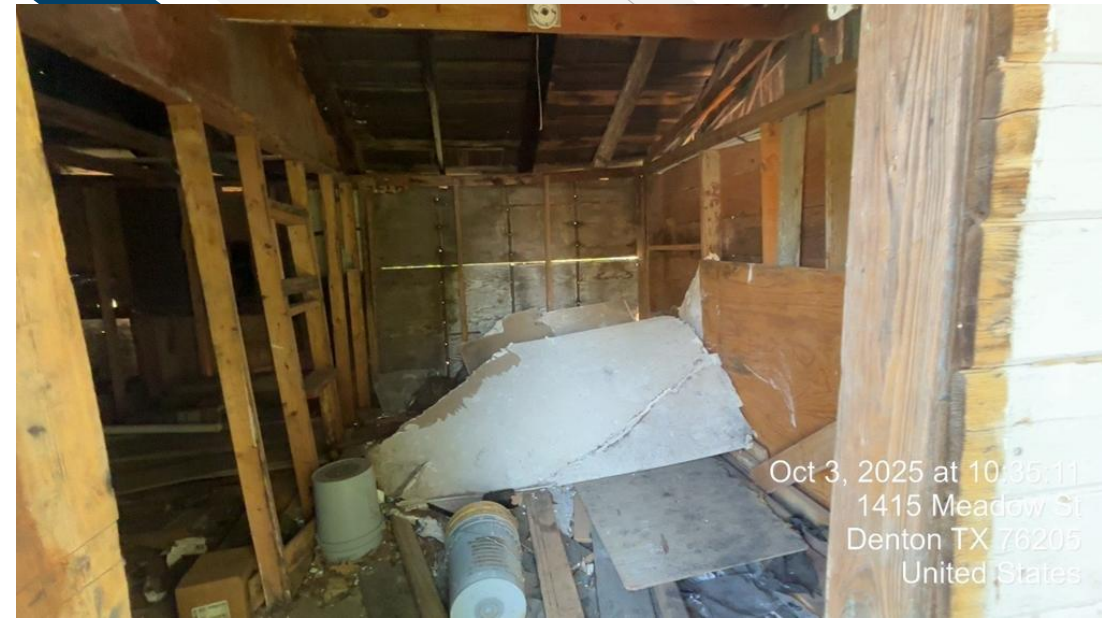
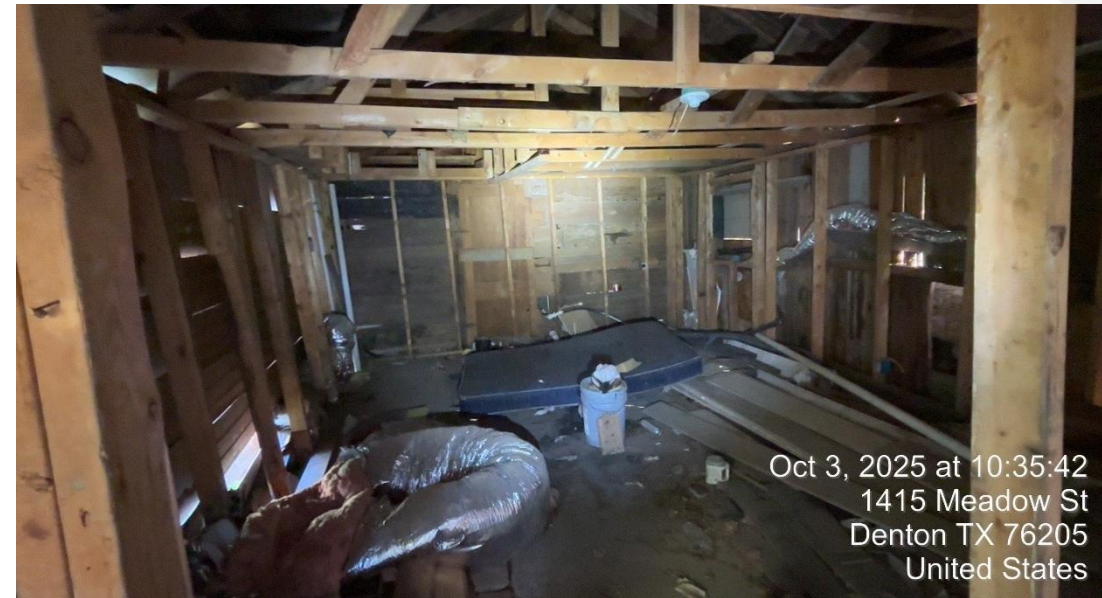
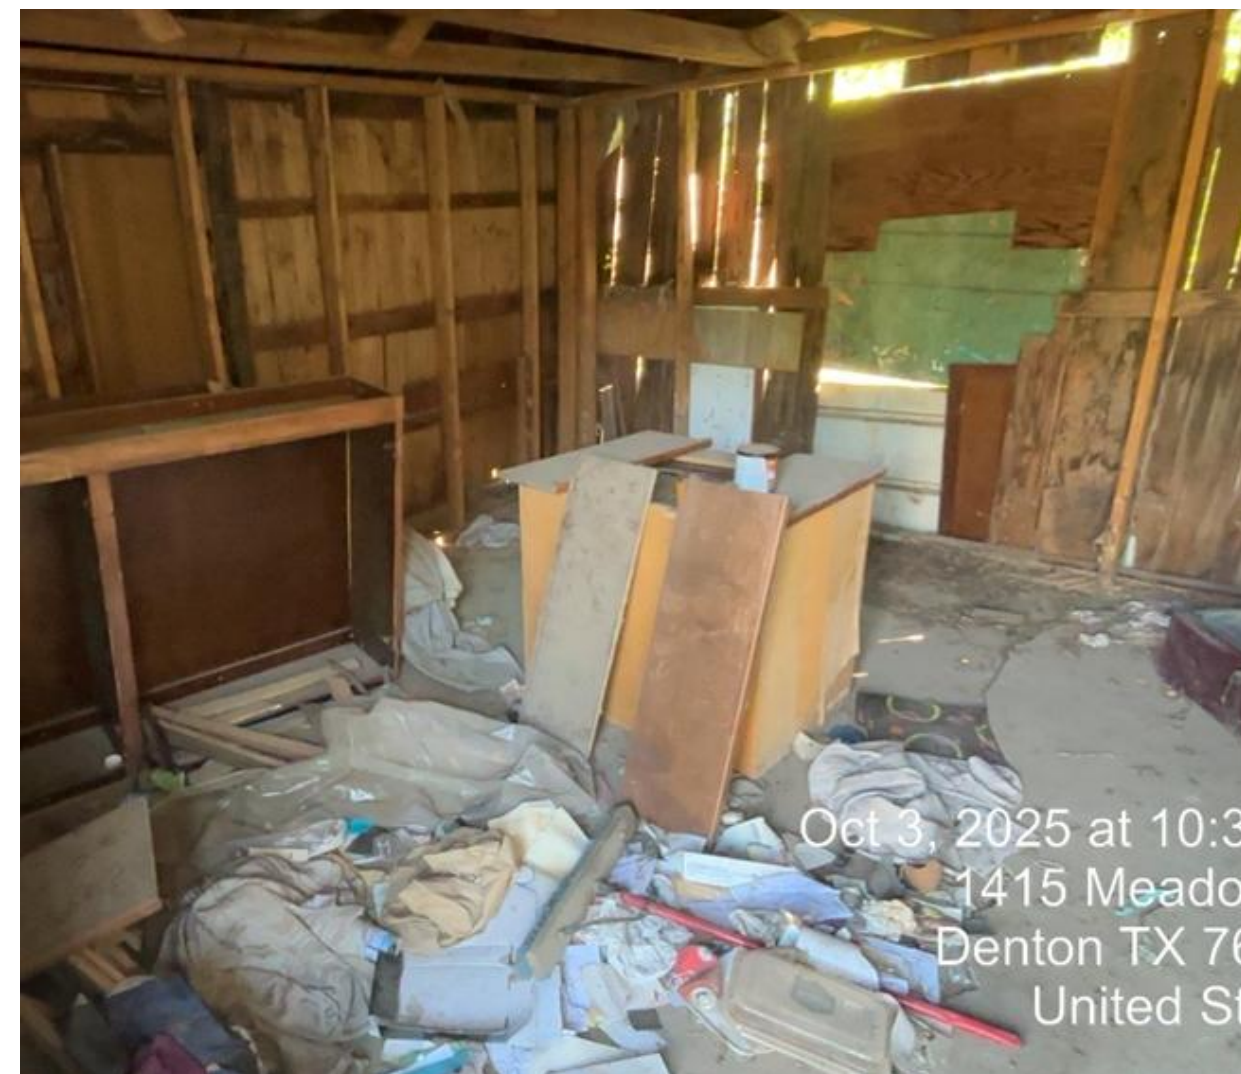
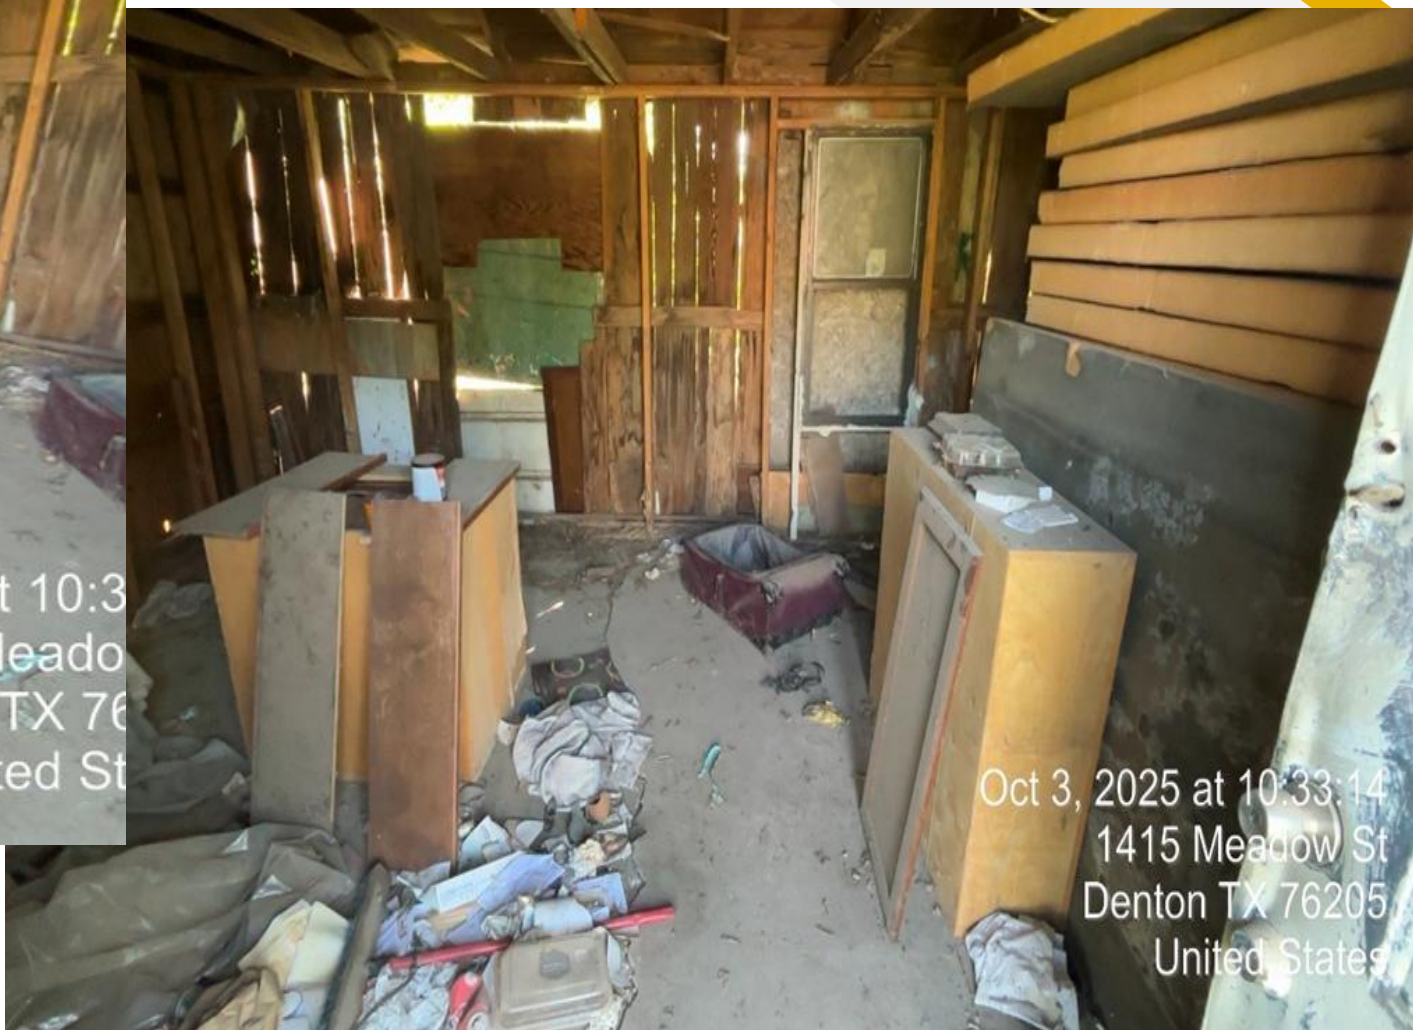
- The structure would not be capable of providing resistance to ice, snow, or rain. Doors/windows and siding are missing in several areas along the exterior of the building.

- The structure is vacant and has been for several years.
