AN ORDINANCE OF THE CITY OF DENTON, TEXAS APPROVING AN ALTERNATIVE ENVIRONMENTALLY SENSITIVE AREA PLAN TO OFFSET THE REMOVAL OF 0.23 ACRE OF ENVIRONMENTALLY SENSITIVE AREAS (ESAS) ON APPROXIMATELY 53.89 ACRES OF LAND LOCATED NORTH OF SPENCER ROAD AND APPROXIMATELY 1,200 FEET WEST OF THE INTERSECTION OF SPENCER ROAD AND LOOP 288 IN THE CITY OF DENTON, DENTON COUNTY, TEXAS; ADOPTING AN AMENDMENT TO THE CITY'S OFFICIAL ENVIRONMENTALLY SENSITIVE AREAS MAP; PROVIDING FOR A PENALTY IN THE MAXIMUM AMOUNT OF \$2,000.00 FOR VIOLATIONS THEREOF; PROVIDING A SEVERABILITY CLAUSE; AND PROVIDING AN EFFECTIVE DATE. (AES25-0001C)

IDI Logistics

Spencer Road Industrial Project Site

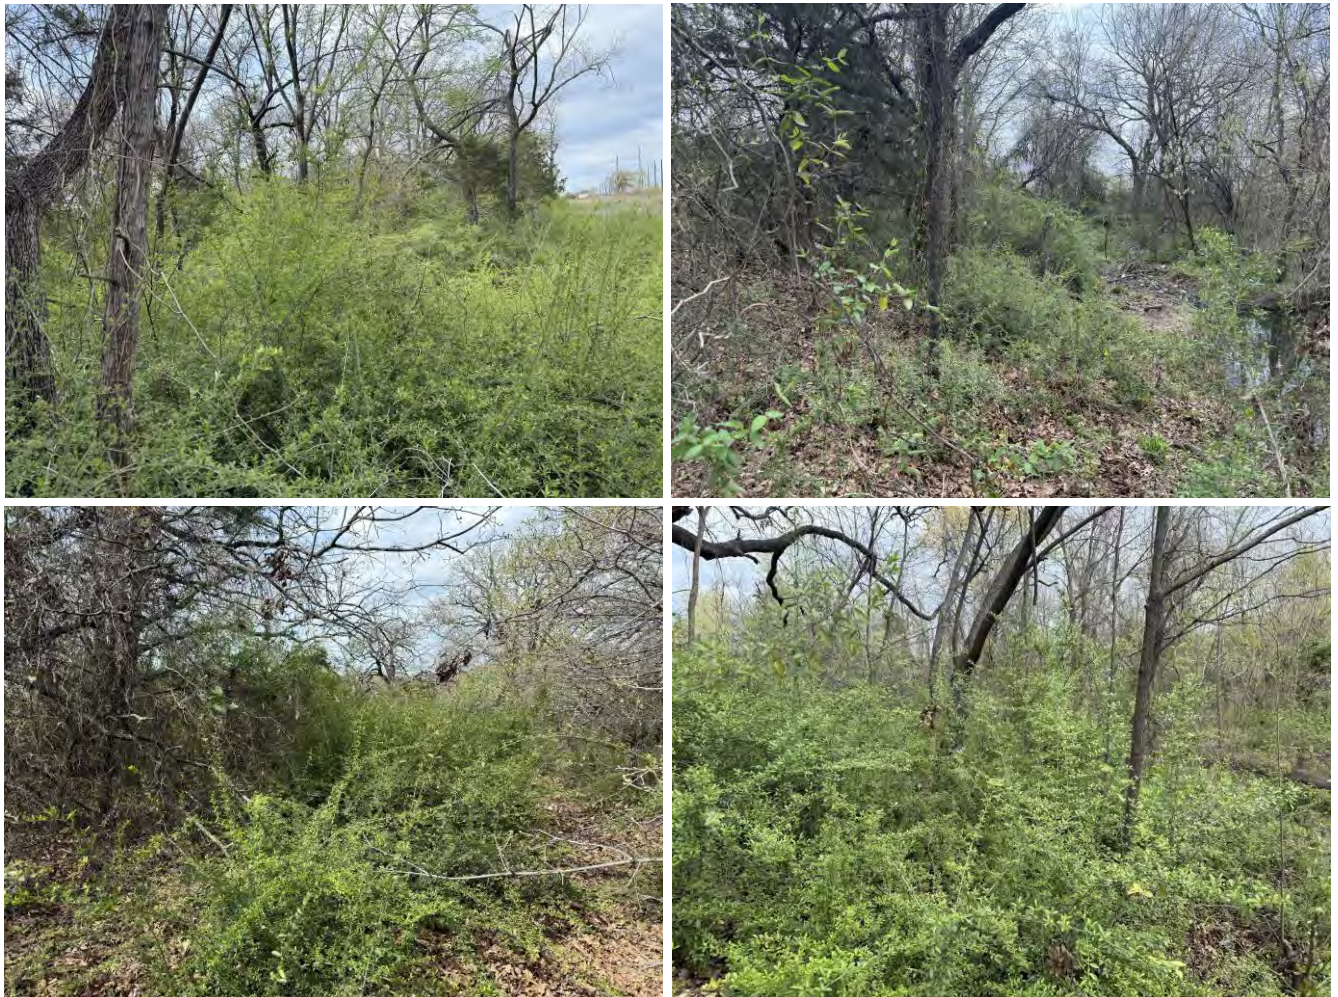
**Figure 1.** The photographs illustrated above depict the understory of invasive Chinese Privet throughout the mitigation area.

**Figure 1** illustrates that invasive Chinese privet currently dominates the canopy understory within the ESA. Mechanical removal will consist of the use of a hydro-axe for most of the area, supplemented with hand clearing to remove Chinese privet immediately surrounding existing trees. The hydro-axe will remove the aboveground portion of the Chinese privet plant but does not remove the root system and sprouting will occur. The regrowth will be spot treated with triclopyr, a pesticide from the City's Integrated Pest Management list, the following spring at the recommended label rate. An additional spot treatment of seedlings will be conducted, if necessary. Debris from the privet removal will be mulched and spread within the mitigation area. The eradication of Chinese privet will open the understory and improve opportunities for diverse native species to thrive with limited invasive competition. A successful eradication will allow for no more than 5 percent of remaining Chinese privet understory cover. Seedlings and regrowth will be monitored and removed seasonally during the 3-year monitoring period within the mitigation area as needed to ensure Chinese privet remains eradicated.

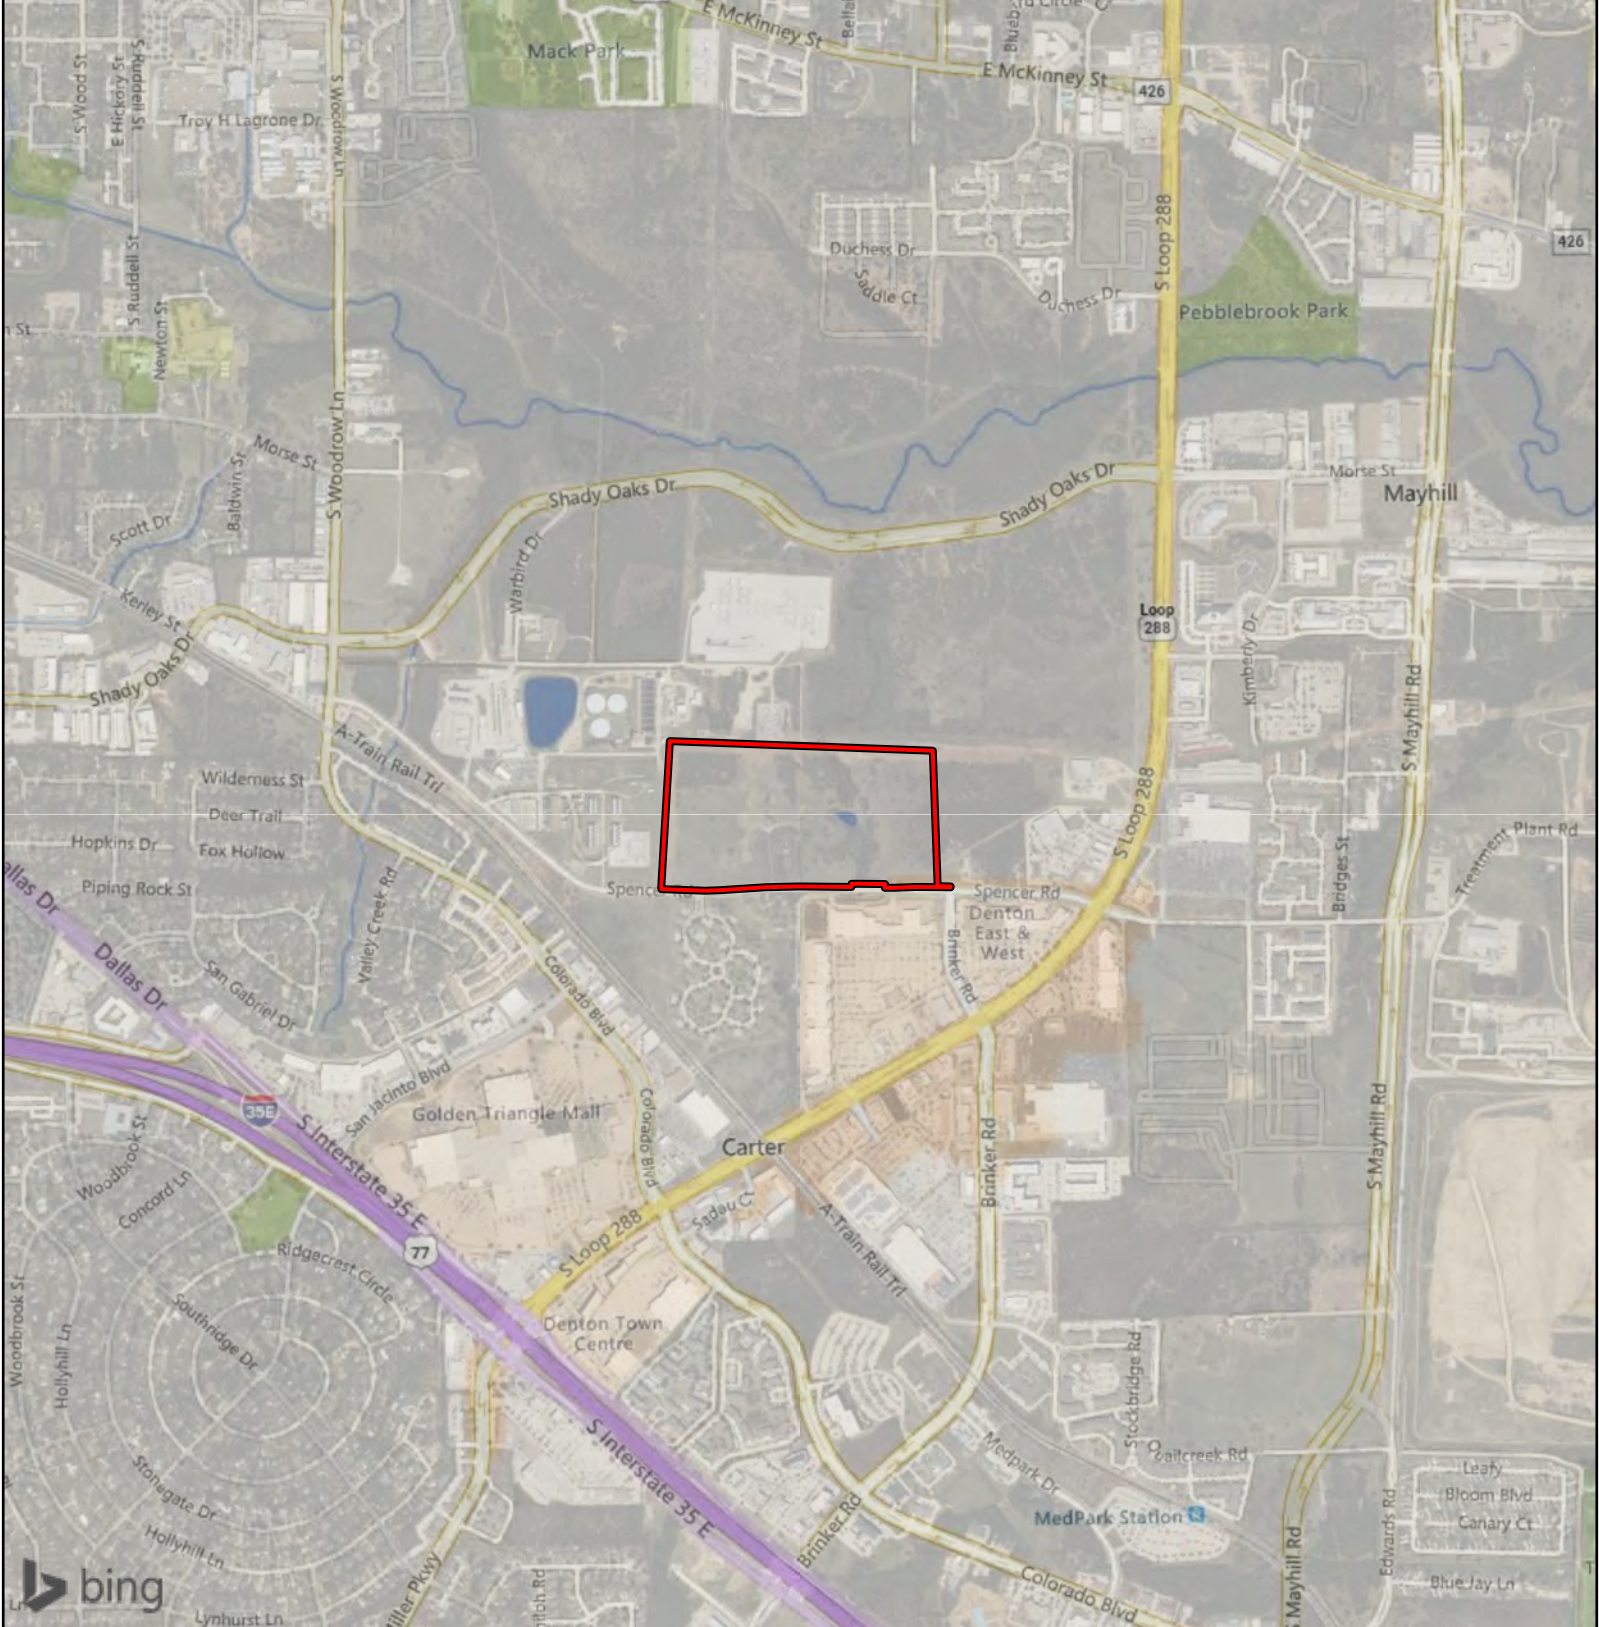
**Figure 1.**  
**General Location Map**

Spencer Road Industrial  
City of Denton  
Denton County, Texas

The proposed Spencer Road Industrial project site is approximately 53.5 acres located at 2201 and 2203 Spencer Road in the City of Denton, Denton County, Texas (**Appendix A, Figure 1**).
