Exeter – Westpark Phase 3

Alternative Environmentally Sensitive Area (AESAs) Report
(AESAs22-0002)

July 2022

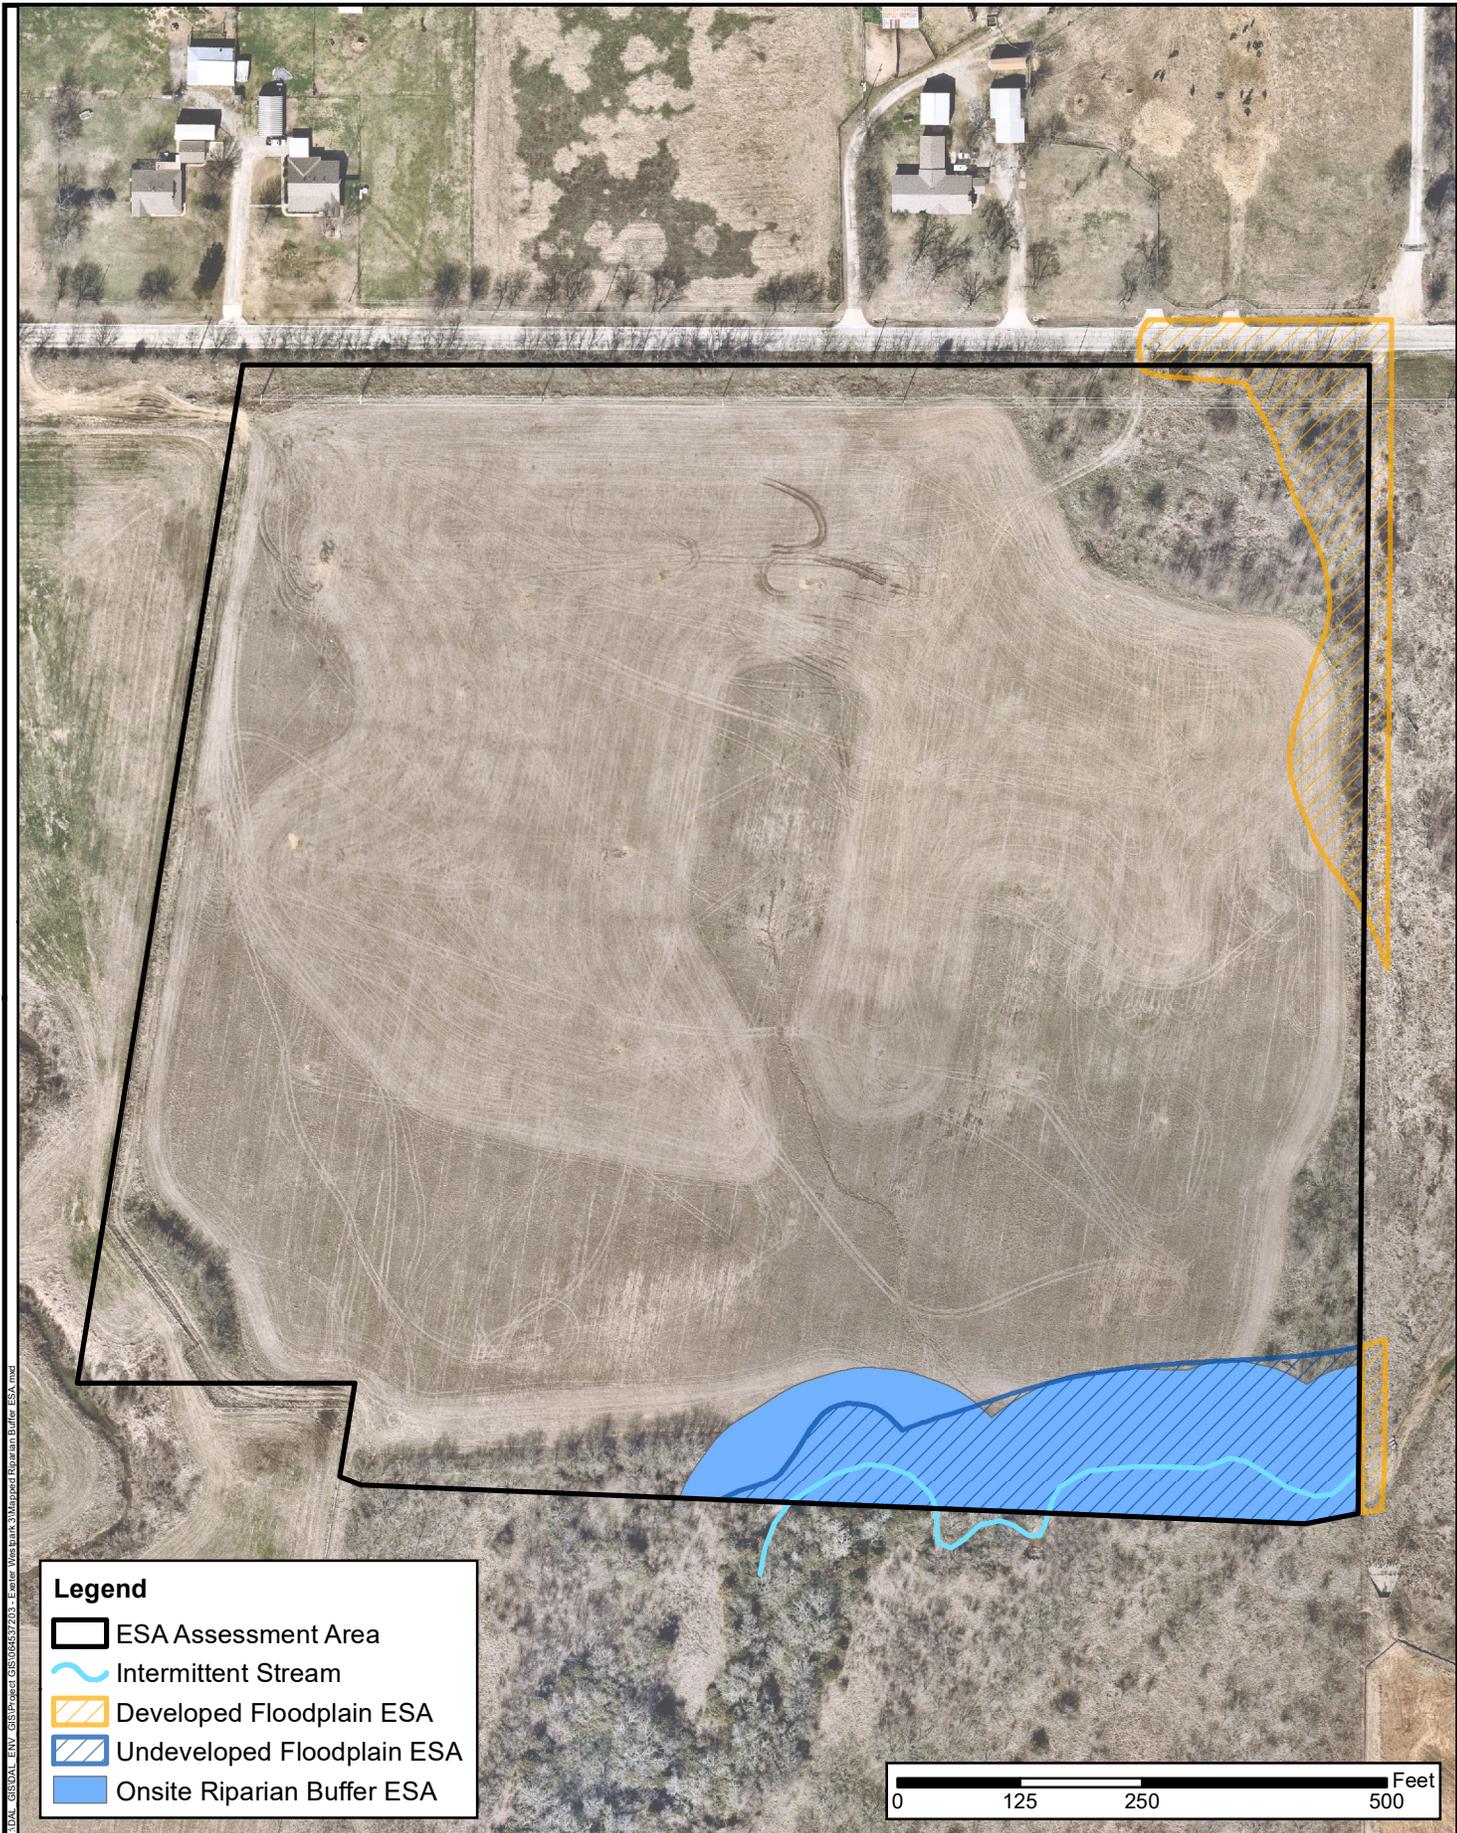
FIGURE 3	DATE: 03/28/2022
	DRAWN: SDG
	CHECKED: EKB
	KHA NO.: 064537203

Figure 3 shows the observed Riparian Buffer and Undeveloped Floodplain ESAs associated with stream channel through the southeastern portion of the site. The total Riparian Buffer ESA covers approximately 2.1-acres and the Undeveloped Floodplain ESA covers approximately 1.8-acres within the assessment area. The Undeveloped Floodplain ESA is almost completely within the Riparian Buffer ESA.

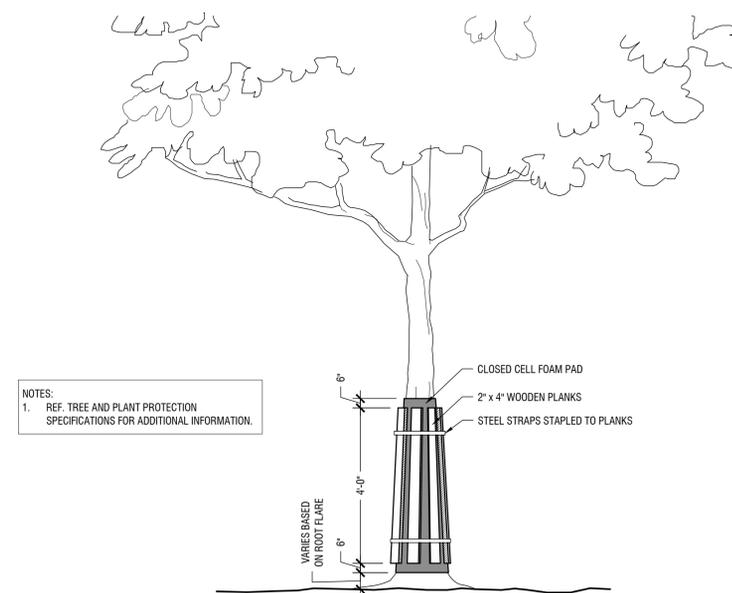
CLOSED CELL FOAM PAD
2" x 4" WOODEN PLANKS
STEEL STRAPS STAPLED TO PLANKS

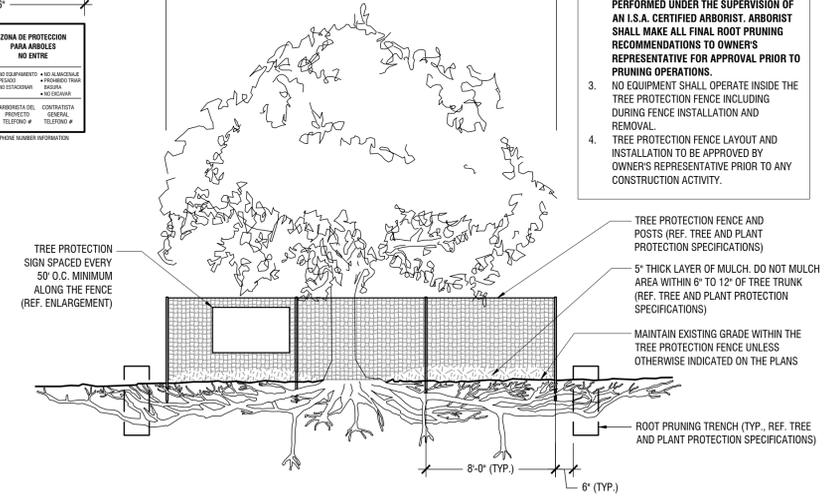
TREE PROTECTION FENCE AND POSTS (REF. TREE AND PLANT PROTECTION SPECIFICATIONS)
5" THICK LAYER OF MULCH. DO NOT MULCH AREA WITHIN 6" TO 12" OF TREE TRUNK (REF. TREE AND PLANT PROTECTION SPECIFICATIONS)
MAINTAIN EXISTING GRADE WITHIN THE TREE PROTECTION FENCE UNLESS OTHERWISE INDICATED ON THE PLANS
ROOT PRUNING TRENCH (TYP., REF. TREE AND PLANT PROTECTION SPECIFICATIONS)
