BOND
PROGRAM 2023

Active Adult Center

Meeting #2
June 1, 2023

Denton Senior Center

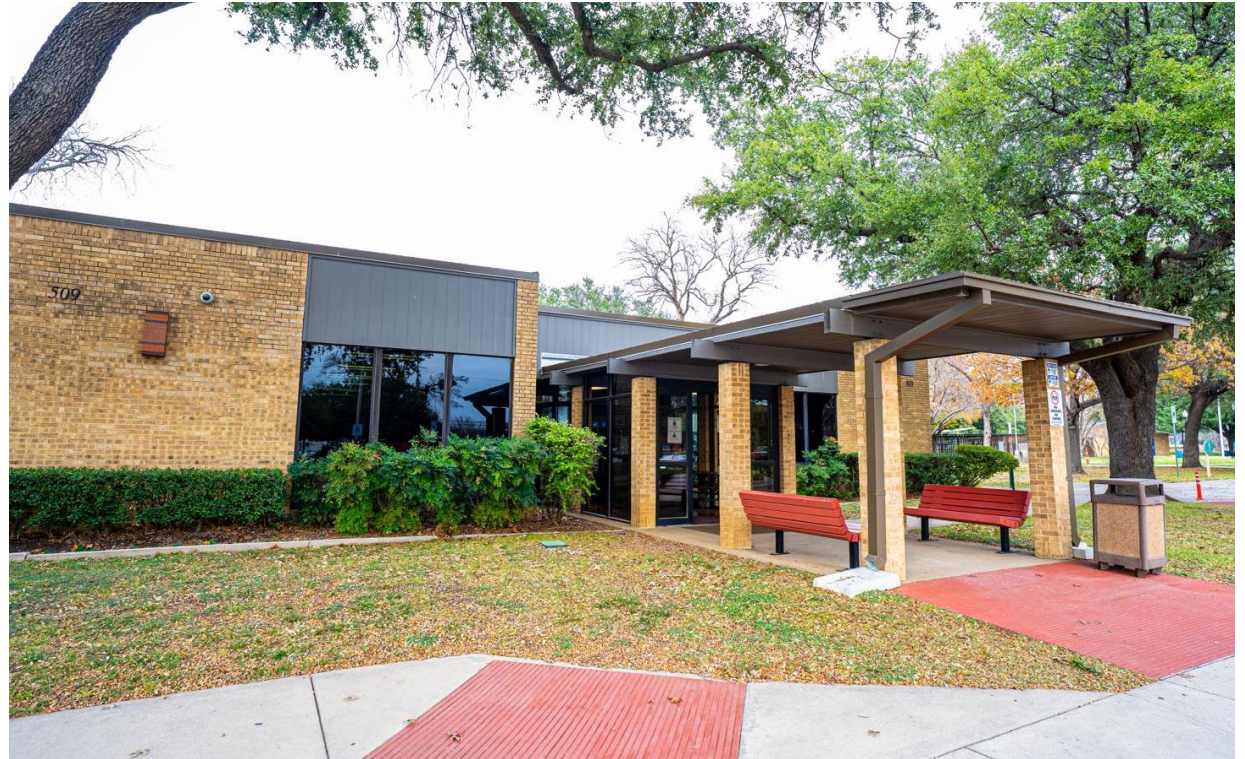
Built - 1977
5,700 sf

Expanded - 1990
16,400 sf

Expanded – 2010
19,430 sf

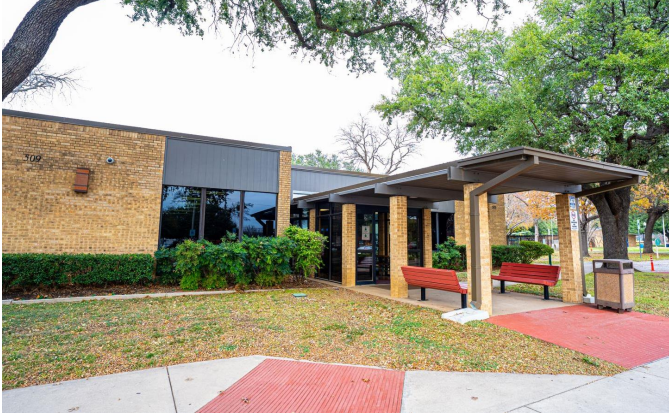
EXTERIOR:

Dated appearance, disjointed

Quakertown Park addition by subtraction, Great park setting

Focus group feedback (#1) was the limited parking and parking in the summer during pool operations

ADA challenges throughout facility

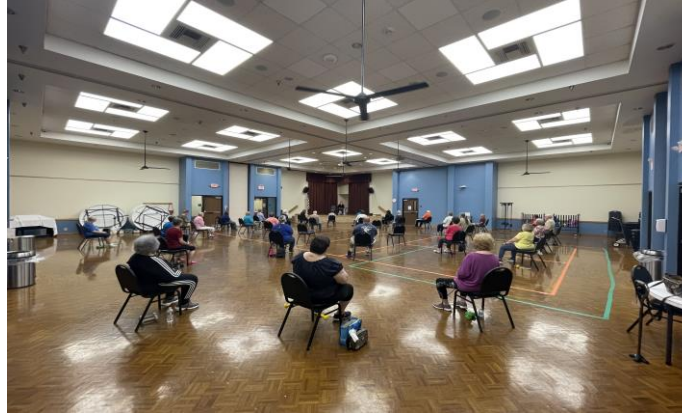
MULTIPURPOSE ROOM/GYM:

Lack of storage for event tables, chairs and equipment

Event space must also serve as group exercise room and music rehearsal space

No dedicated gym space for programs

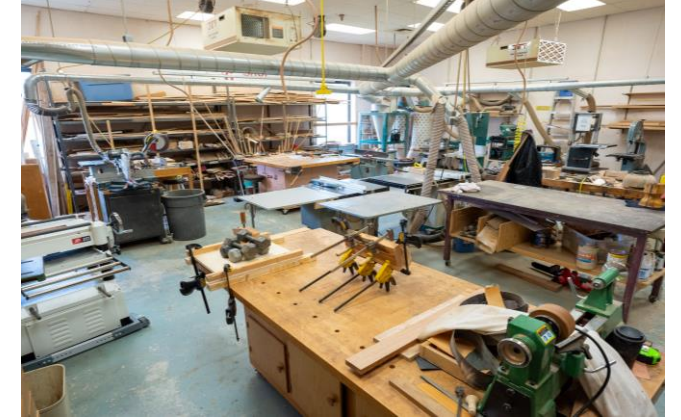
WOODSHOP/CLASSROOMS:

Safety standards allow 6 in at a time, not sufficient for current user base

Lack of storage and workspace

Need additional programmable space
