PROPOSAL P17147R3

SUBJECT Proposal to assist with Oil and Gas Inspection Activities
City of Denton

ANNUAL PADSITE INSPECTION REPORT

Padsite Name: Example Farms & Family Trust Padsite (#34)

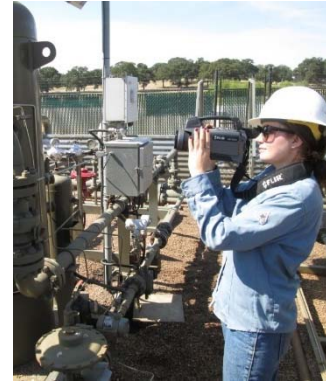
Photo above depicts an Optical Gas Imaging (OGI) leak survey in Flower Mound. OGI allows for faster leak inspections as methane and VOC leaks are visually identifiable.

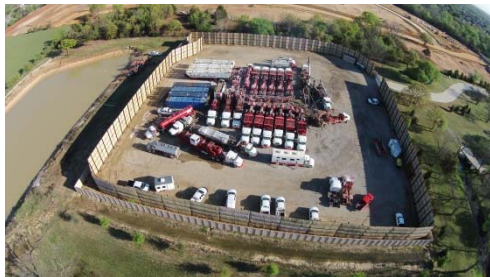
Photo above depicts a hydraulic fracturing event in Colleyville. Modern deployed several up and downwind monitors as well as conducted on and off-site air quality surveys. By giving immediate feedback, several emissions were curtailed and impact to neighboring properties was minimized.

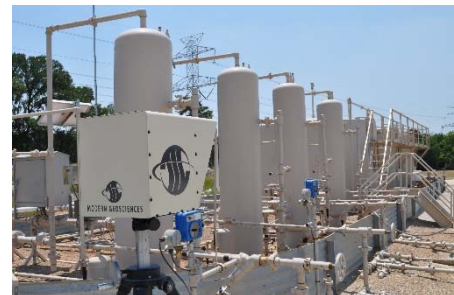
Photo above depicts an Open Path Monitor (OPM) collecting real-time VOC concentration data across separators in Kennedale.

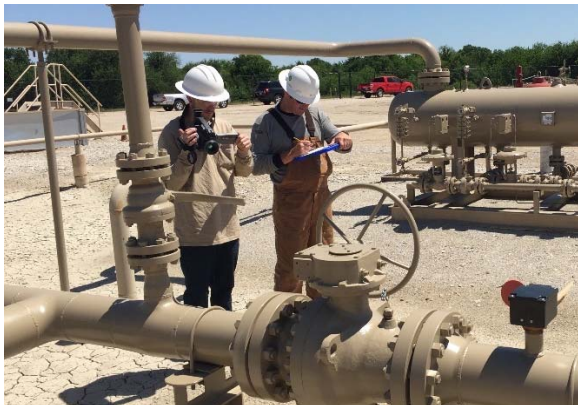
View of OGI efforts during a padsite inspection event.

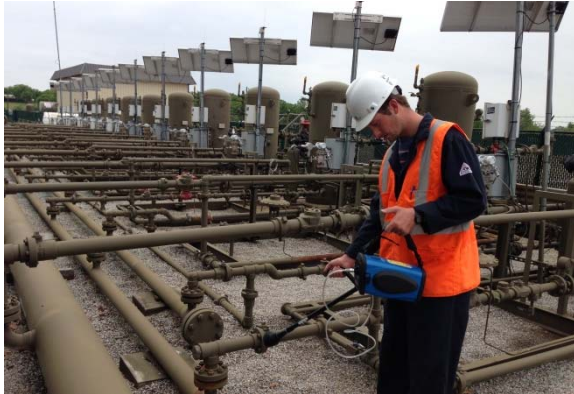
Example of infrared methane monitoring after a leak has been identified with the OGI equipment.

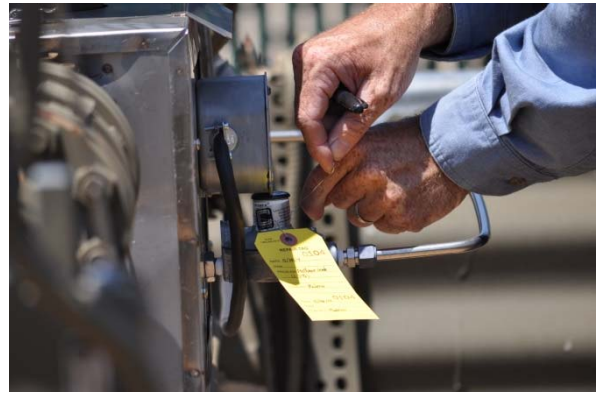
Example of tagged equipment in need of repair or replacement.

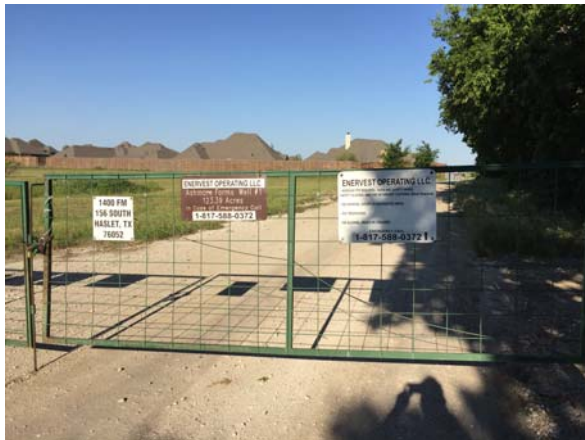
No. 1 View of padsite entrance with well signage and Knox Lock.

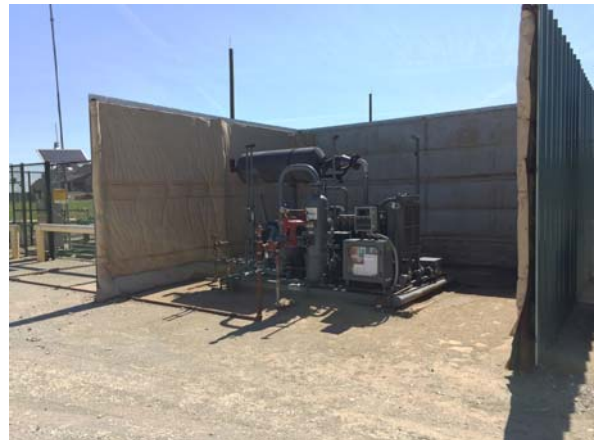
No. 2 View of on-site compressor and acoustic wall.

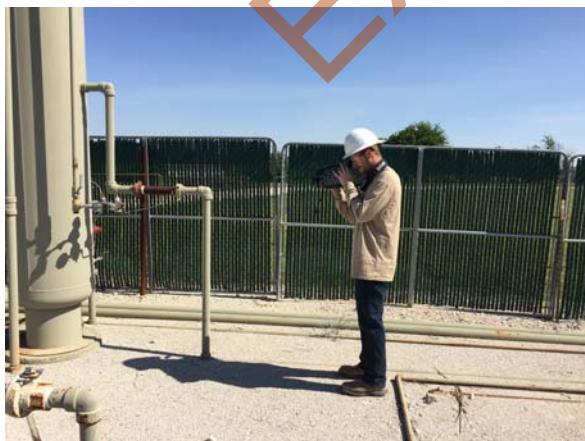
No. 5 View of OGI operation at leak observed on Separator D.

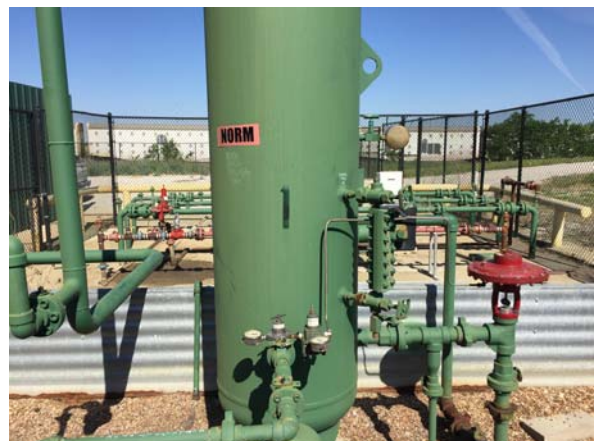
No. 6 View of NORM labeled separator (A).

Location ID:	Leaks (OGI):	NORM (µR/hr; max):	Date Reported ¹ :	Date Addressed ² :
Separator A	None	150	NA	NA
Separator B	None	<15	NA	NA
Separator C	None	<15	NA	NA
Separator D	Compression Fitting	<15	05/05/17	05/05/17
Separator E	None	<15	NA	NA
General Notes: No other concerns noted.

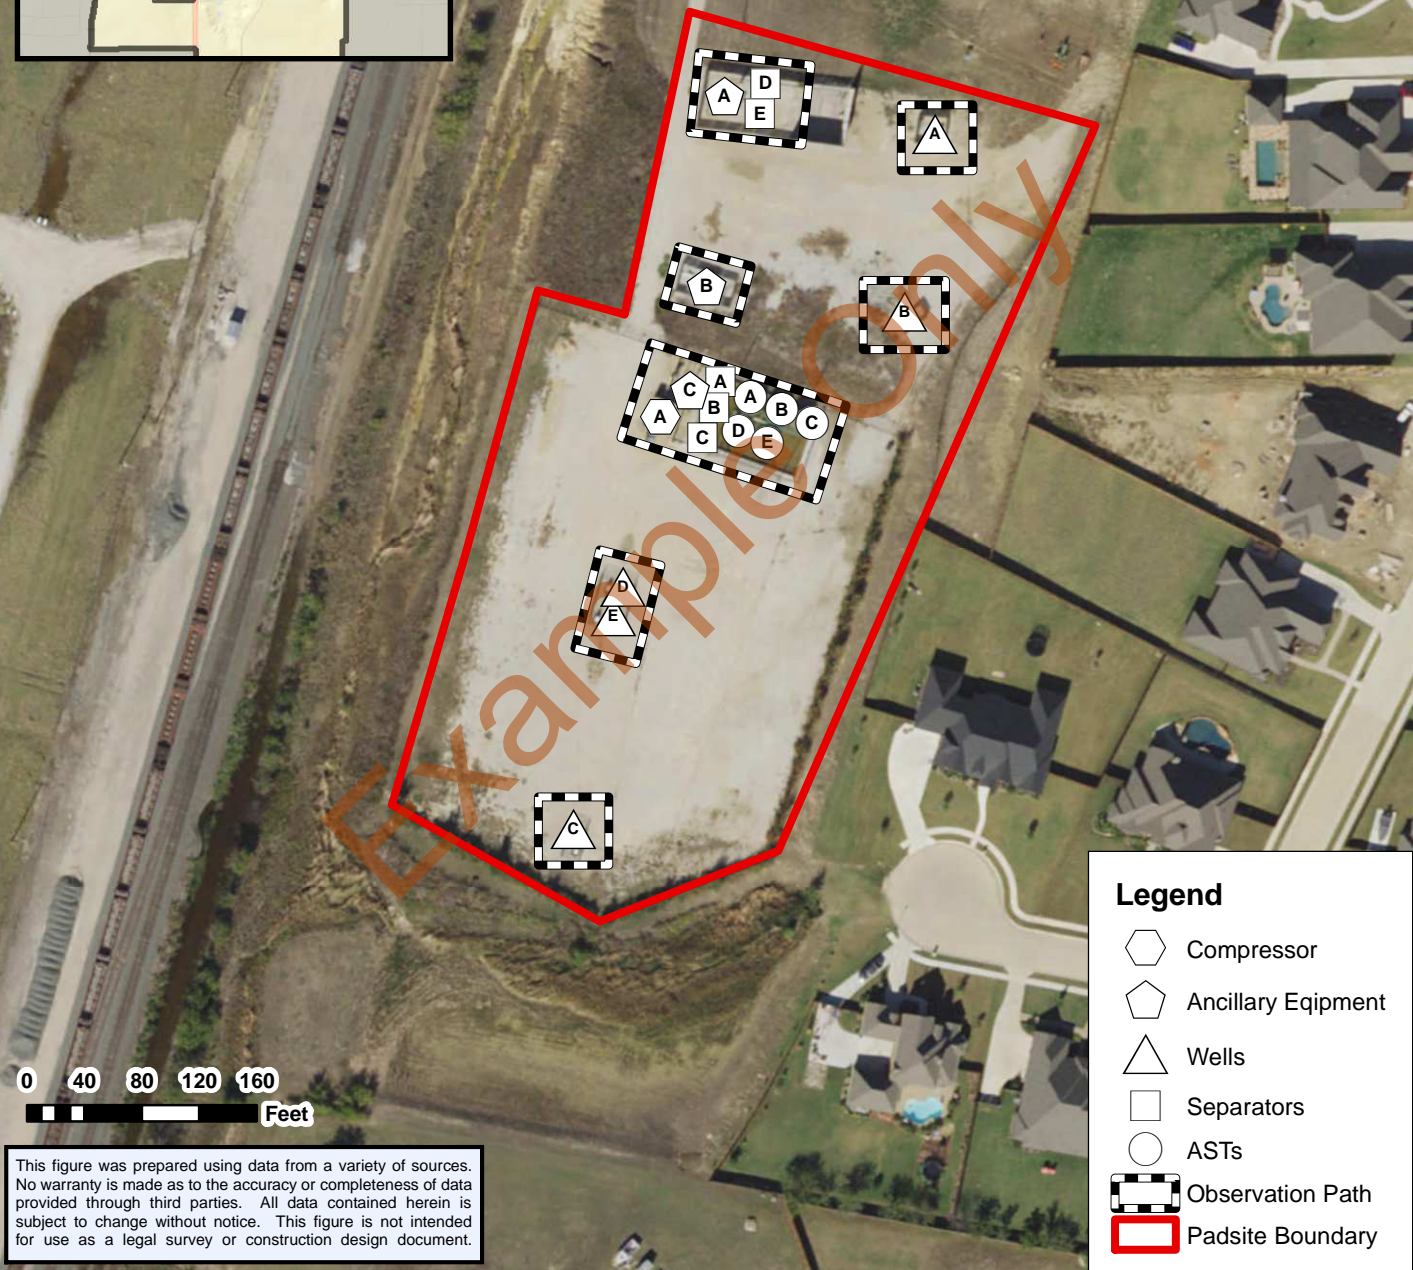
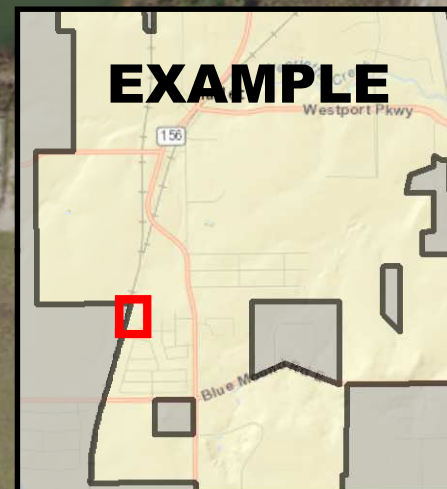
SITE MAP

Example Operating, LLC	
Well ID	RRC ID
A	192000
B	193000
C	241000
D	197000
E	241000

Example Trust/Family Farms Padsite (No. 34)
Example, Texas
