12 July 2022

RE: City Hall West Selective Demolition (1927 Old Denton City Hall)

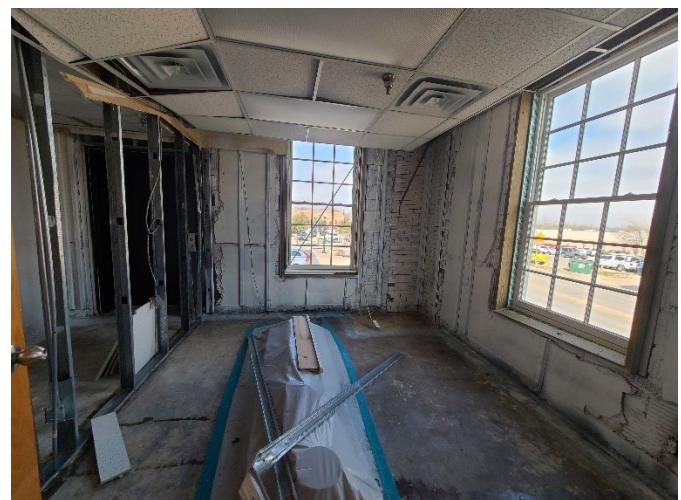
Level C North elev. Door in former window opening

New windows and doors are limited to the removal of the north elevator addition. Windows will match the previously approved metal clad wood product used in the 2020 full exterior window replacement scope of work. Cast stone panels and water table will be reconstructed to match existing panels at window type E
