ROADWAY SAFETY AUDIT

Eagle Drive, from North Texas Boulevard
to Bell Avenue

City of Denton

North Central Texas
Council of Governments

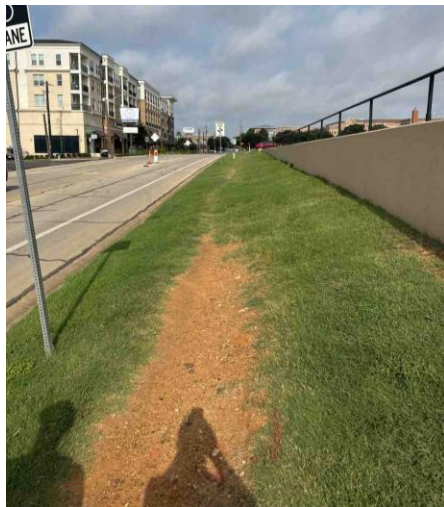
Figure 7 – Example of Sidewalk Gaps

Sidewalks are not present along both sides of the corridor, although many sections have an obvious desired pedestrian path, as shown in **Figure 7**, which shows a demand for a sidewalk. The sidewalk gaps provide very little comfort for pedestrians along the corridor, as some of the pedestrian crossings are not connected through sidewalks.

CD.1	Eagle Dr	Segment	Avenue C-Collier St, entire northern side of block	Long	New Sidewalk	Observation: There is a sidewalk gap along the north side of Eagle for approximately 420' Recommendation: Install approximately 420' of accessible sidewalk along the north side of the Eagle Drive	Sheet 1 of 3
D.1	Eagle Dr	Intersection	Collier St	Short	Left Turn Lane	Observation: There is a break in the two-way left turn lane since that is confusing Recommendation: Restripe the turn lanes to be back to back even between Collier Street and Avenue B	Sheet 1 of 3
DE.1	Eagle Dr	Segment	Collier St-Avenue B, entire northern side of block	Long	New Sidewalk	Observation: There is a sidewalk gap along the north side of Eagle Drive for approximately 270'. Recommendation: Install approximately 270' of accessible sidewalk along the north side of Eagle Drive.	Sheet 1 of 3
E.1	Eagle Dr	Intersection	Avenue B	Short	Left Turn Lane	Observation: There is a break in the two-way left turn lane since that is confusing Recommendation: Restripe the turn lanes to be back to back even between Collier Street and Avenue B	Sheet 1 of 3

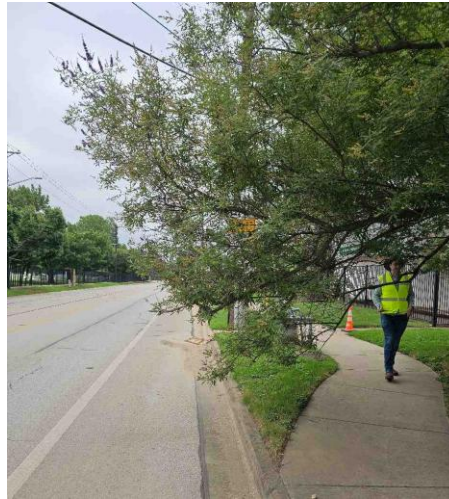
Figure 8 – Example of
Overgrown Vegetation

Overgrown vegetation is infringing on sidewalks, warning signs, and lighting in several places along the corridor. The vegetation is interfering with the pedestrian's path as well as obstructing the view of warning signs and blocking lighting. This leads to uncomfortable situations for pedestrians, as shown in **Figure 8** and poor sight distance for vehicles on the roadway.

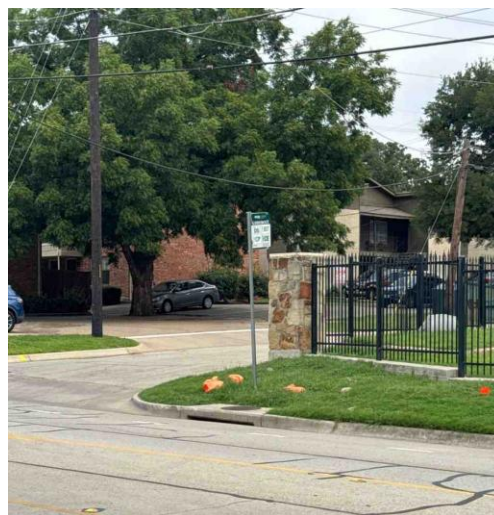
Figure 9 – Example of Existing
Bus Stop

This section of Eagle Drive features several bus stops along the corridor. The existing bus stops are only bus stop signs with no bus pads or shelters, which do not provide accessibility for riders, as shown in **Figure 9**.

This corridor features several bus stops. Some of which are missing pads and/or shelters. It is recommended that pedestrian pads and shelters (**Figure 23**) be installed at bus stops to ensure the safety of vulnerable road users while they wait for public transportation.

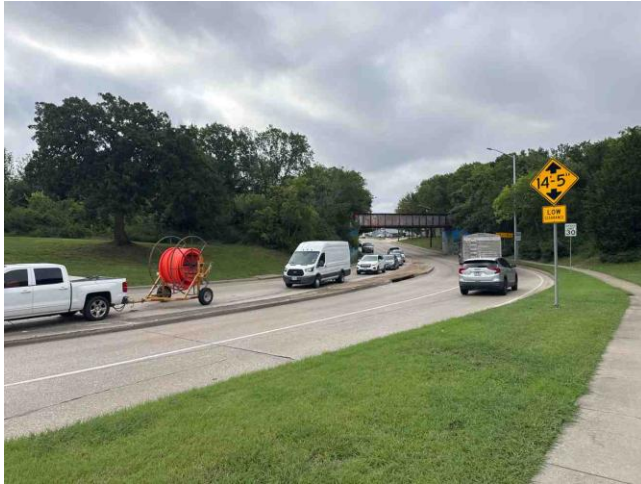
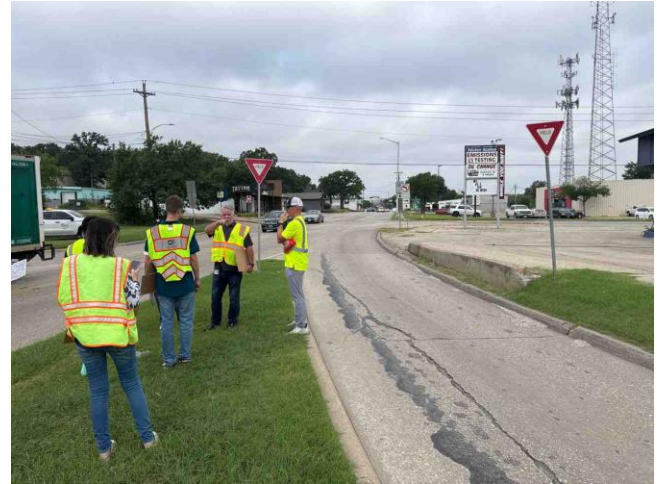
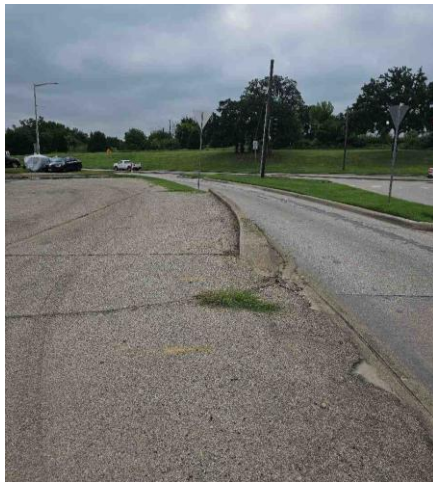
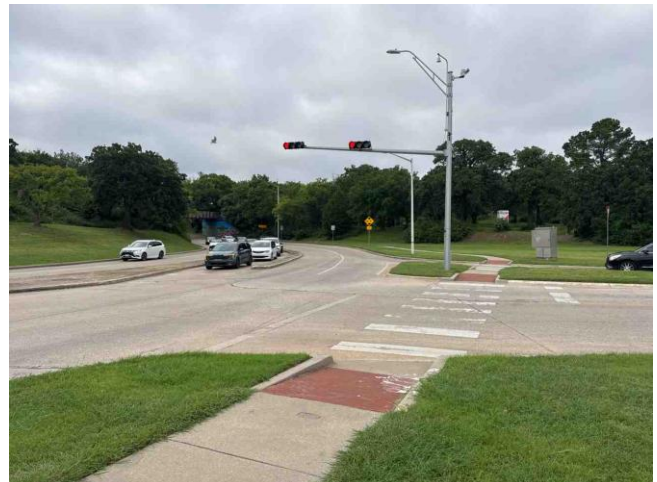
Figure 15 – Field Observations at Bell Avenue

While the observations above were consistently seen at the intersections of the corridor, the intersection of Eagle Drive and Bell Avenue had unique issues identified during the in-field visit. The intersection at Bell Avenue has a lot of conflicts, including vehicular traffic, pedestrian activity, a northbound curve, and southbound right-turn channelization, as shown in **Figure 15**. The pedestrian signal equipment and crossing are not accessible, and the southbound right-turn yield lacks visibility for pedestrians and weaving cars from the northbound left turn traffic, making turns on northbound Locust St difficult.

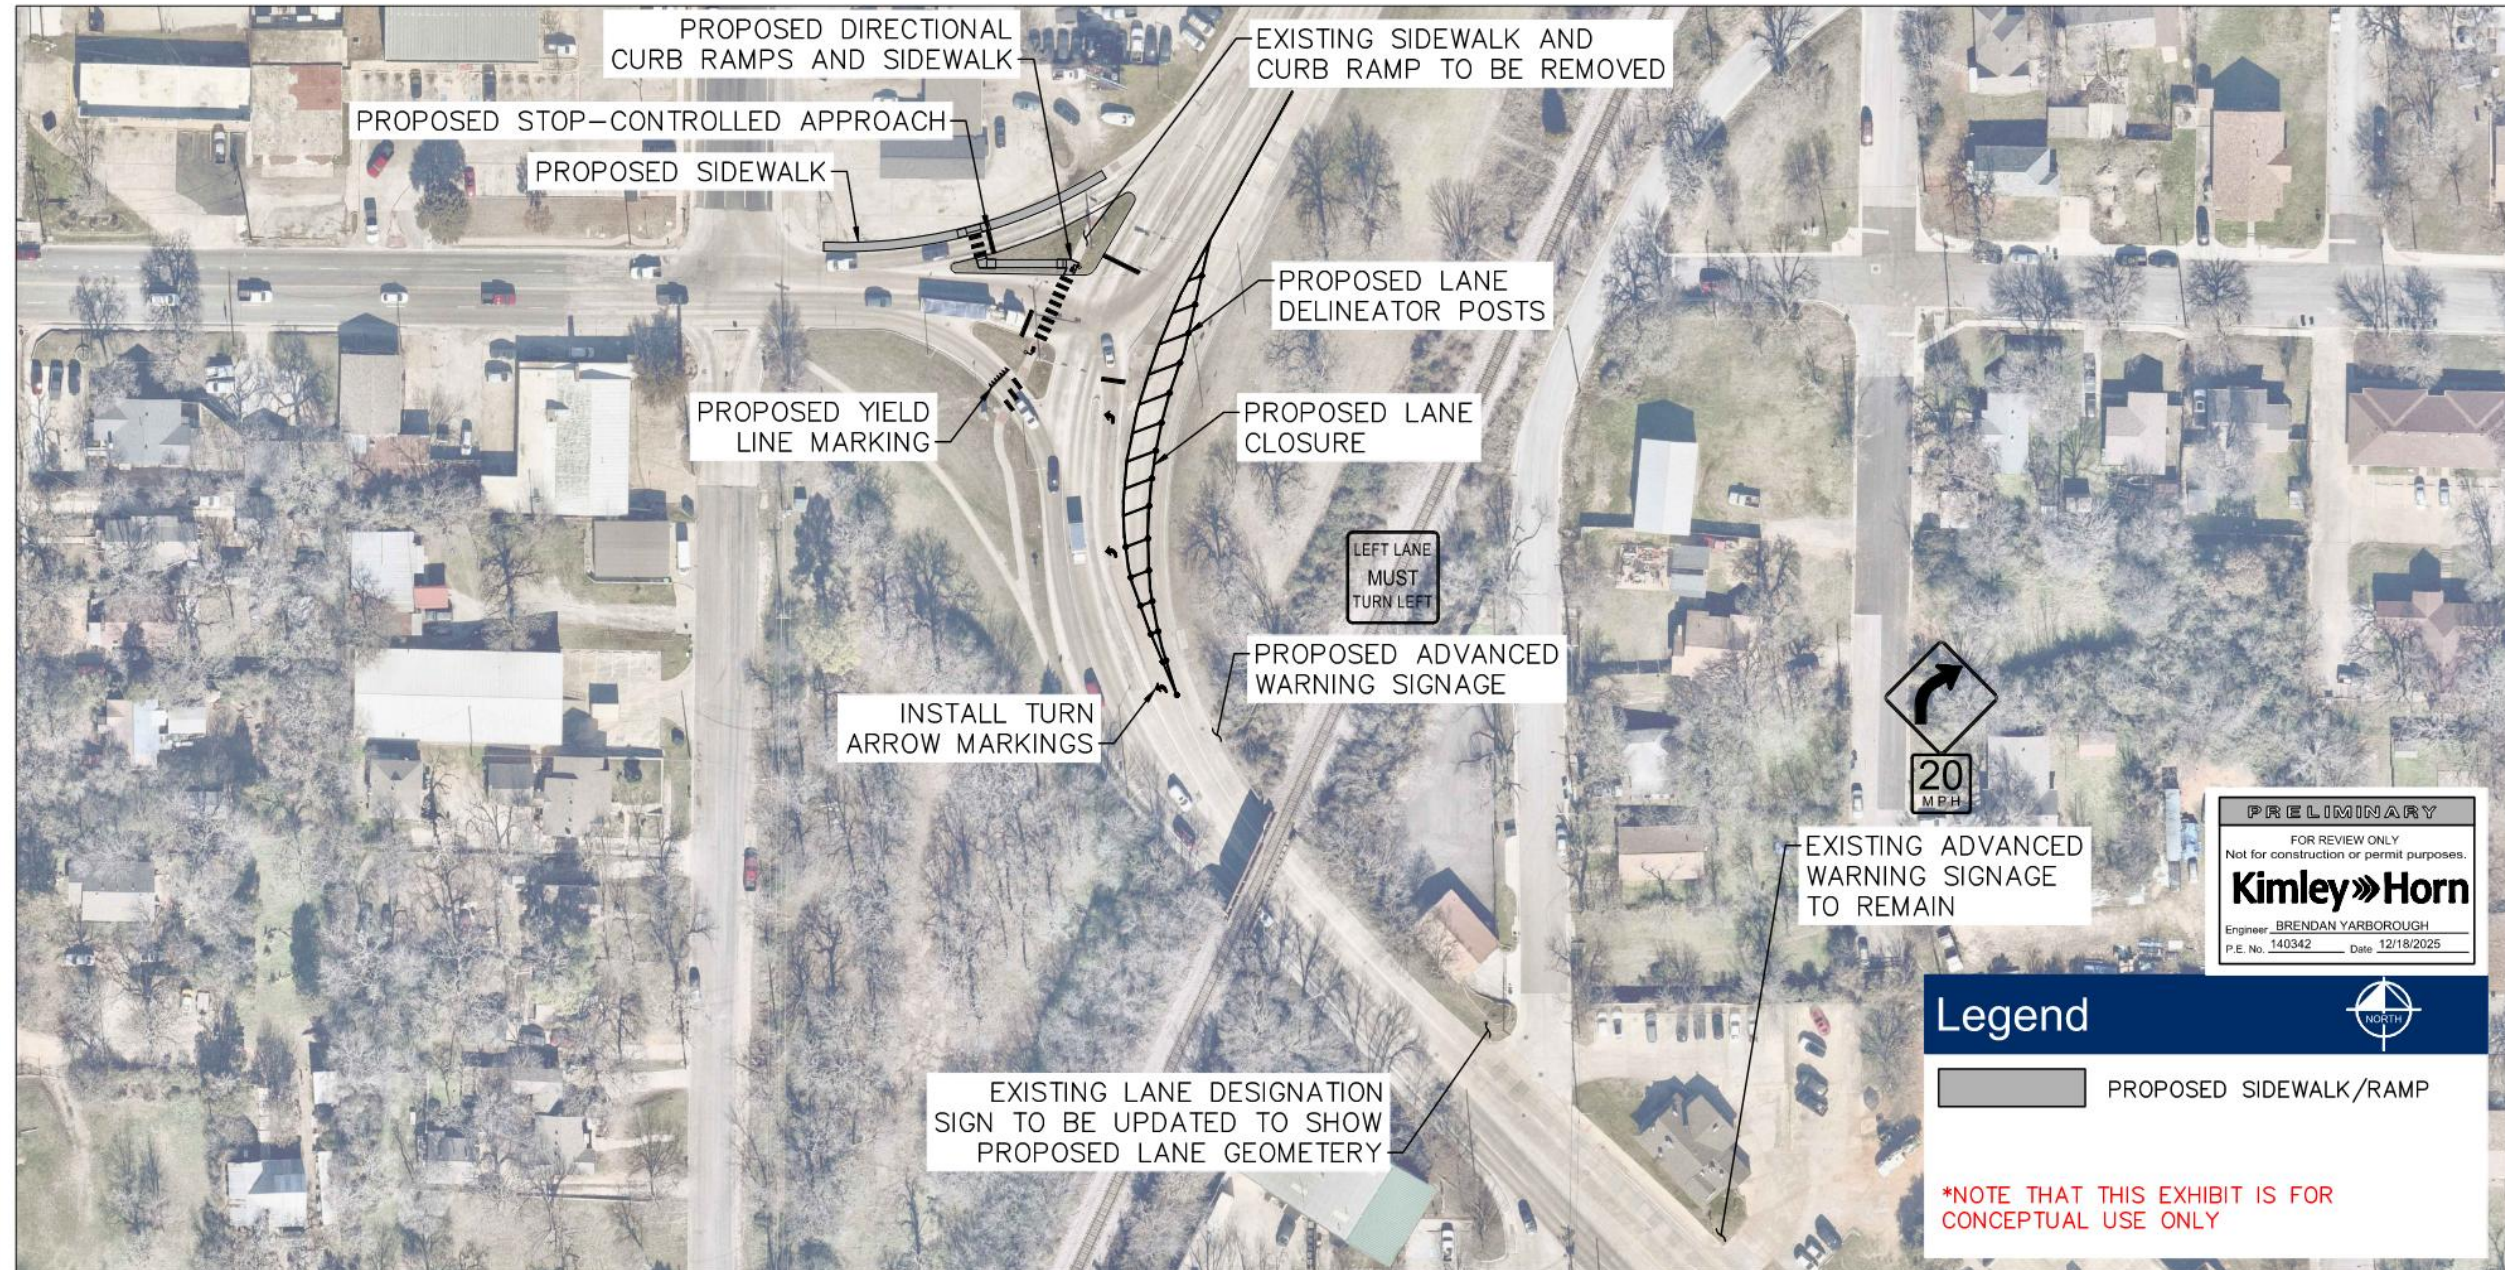
Figure 26 – Eagle Drive and Bell Avenue Intersection Reconfiguration

O.1	Eagle Dr	Intersection	Bell Ave	Short	Signal Ahead Warning Sign	Observation: Signalized intersection is around a curve for northbound traffic on Bell Ave Recommendation: Install signal ahead warning signs approximately 300' in advance of the intersection for northbound traffic	Sheet 3 of 3
O.2	Eagle Dr	Intersection	Bell Ave	Short	Pavement Marking	Observation: Northbound left turn is missing lane use pavement markings Recommendation: Add a left turn arrow pavement marking for northbound left turns to discourage last-minute through movement	Sheet 3 of 3
O.3	Eagle Dr	Intersection	Bell Ave	Short	Sign Improvement	Observation: Multiple signs leading up to and in intersection are faded Recommendation: Replace faded "CURVE AHEAD" warning and "20 MPH" advisory sign south of Johnson St along the northbound side and replace faded Merge Traffic sign on the center median in the northbound direction, north of the intersection	Sheet 3 of 3

O.4	Eagle Dr	Intersection	Bell Ave	Long	Install Stop-Controlled Approach	Observation: Southbound right turn is a yield operation Recommendation: Change to a stop-controlled approach with a stop bar marking and supplementary red reflective tape on the "STOP" sign pole. Reroute the curb ramp and crosswalk pavement markings to be further west in front of the stop bar.	Sheet 3 of 3
O.5	Eagle Dr	Intersection	Bell Ave	Long	Intersection Reconfiguration	Observation: No pedestrian infrastructure, through traffic and right turn issues Recommendation: Rebuild intersection where northbound through traffic is pushed to the right and the other through lane will be a drop left turn onto Eagle Drive. For the southbound right turn, change the yield operations to stop controlled approach. Add all new pedestrian infrastructure in reconfiguration. Prior to altering the lane geometry or closing a lane, a comprehensive traffic analysis should be performed to ensure intersection operations are not negatively impacted. The City of Denton would need to get approval from the TxDOT Denton Area Office prior to any lane closure.	Sheet 3 of 3

The intersection of Eagle Drive and Bell Avenue is a complex one. There is a northbound curve that can cause sight distance issues, a southbound right-turn channelization with a pedestrian crossing, and a lack of pedestrian infrastructure throughout the intersection. Several improvements can be made at this intersection. An example of some of the recommendations can be seen in **Figure 26**. Please note that the recommendations shown in the figure are for conceptual purposes only. Prior to altering the lane geometry or closing a lane, a comprehensive traffic analysis should be performed to ensure intersection operations are not negatively impacted. The City of Denton would need to get approval from the TxDOT Denton Area Office prior to any lane closure.

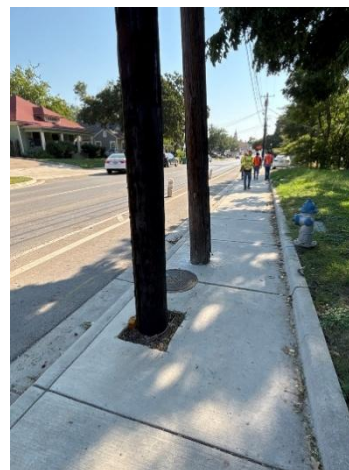
During the in-field visit, safety deficiencies were observed in the corridor, such as obstructed sidewalks, turning movements that might result in conflict, insufficient lighting, and bus stops that needed improvement. Obstructed sidewalks exist on both ends of the corridor, but they are more prevalent east of Locust Street. Sidewalk obstructions include fire hydrants, vegetation, and utility features as shown in **Figure 5**. These sidewalk obstructions narrow the pedestrian paths and may create mobility challenges for some users.

(B) Power poles on the south side of the corridor, east of Denton St

One of the most common observations in the corridor was the obstructed sidewalks. Sidewalks were primarily obstructed by overgrown vegetation or gravel debris. All sidewalks should be cleared of obstructions to ensure a clear walkway with no tripping hazards. All overgrown vegetation should be trimmed, all debris should be swept off the sidewalk, and all obstructing utility poles and infrastructure should be relocated.

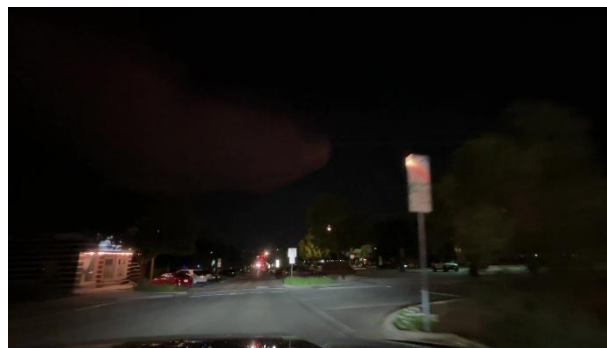
Figure 7 – Example of Insufficient Lighting

During nighttime field observations, there were locations along the corridor that were dark, as shown in **Figure 7**. Throughout the corridor, the light poles alternate on which side of the street they are located which resulted on different levels of lighting along the corridor. Based on the site observations, there are not enough light poles to adequately illuminate the roadway.

Street lighting was a corridor-wide issue observed by the RSA team during nighttime observations. The existing luminaires alternate which side of the street they are located on and resulted in insufficient lighting in some segments of the corridor and at some crosswalks. The corridor should have a consistent, uniformly spaced number of lighting fixtures along the limits of the corridor (**Figure 19**). A lighting study ensures that the roadway and pedestrian facilities are properly covered by street lighting, resulting in improved visibility of drivers and pedestrians at nighttime.

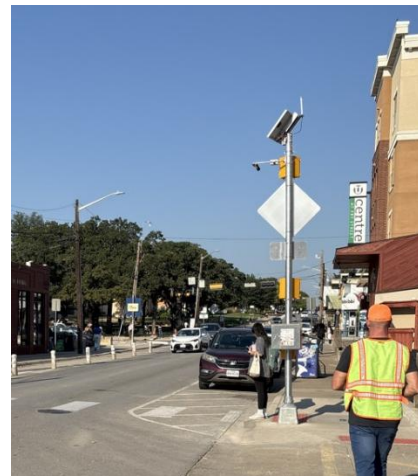
Figure 11 – Example of on-street parking

Another common observation was pedestrian visibility issues or “daylighting”, particularly at crossings where parking is near the intersections. Several intersections along the corridor do not have physical bulb outs which creates a longer crossing distance and where a pedestrian starts to cross is hidden by the parked vehicles (**Figure 11**).

At intersections with on-street parking it is recommended to add corner bulb outs, as seen in **Figure 17**. Corner bulb-outs shorten the crossing distance for pedestrians, allow pedestrians to see past parked vehicles along the street, and improve sight distance between drivers and pedestrians.

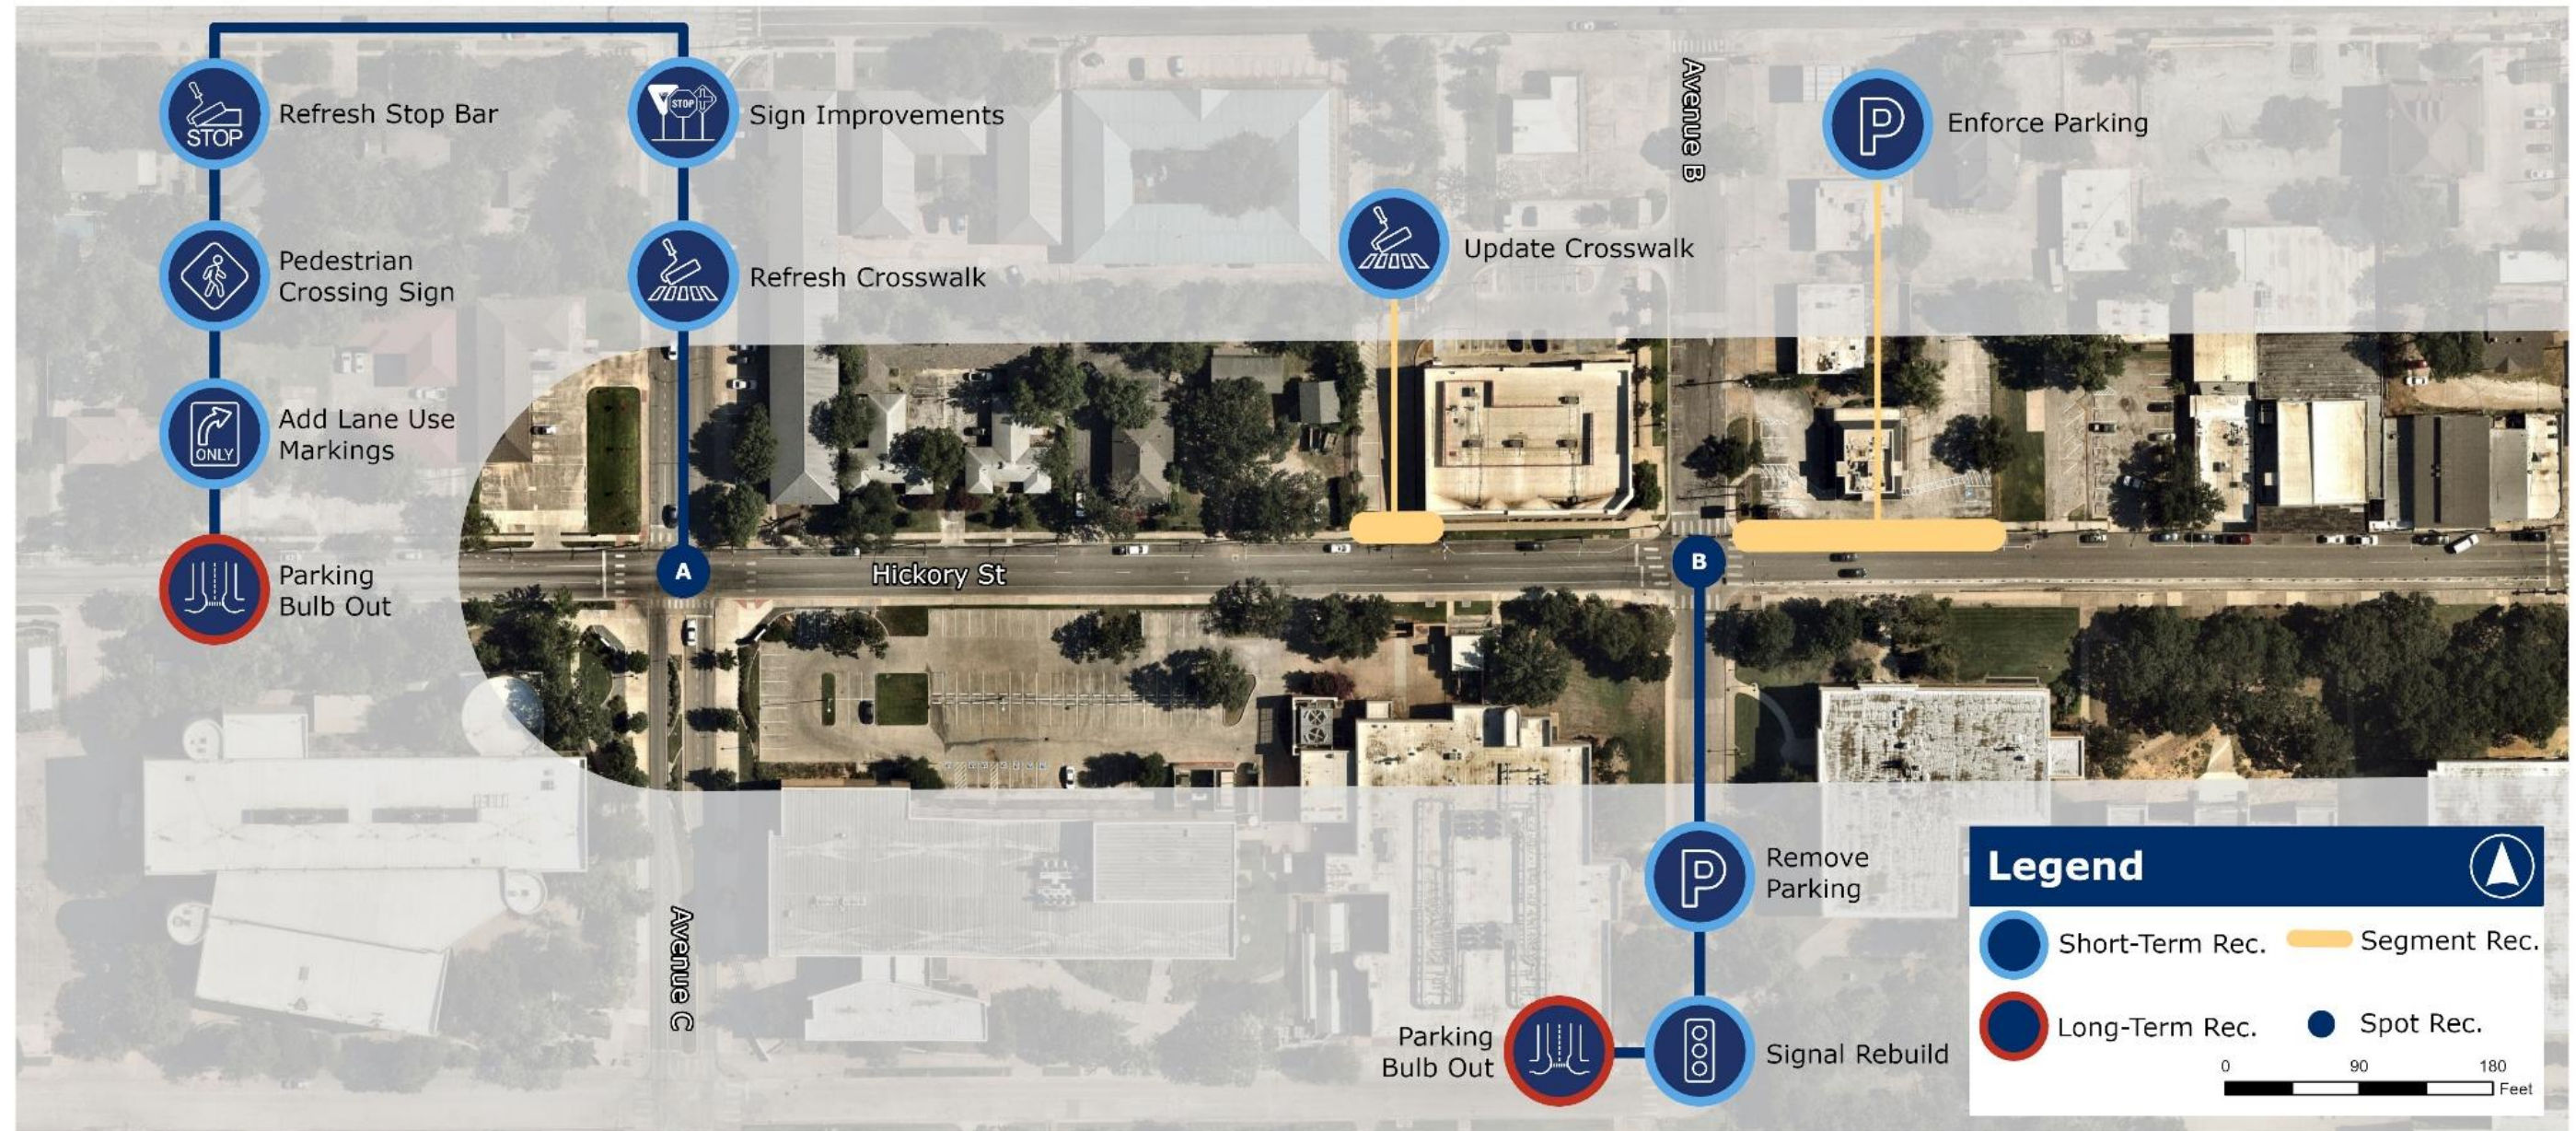
Figure 20 - Recommendations Exhibit (Page 1 of 5)

ID	Study Corridor	Context	Location	Timeline	Simplified Recommendation	Detailed Observation/Recommendation	Countermeasure On Page
1.1	Hickory St	Corridor-Wide	Along the corridor	Short	Add Retroreflective Backplates	Observation: Signal heads do not have retroreflective backplates Recommendation: Install retroreflective backplates to all signal heads	All Sheets

1.2	Hickory St	Corridor-Wide	Along the corridor	Short	Add Bike Lane Markings	Observation: Few bike lane symbols are present throughout the corridor. Recommendation: Install additional bike lane symbols spaced at 250' between Avenue C and Carroll Avenue. Install conflict green pavement markings at streets designated by the city.	All Sheets

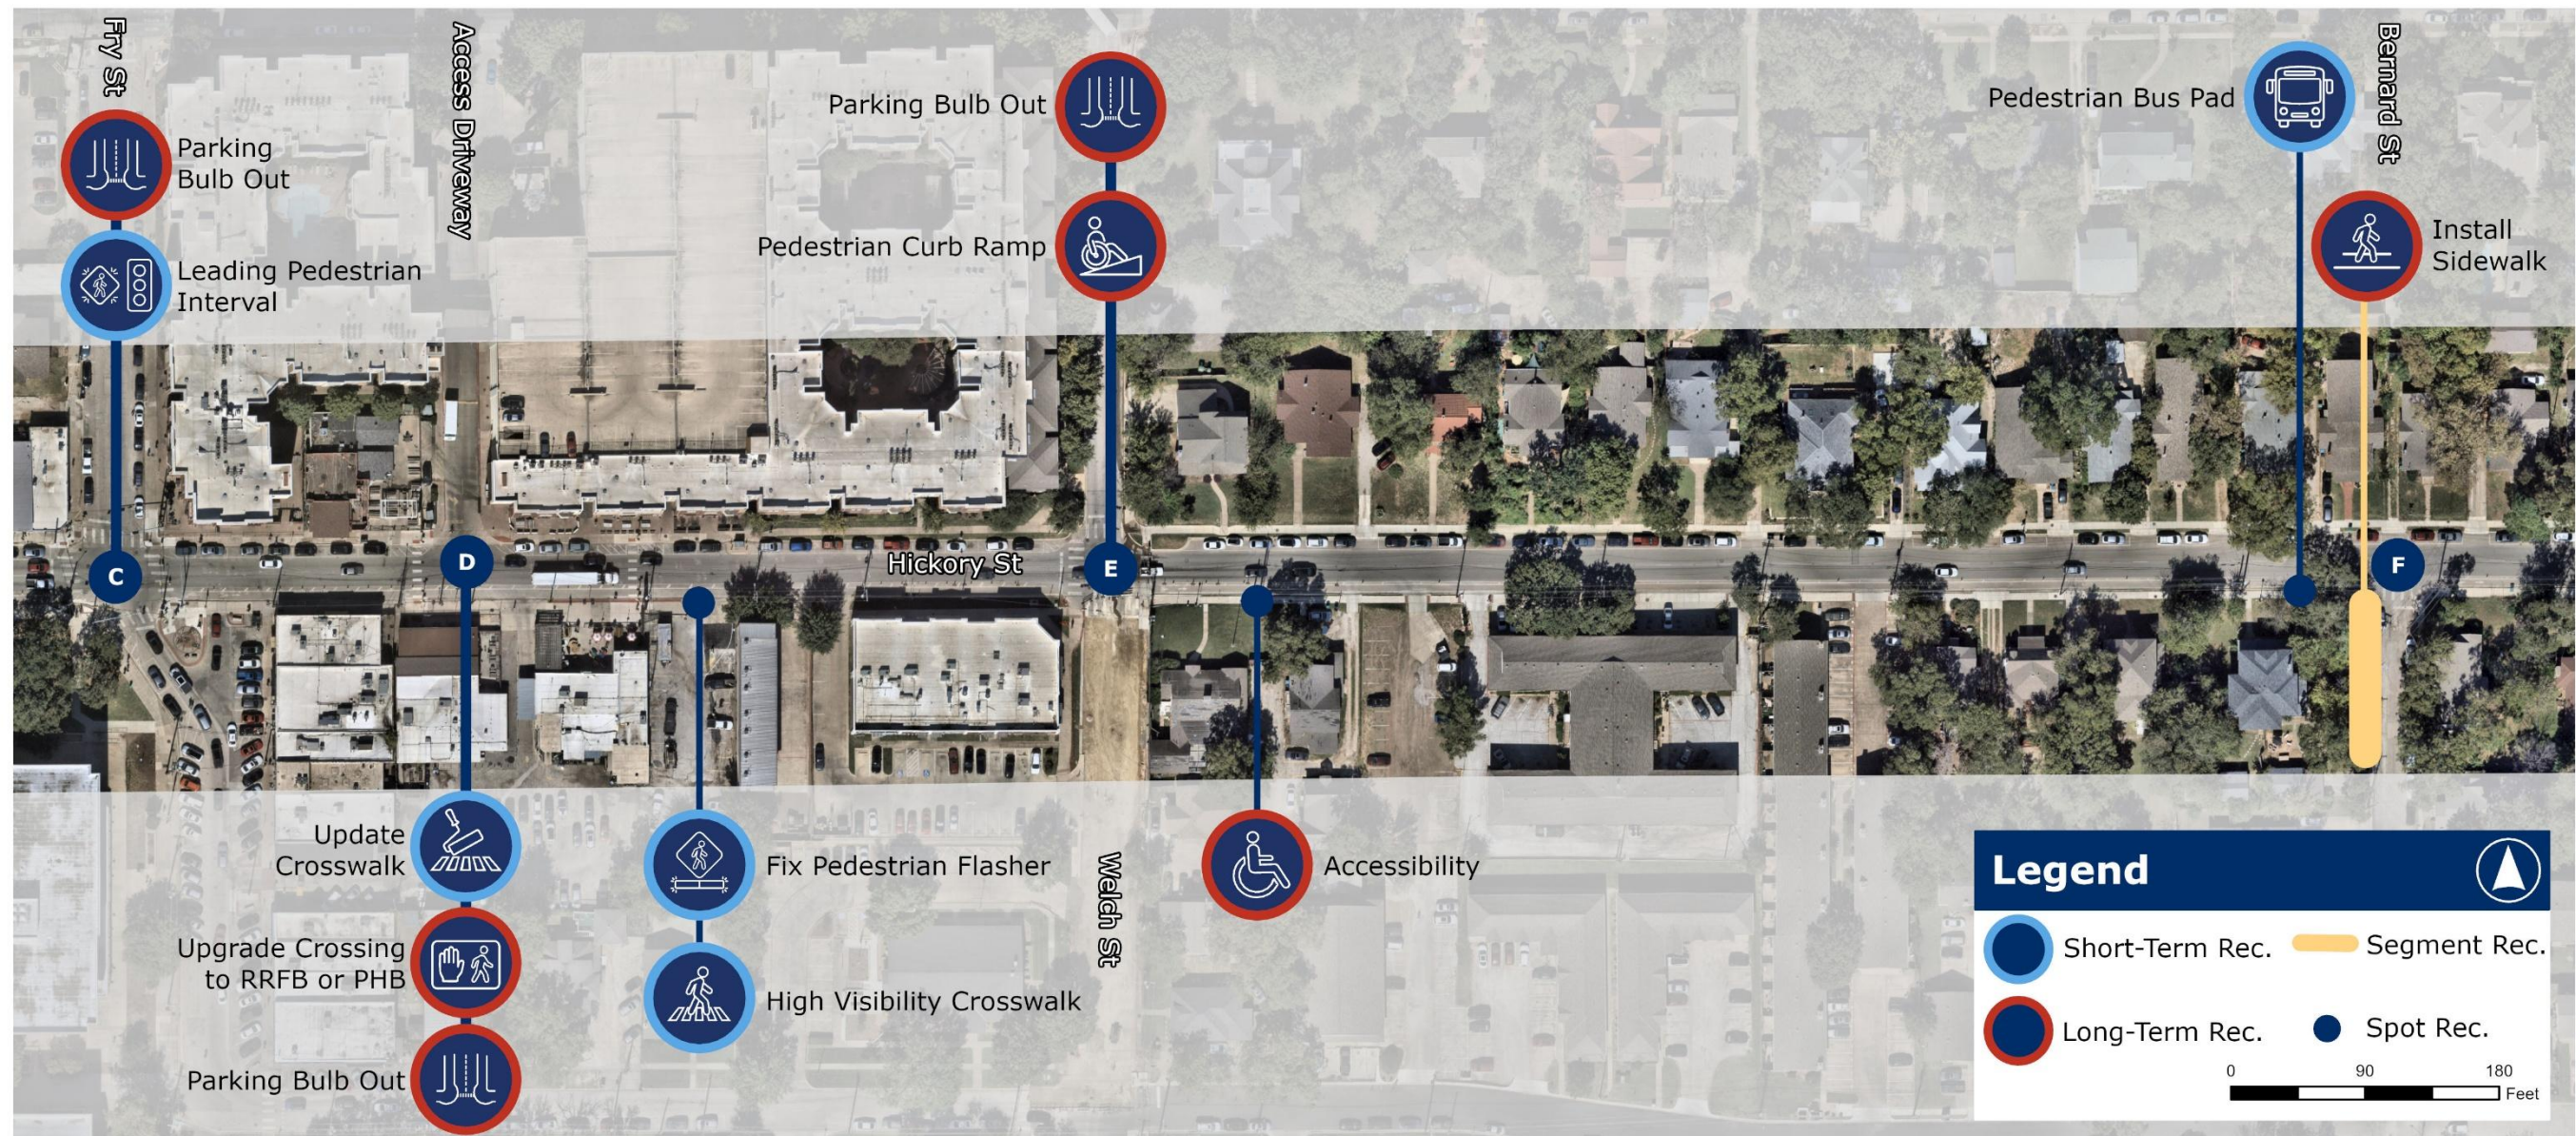
ID	Study Corridor	Context	Location	Timeline	Simplified Recommendation	Detailed Observation/Recommendation	Countermeasure On Page
C.2	Hickory St	Intersection	Fry St	Long	Parking Bulb Out	Observation: On-street parking is not physically separated at the intersections. Currently only striping. Recommendation: Recommend bulbding the northeast and northwest corners to provide a physical barrier for the on-street parking. This will also shorten the crossing distance for pedestrians.	Sheet 2
D.1	Hickory St	Intersection	Access Driveway	Short	Update Crosswalk	Observation: Existing crosswalk pavement markings at the access driveway are yellow and do not comply with TMUTCD. Recommendation: Update the existing crosswalk pavement markings to be in accordance with the TMUTCD.	Sheet 2
D.2	Hickory St	Intersection	Access Driveway	Long	Upgrade Crossing to RRFB or PHB	Observation: Pedestrians were observed not using the ped push buttons to cross Hickory St. Recommendation: Recommend upgrading the crossing to either a RRFB or PHB with pedestrian detection.	Sheet 2

D.3	Hickory St	Intersection	Access Driveway	Long	Parking Bulb Out	Observation: On-street parking is not physically separated at the intersections. Currently only striping. Recommendation: Recommend bulbding the northeast and northwest corners to provide a physical barrier for the on-street parking. This will also shorten the crossing distance for pedestrians.	Sheet 2
DE.1	Hickory St	Spot	South side of Hickory St; east of Access Driveway	Short	Fix Pedestrian Flasher	Observation: South side flashers do not work Recommendation: Fix south side flashers	Sheet 2
DE.2	Hickory St	Spot	Across Hickory St	Short	High Visibility Crosswalk	Observation: Crosswalk pavement markings are not very visible. Sun makes it hard to see the existing crosswalk markings Recommendation: Install high visibility crosswalk markings on the east pedestrian crossing	Sheet 2
E.1	Hickory St	Intersection	Welch St		Pedestrian Curb Ramp	Observation: Existing pedestrian curb ramp on the northeast corner has a drainage issue Recommendation: Install pedestrian curb ramp with appropriate cross slope to mitigate drainage issue.	Sheet 2

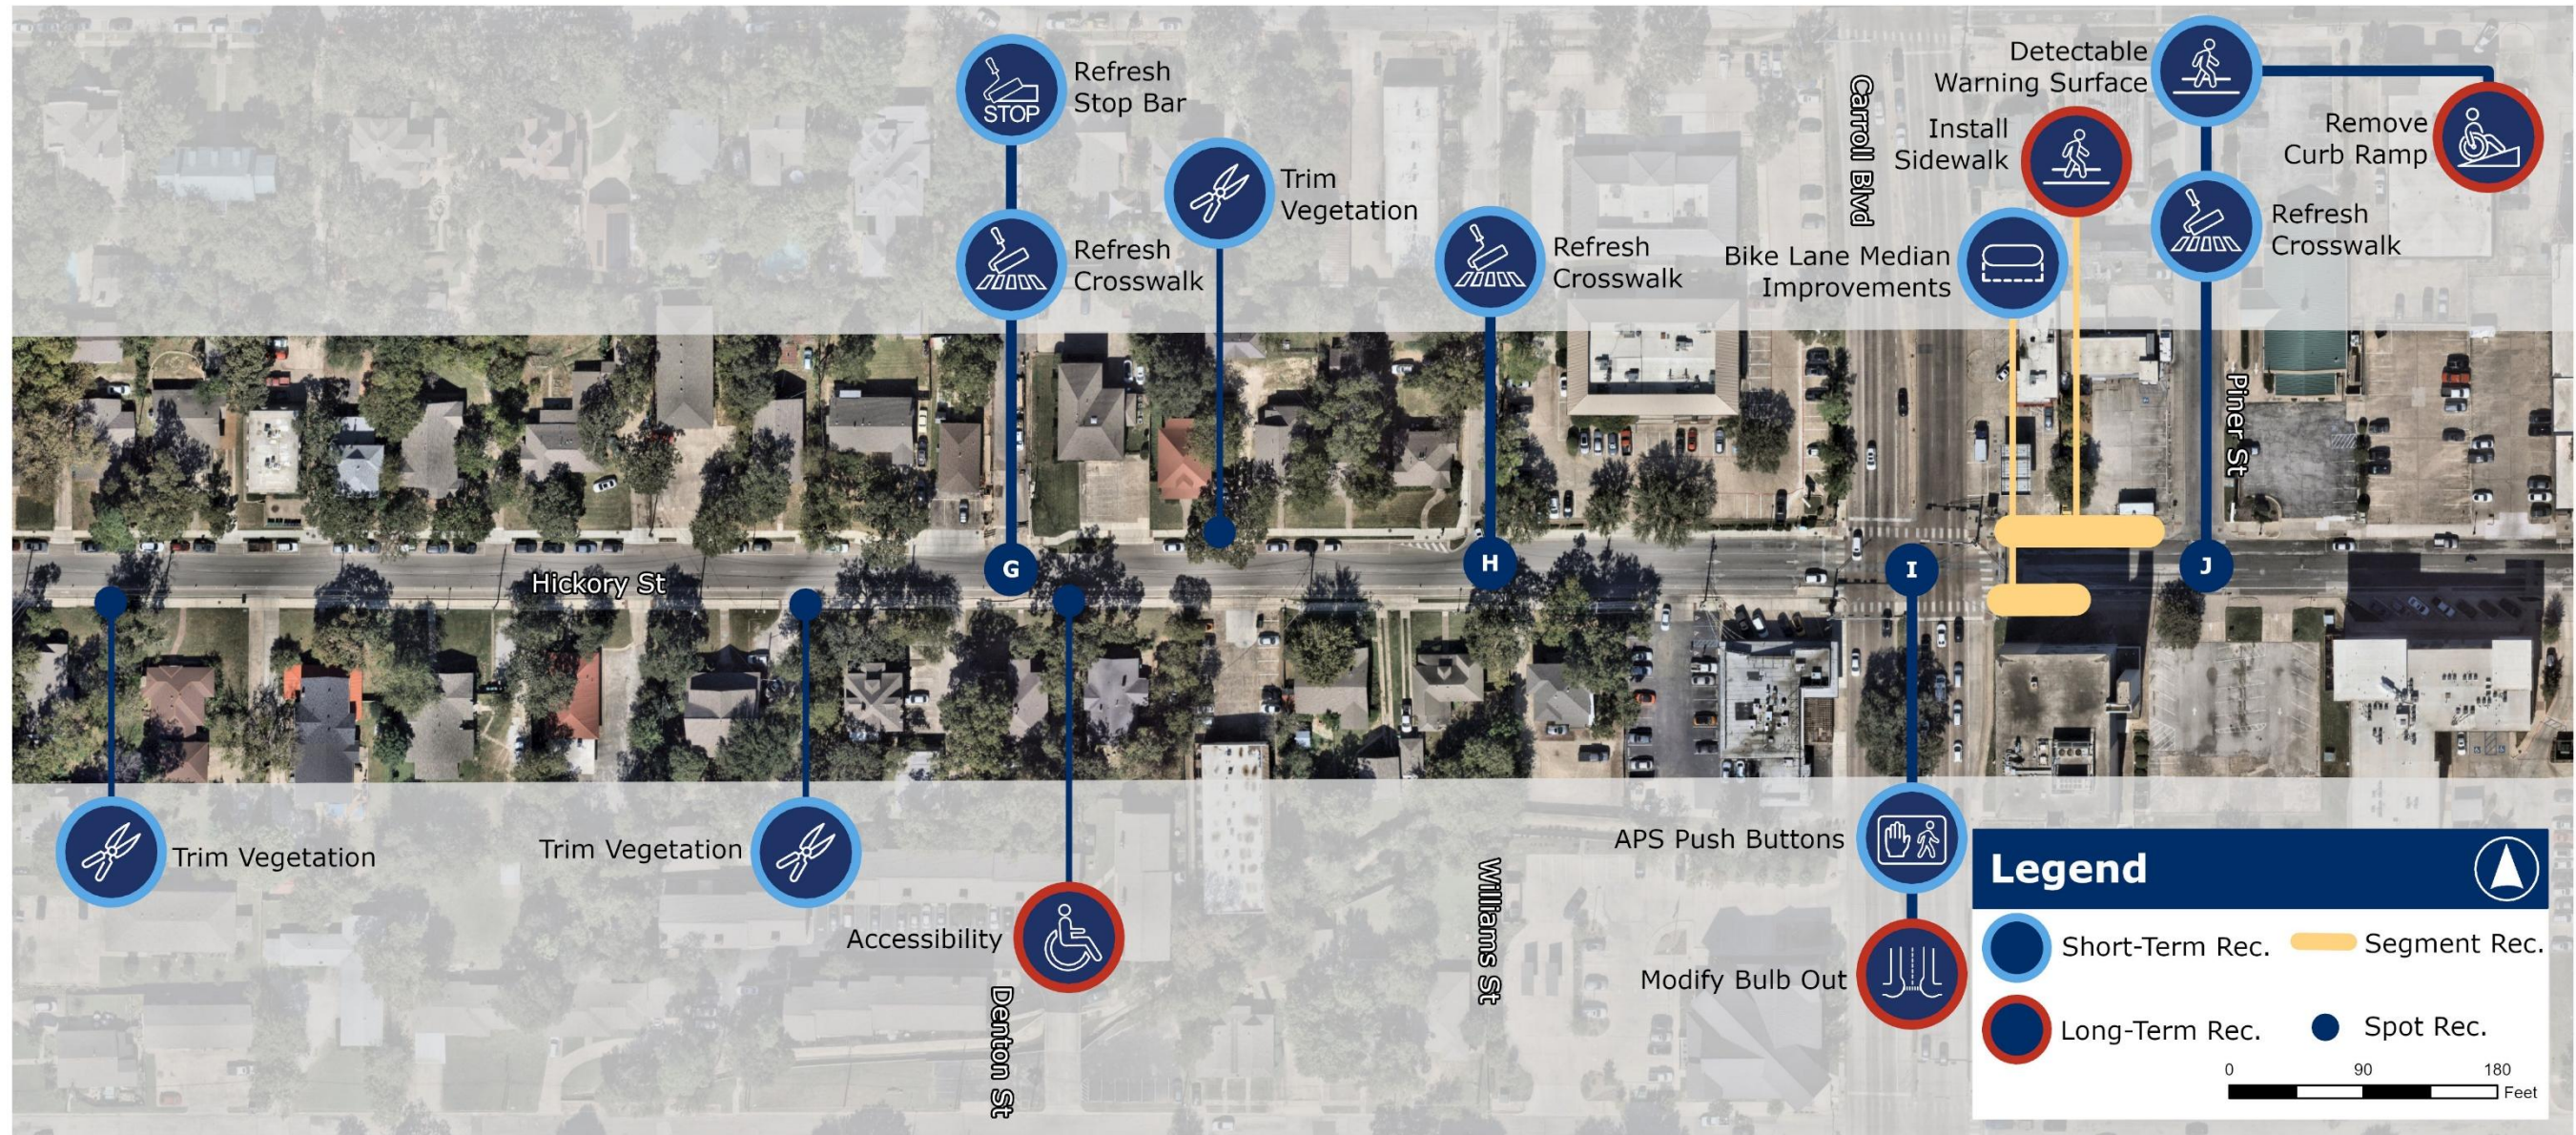
Figure 20 - Recommendations Exhibit (Page 3 of 5)

ID	Study Corridor	Context	Location	Timeline	Simplified Recommendation	Detailed Observation/Recommendation	Countermeasure On Page
H.1	Hickory St	Intersection	Williams St	Short	Refresh Crosswalk	Observation: Existing crosswalk pavement markings are faded Recommendation: Refresh existing crosswalk pavement markings at the north crossing	Sheet 3
I.1	Hickory St	Intersection	Carroll Blvd	Short	APS Push Buttons	Observation: Push buttons at intersection are not APS push buttons Recommendation: Install APS pedestrian push buttons at every signal	Sheet 3
I.2	Hickory St	Intersection	Carroll Blvd	Long	Modify Bulb Out	Observation: Existing bulb out on the northeast corner is the just the ramp extending out into the roadway Recommendation: Modifying bulb out up to the gas station driveway. This will require inlet/drainage improvements as well.	Sheet 3
II.1	Hickory St	Segment	South side of Hickory St; median between vehicle lane and bike lane	Short	Bike Lane Median Improvements	Observation: Pavement markings on median between the bike lane and the travel lane are faded. Recommendation: Refresh pavement markings on the bike lane median and replace existing bollard with new bollard as the existing one is damaged.	Sheet 3

II.2	Hickory St	Segment	North side of Hickory St; from Carroll Blvd to Piner St	Long	Install Sidewalk	Observation: Existing sidewalk is broken and cracking. Recommendation: Install 105' of accessible sidewalk	Sheet 3
J.1	Hickory St	Intersection	Piner St	Short	Refresh Crosswalk	Observation: Existing crosswalk pavement markings are faded Recommendation: Refresh existing crosswalk pavement markings at the north crossing	Sheet 3
J.2	Hickory St	Intersection	Piner St	Short	Detectable Warning Surface	Observation: Existing detectable warning surfaces on the north crossing does not extend the full width of the ramp. Recommendation: Extend the detectable warning surface the full width of the ramp.	Sheet 3
J.3	Hickory St	Intersection	Piner St	Long	Remove Curb Ramp	Observation: Existing curb ramp on the northeast corner going south does not have a corresponding curb ramp across the street Recommendation: Remove existing curb ramp going south on the northeast corner	Sheet 3

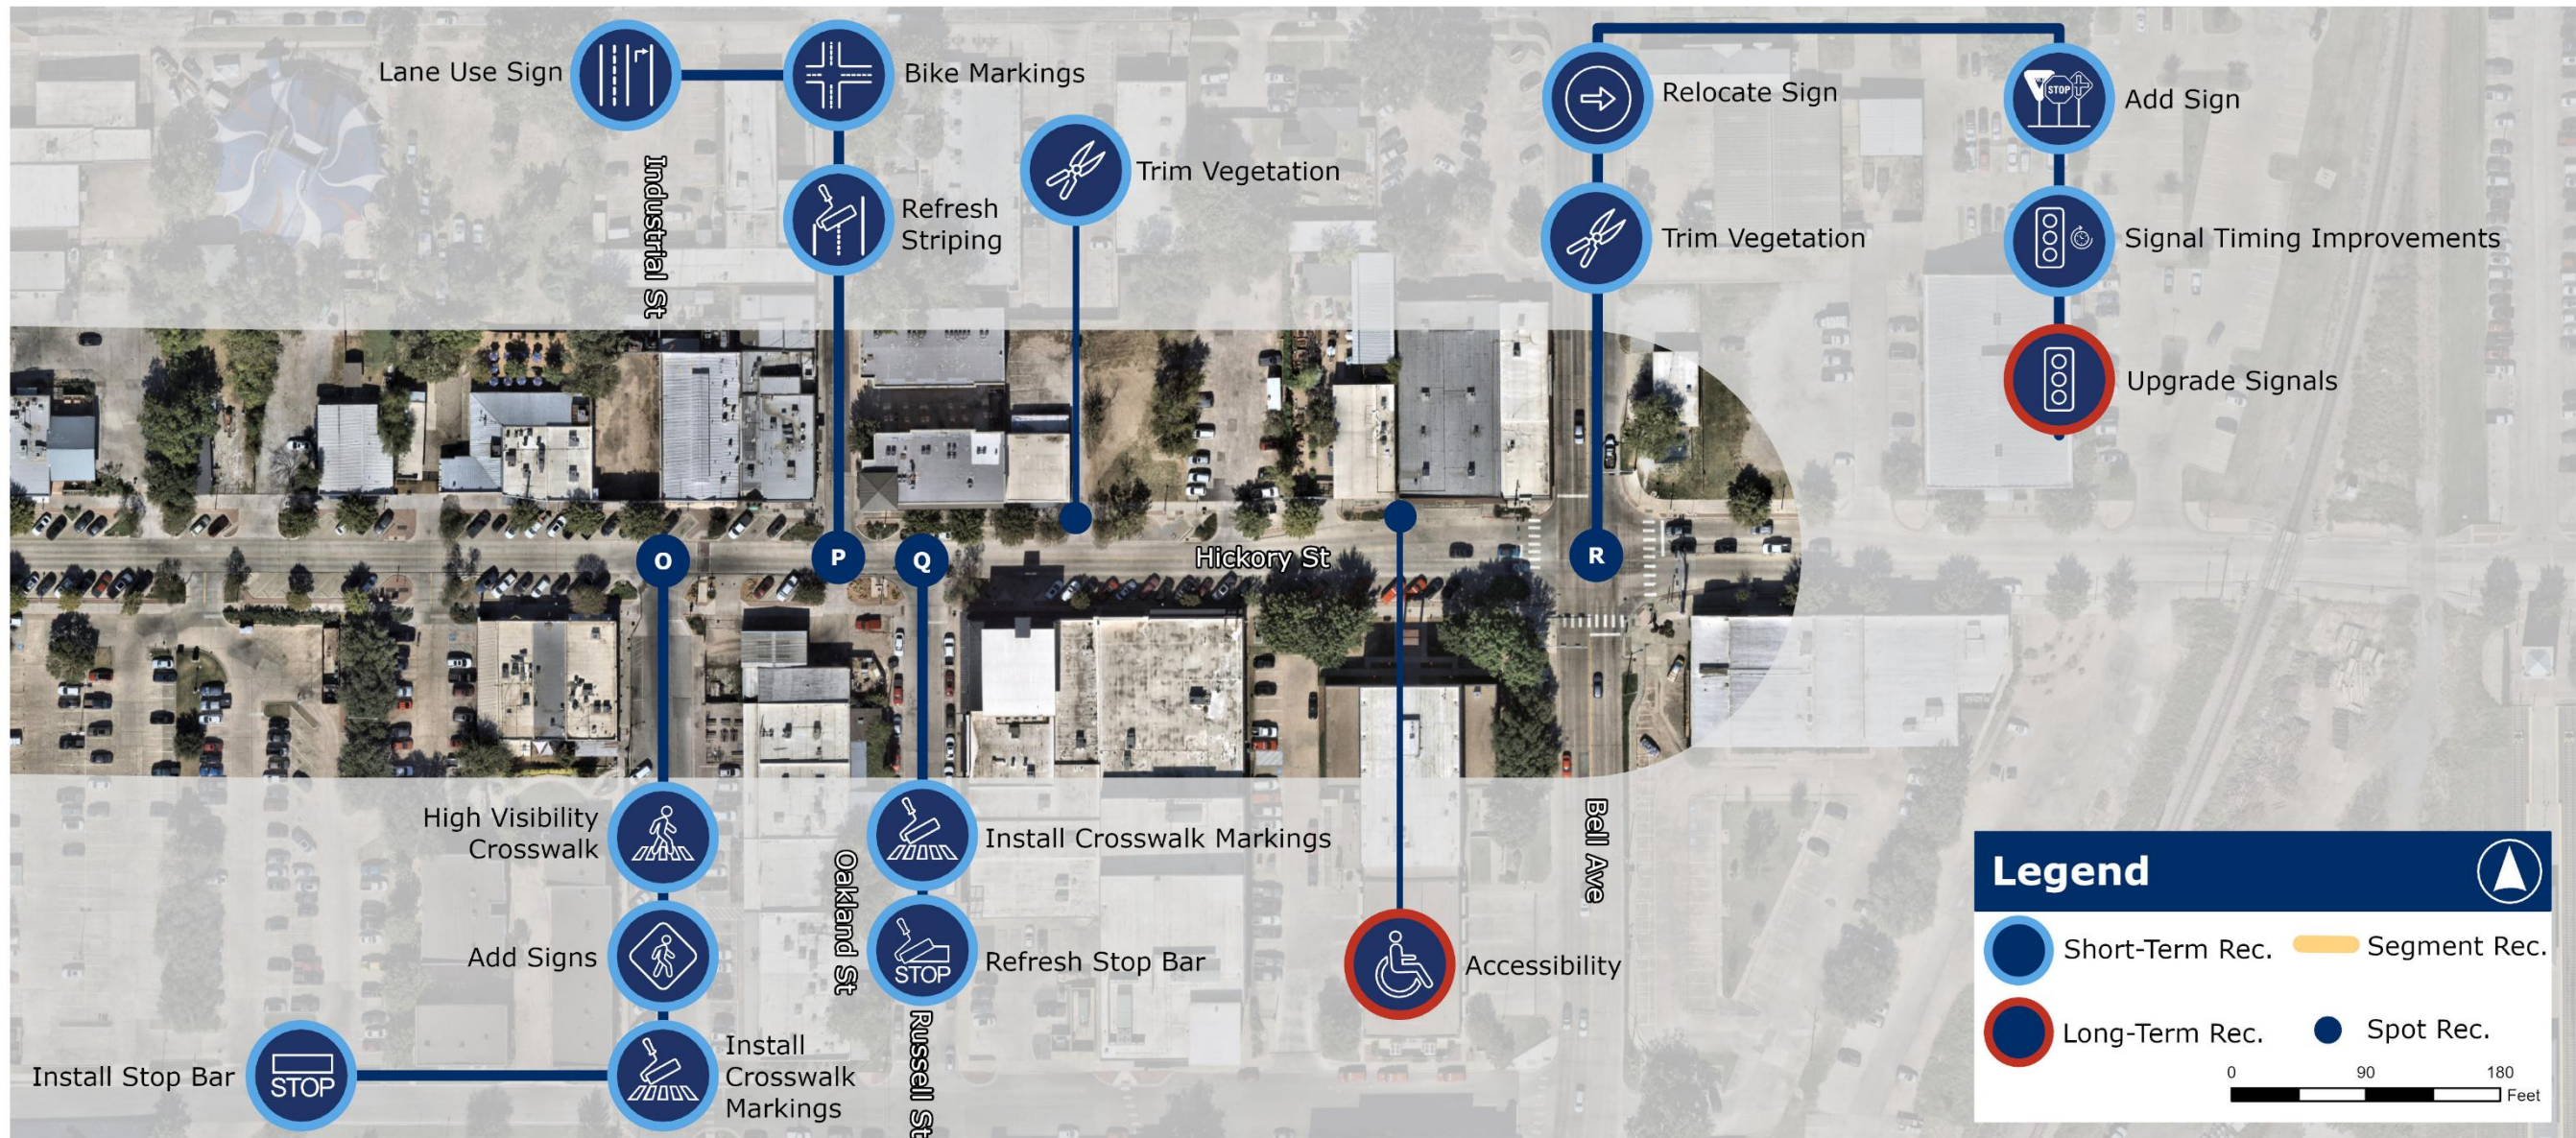
Figure 20 - Recommendations Exhibit (Page 5 of 5)

ID	Study Corridor	Context	Location	Timeline	Simplified Recommendation	Detailed Observation/Recommendation	Countermeasure On Page
M.1	Hickory St	Intersection	Locust St	Short	Refresh Crosswalk	Observation: Existing crosswalk pavement markings are faded Recommendation: Refresh existing crosswalk pavement markings throughout the intersection	Sheet 4
N.1	Hickory St	Intersection	Austin St	Short	High Visibility Crosswalk	Observation: Crosswalk pavement markings are faded Recommendation: Install high visibility crosswalk markings on all the pedestrian crossings	Sheet 4
NO.1	Hickory St	Spot	North side of Hickory St; east of Austin St	Short	Trim Vegetation	Observation: Vegetation is blocking pedestrian path Recommendation: Trim the vegetation on the north side of Hickory St	Sheet 4
O.1	Hickory St	Intersection	Industrial St	Short	High Visibility Crosswalk	Observation: East crosswalk pavement markings are faded Recommendation: Replace east crosswalk pavement markings with high visibility crosswalk markings	Sheet 5

O.2	Hickory St	Intersection	Industrial St	Short	Add Signs	Observation: There are no pedestrian signs on the east crossing Recommendation: Upgrade to "STOP HERE TO PEDS" signs on both sides of the street	Sheet 5
O.3	Hickory St	Intersection	Industrial St	Short	Install Crosswalk Markings	Observation: There are no crosswalk markings on the south crossing Recommendation: Install crosswalk pavement markings on the south pedestrian crossing	Sheet 5
O.4	Hickory St	Intersection	Industrial St	Short	Install Stop Bar	Observation: There is not stop bar on the south approach of the intersection Recommendation: Install stop bar on the south approach	Sheet 5
P.1	Hickory St	Intersection	Oakland St	Short	Refresh Striping	Observation: Existing roadway striping is faded Recommendation: Refresh roadway striping	Sheet 5
P.2	Hickory St	Intersection	Oakland St	Short	Bike Markings	Observation: The two-way cycle track along Oakland St north of Hickory lacks signage and protection from vehicular traffic Recommendation: Add bicycle buffer between the bike lanes and the travel lane.	Sheet 5
