2017-08-10

City of Denton

**Old Denton City Hall
(City Hall West)
Preliminary Rehabilitation
Assessment Report
Denton, Texas**

This report includes a brief historical summary and architectural description. The building evaluation focuses on exterior and interior conditions with related recommendations for rehabilitation.

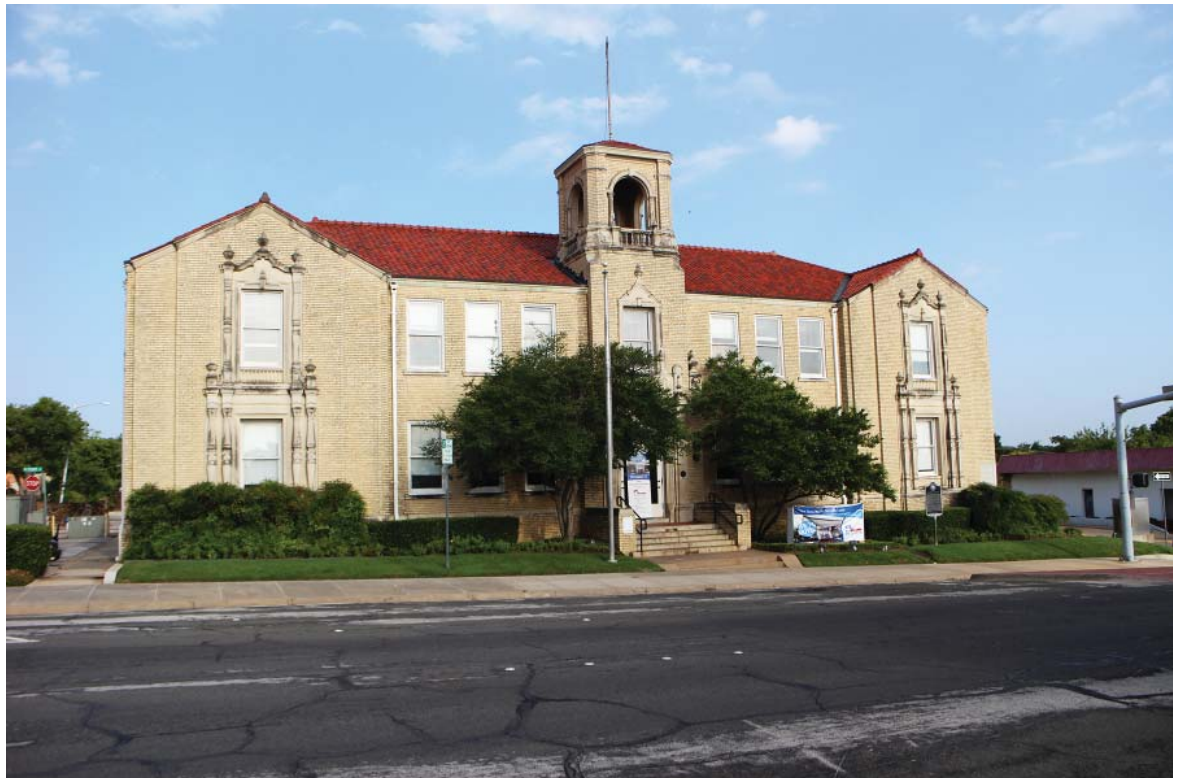
**Southeast oblique
(Architexas, 2017)**

The brick was found to be in good condition with some general biological staining. Brick used at the north and south additions and as infill where doors and windows have been infilled is a close match, but slightly lighter than the original.

Typical masonry conditions at north elevation. Masonry needs cleaning. Brick infill at bay door location is evident. (Architexas 2017)

It is recommended that the brick be cleaned with a restoration cleaner designed for that purpose. The use of abrasive or high-pressure water blasting should be avoided.

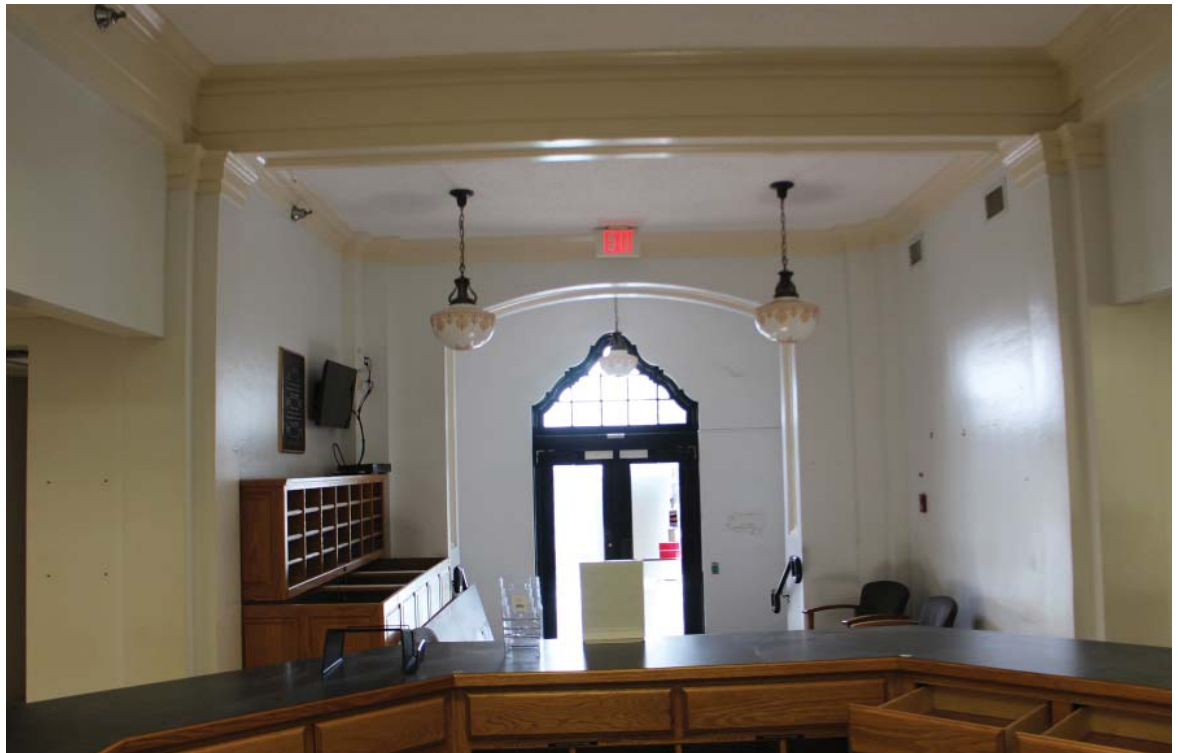
View of the primary lobby at the main entrance. (Architexas 2017)

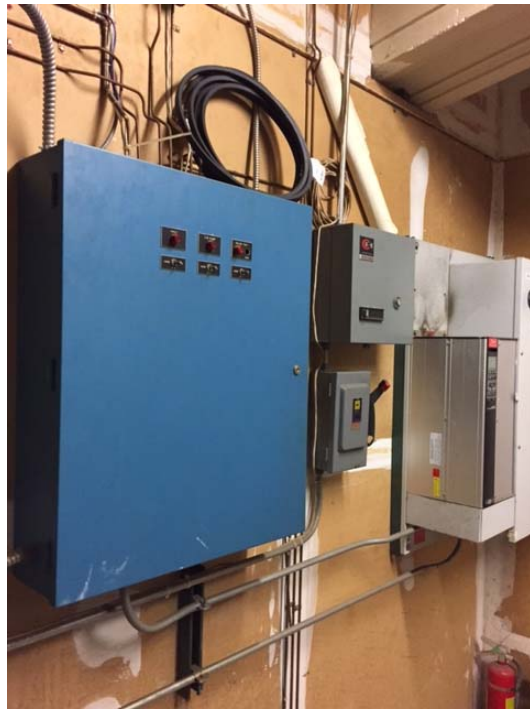
7. Controls for Air Handler.

The air handler on the top floor was installed in approximately 1980 and is beyond its normally expected life. It is currently leaking and, with any renovation, should be replaced with a new 36,000 CFM air handler.

1. Replace the 60 Ton Chiller with a 90 Ton Chiller.
2. Replace the Air Handler on the top floor.
3. Develop the Return Air System for the building.
