# **Electromagnetic Inspection and Visual Assessment Report**

## **30-Inch Raw Water Transmission Main**

**City of Denton**

**Pure Technologies U.S. Inc.**  
**(Revised DRAFT – September 6, 2017)**

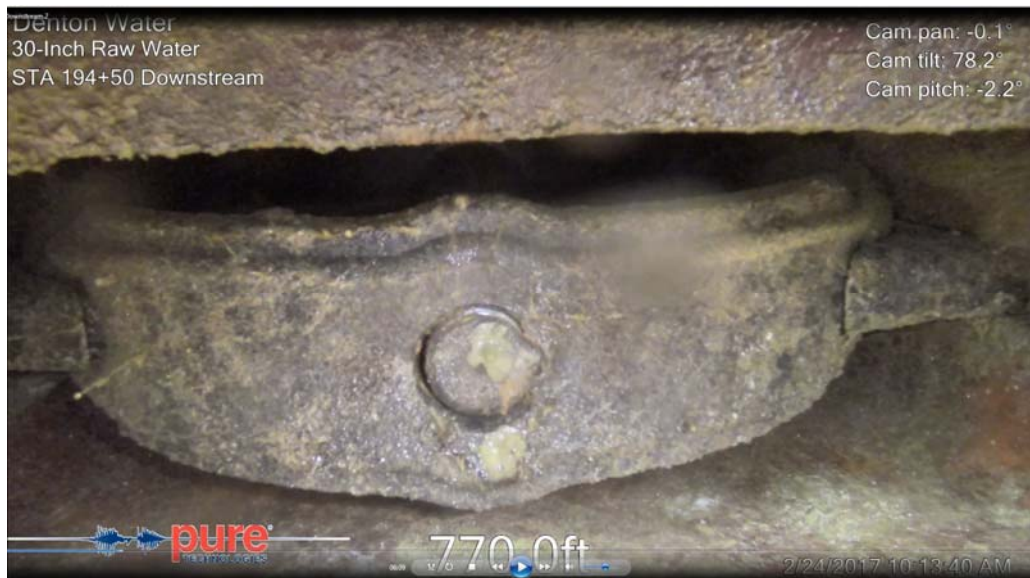
Figure 3.21: Pipe number N/A, Typical gate valve, 770 feet from insertion  
(Station 194+50, Downstream, Video 2), Pipe laying schedule unavailable

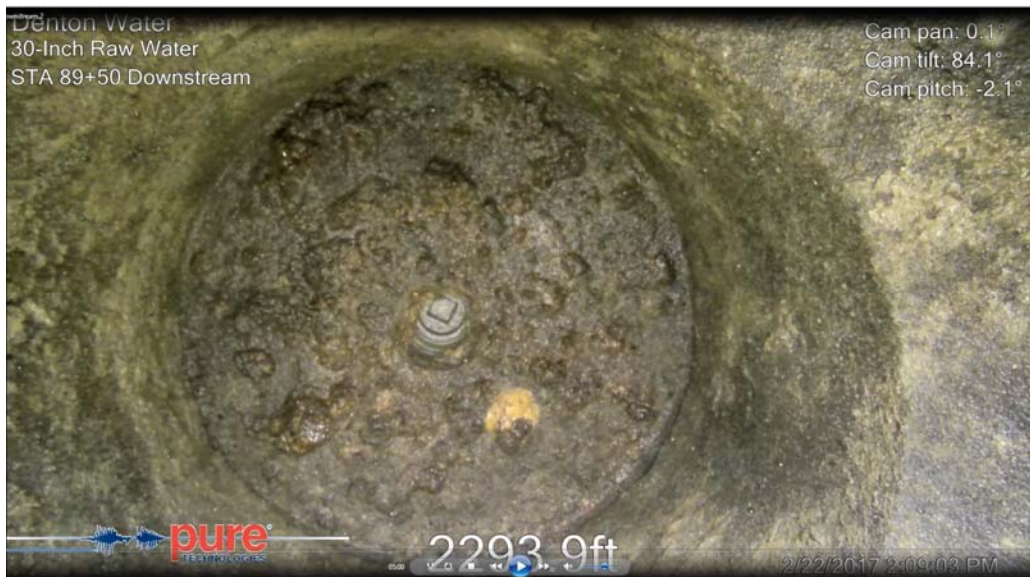
Figure 3.22: Pipe 2267, General view of top outlet, 2,294 feet from insertion  
(Station 89+50, Downstream, Video 2)

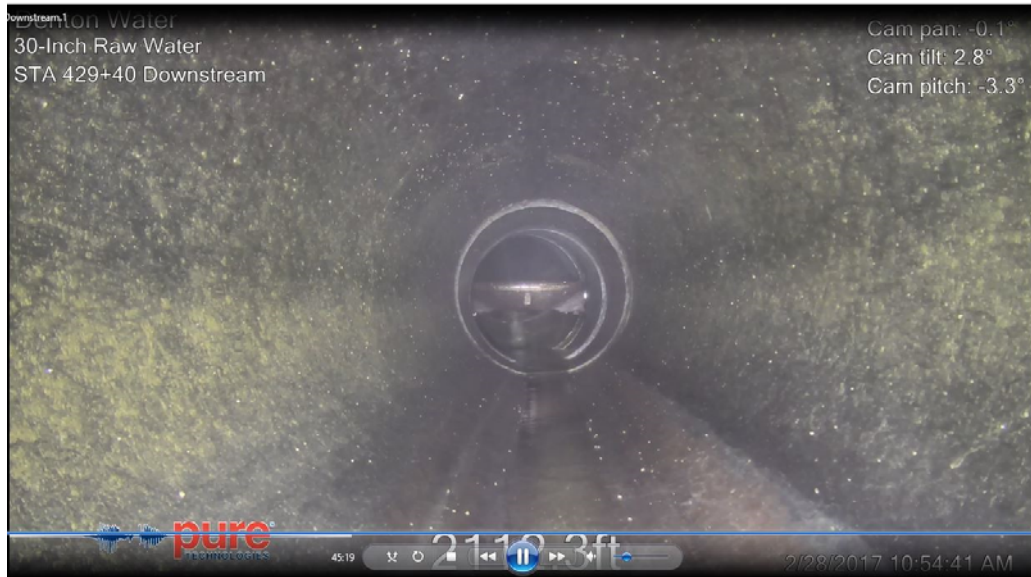
*Figure 3.27: Butterfly valve, 2,125 feet from insertion towards Rapid Mix Basin  
(Station 429+40, Downstream, Video 1) end of inspection*

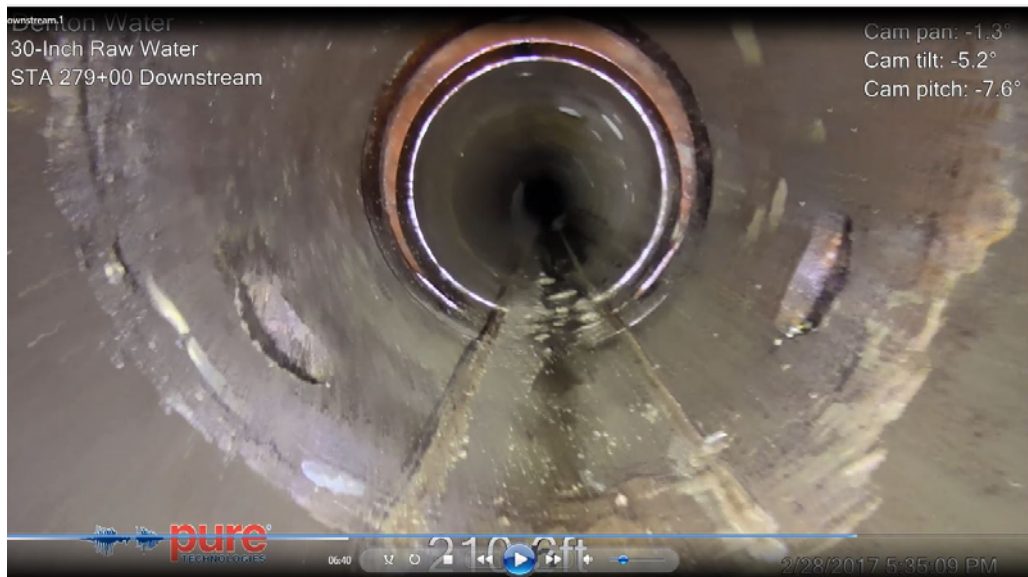
*Figure 3.28: Pipe 2771, Gate valve and outlets, 210 feet from insertion  
(Station 279+00, Upstream, Video 1)*
