AN ORDINANCE OF THE CITY OF DENTON, TEXAS APPROVING AN ALTERNATIVE ENVIRONMENTALLY SENSITIVE AREAS PLAN ON APPROXIMATELY 14.176 ACRES OF LAND GENERALLY LOCATED ON THE SOUTHWEST CORNER OF HICKORY CREEK ROAD AND FM 2499 IN THE CITY OF DENTON, DENTON COUNTY, TEXAS; ADOPTING AN AMENDMENT TO THE CITY'S OFFICIAL ENVIRONMENTALLY SENSITIVE AREAS MAP; PROVIDING FOR A PENALTY IN THE MAXIMUM AMOUNT OF \$2,000.00 FOR VIOLATIONS THEREOF; PROVIDING A SEVERABILITY CLAUSE AND AN EFFECTIVE DATE. (AESA22-0004b)

### ALTERNATIVE ENVIRONMENTALLY SENSITIVE AREA REPORT (AESAs# 22-0004)

**Curve Development; CO/ Bear Land Consultants  
Barrel Strap Residential Project Site**

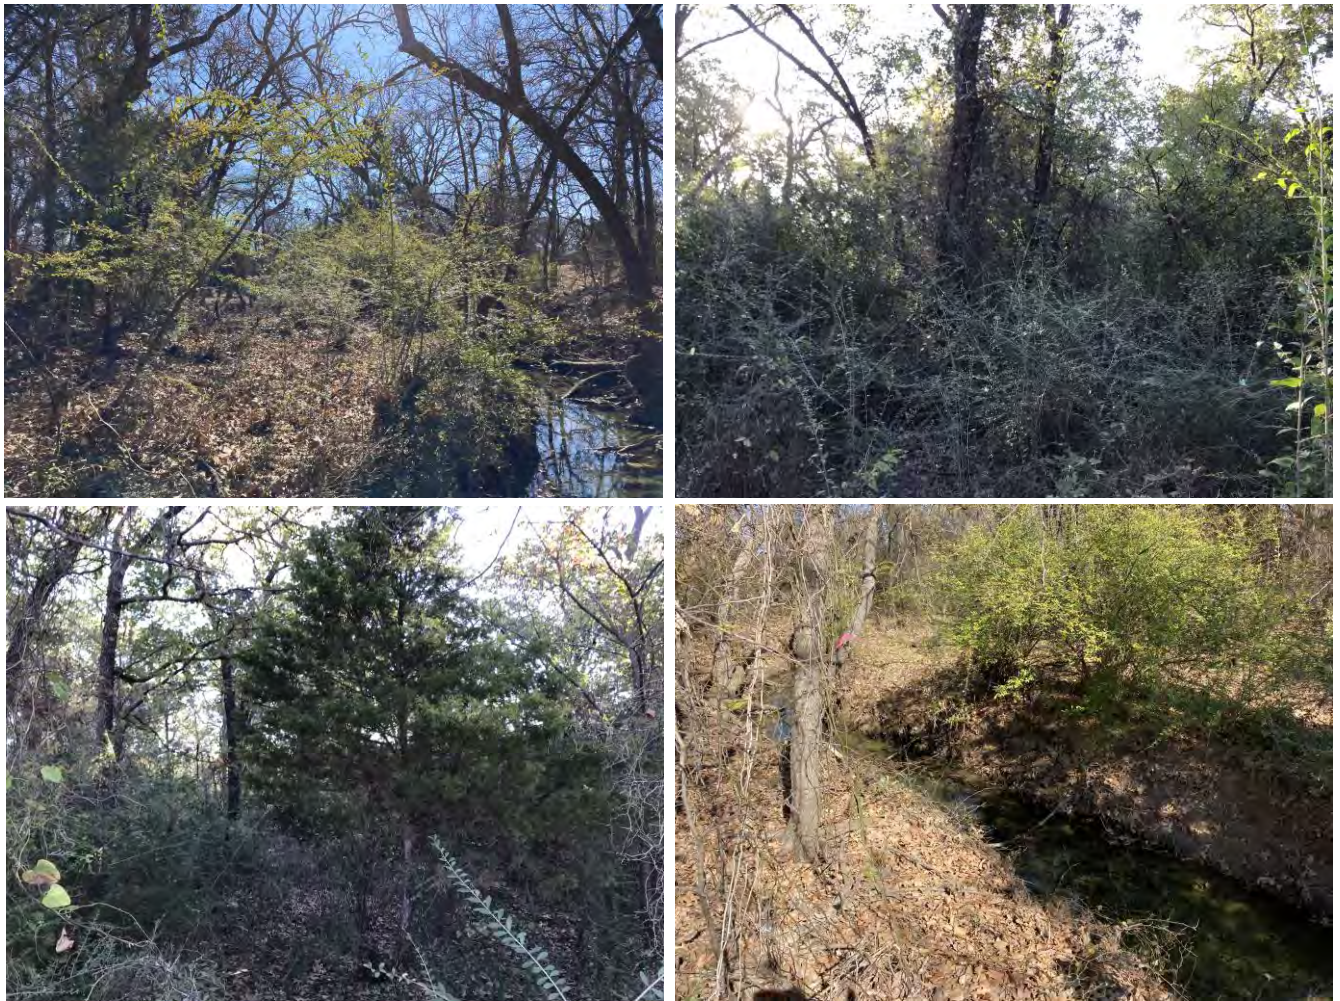
**Figure 1.** The photographs illustrated above depict the understory of invasive Chinese Privet throughout the mitigation area.

privet removal, as an erosion and sediment control measure and seeding strategy, the mitigation area will be hydromulched at 2,000 pounds per acre of wood fiber mulch with tackifier. **Figure 1** illustrates that invasive Chinese privet currently dominates the canopy understory within the ESA. Mechanical removal will consist of the use of a hydro-axe for most of the area, supplemented with hand clearing to remove Chinese privet immediately surrounding existing trees. The hydro-axe will remove the aboveground portion of the Chinese privet plant but does not remove the root system and sprouting will occur. The regrowth will be spot treated with triclopyr, a pesticide from the City’s Integrated Pest Management list, the following spring at the recommended label rate. An additional spot treatment of seedlings will be conducted if necessary. Debris from the privet removal will be collected and disposed of outside of the mitigation area. The eradication of Chinese privet will open the understory and improve opportunities for diverse native species to thrive with limited invasive competition. A successful eradication will allow for no more than 5 percent of remaining Chinese privet understory cover prior to the mitigation area planting. Seedlings and regrowth will be monitored and removed seasonally within the mitigation area as needed to ensure Chinese privet remains eradicated. Once the Chinese privet has been successfully removed, a range of native saplings, shrubs, and herbaceous vegetation will be planted within the remaining portion of the on-site ESA to replace the removed caliper inches in the impacted area and increase diversity.

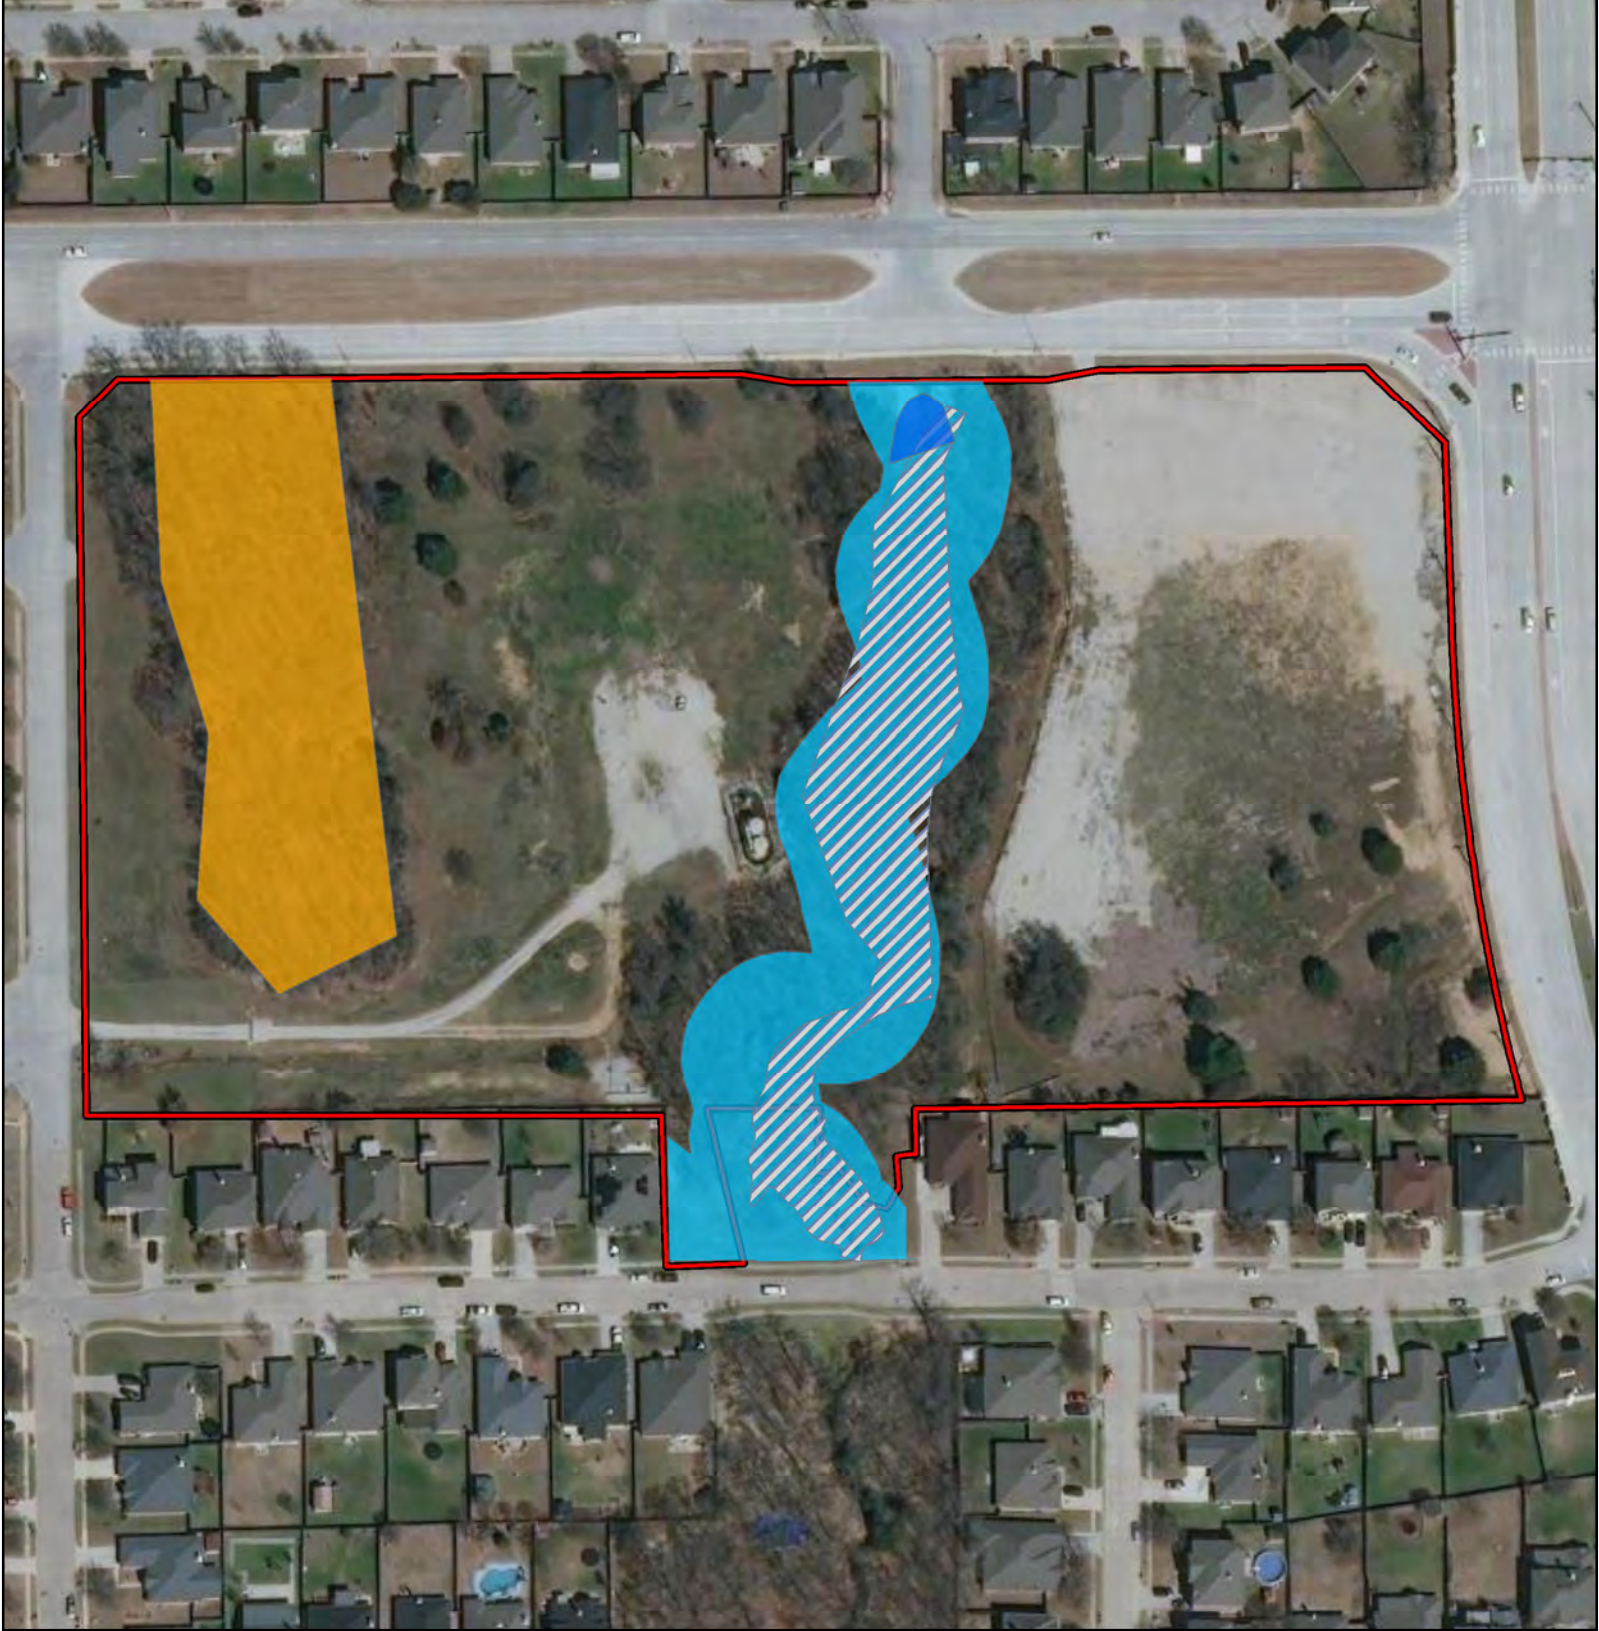
**Figure 2.**  
**City Mapped Environmentally**  
**Sensitive Areas (ESAs)**

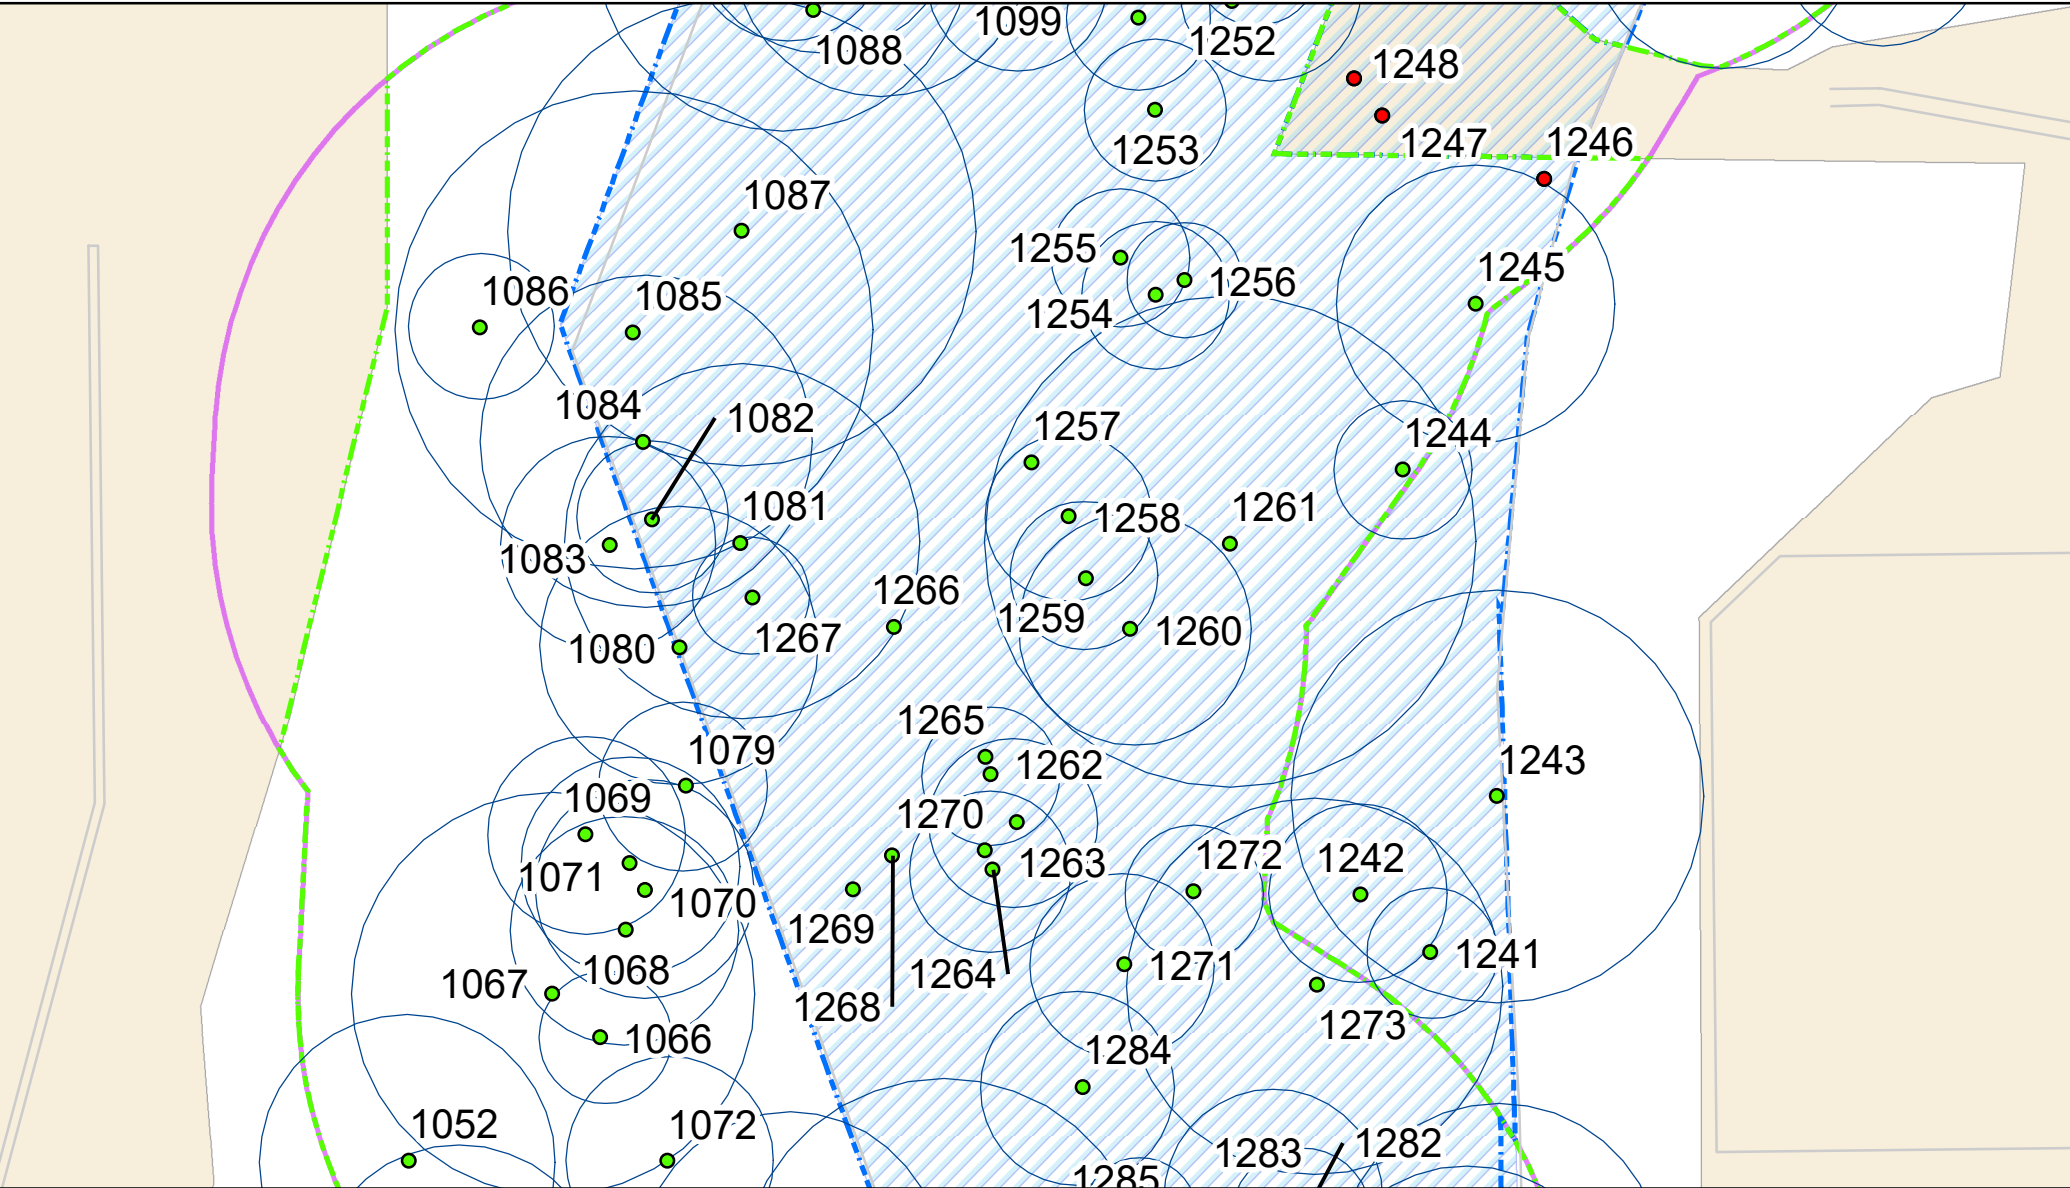
# Figure 2C. Tree Inventory

- Survey Area
- Riparian Buffer ESA
- Floodplain ESA
- Mitigation Areas**
  - Floodplain
  - Riparian Buffer
- Trees within the Unaffected Riparian Buffer
- Trees within the Proposed Impact Area
- Critical Root Zones
- Site Plan Structures
- Grading Area
