**City of Denton Historic Landmark Commission**  
**Tax Exemption Application for Designated Historic Sites**

Name of Owner TJD Holdings, LLC  
Property Address 1314 N Locust St., Denton, Texas 76201  
Telephone/Email 940-387-0512

Brief Description of Completed Improvements and/or Restoration Work:  
Circumferential water drainage system, foundation repair and electrical (for water pumps).

THIS IS TO CERTIFY THAT ON THIS DATE, I MADE AN ON-SITE INSPECTION OF THE FOUNDATION AND DRAINAGE PERFORMANCE FOR THE ADDRESSED PROPERTY. THE SUBJECT IS A ONE STORY, DENTAL OFFICE, SIDING VENEER DWELLING, SUPPORTED ON A PIER-AND-BEAM FOUNDATION. FOR ORIENTATION PURPOSES, IT IS ASSUMED THAT THE PROPERTY FACES WEST.

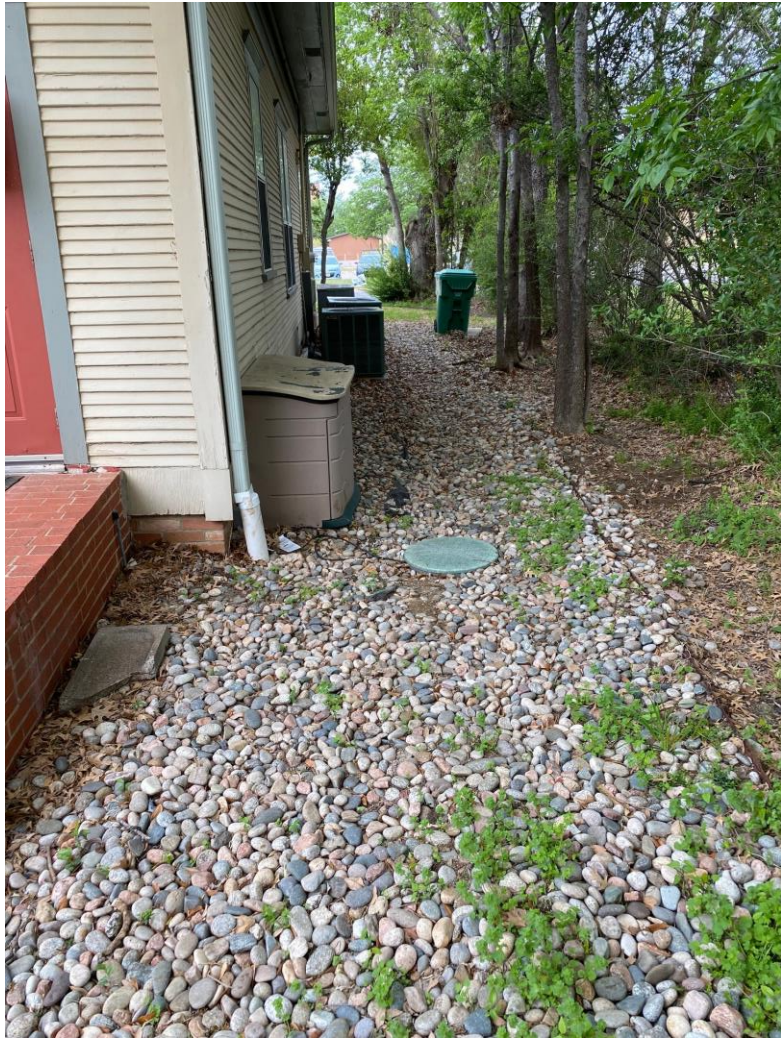
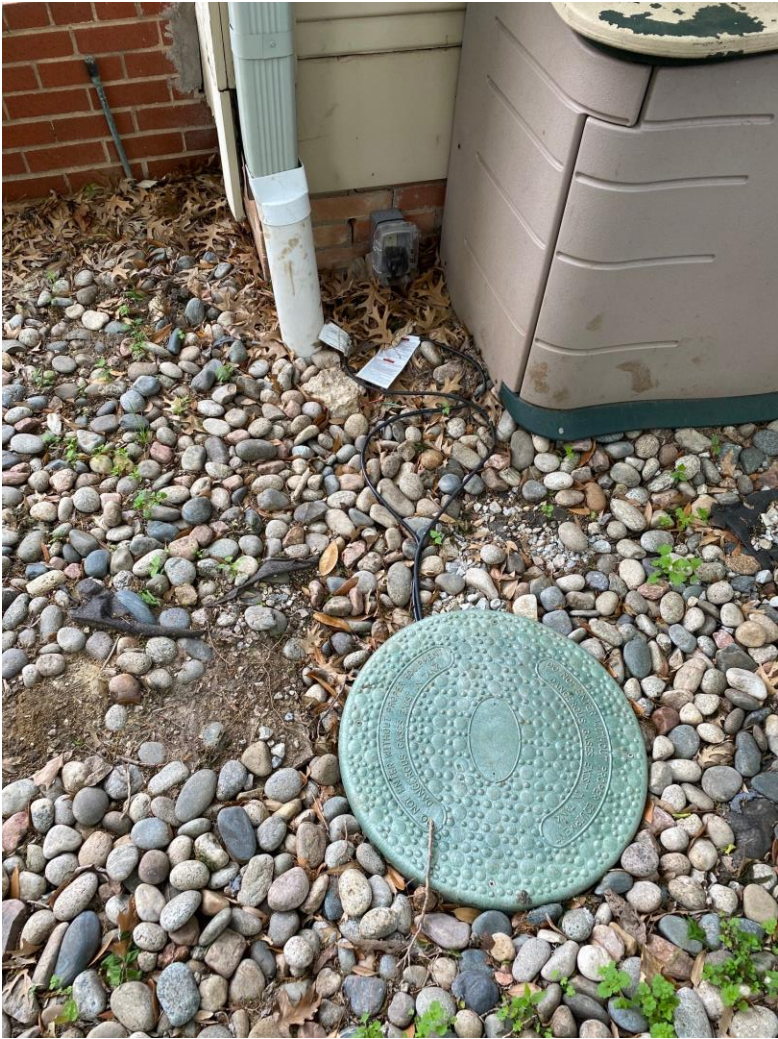
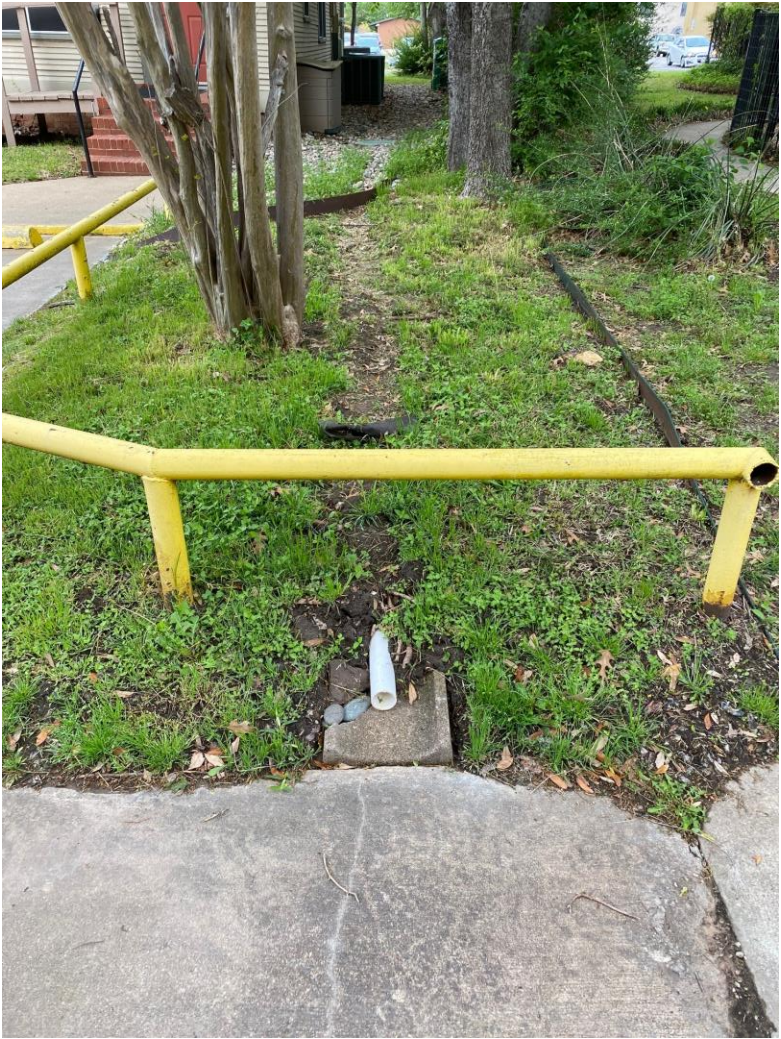
New Water Pumps & Drainage System

Will install appx. 159ft. of 6" dia. perforated ADS pipe french drain with filter fabric wrap around pipe. Will start appx. 18" deep per Engineers recommendation. Will set in rock up to 1ft. from surface that will be filled in with dirt. Will install plastic liner on inside edge of ditch. Will tie in downspouts into the system with solid 4" dia. ADS pipe. Will drain water out to back parking lot and to side street per diagram.

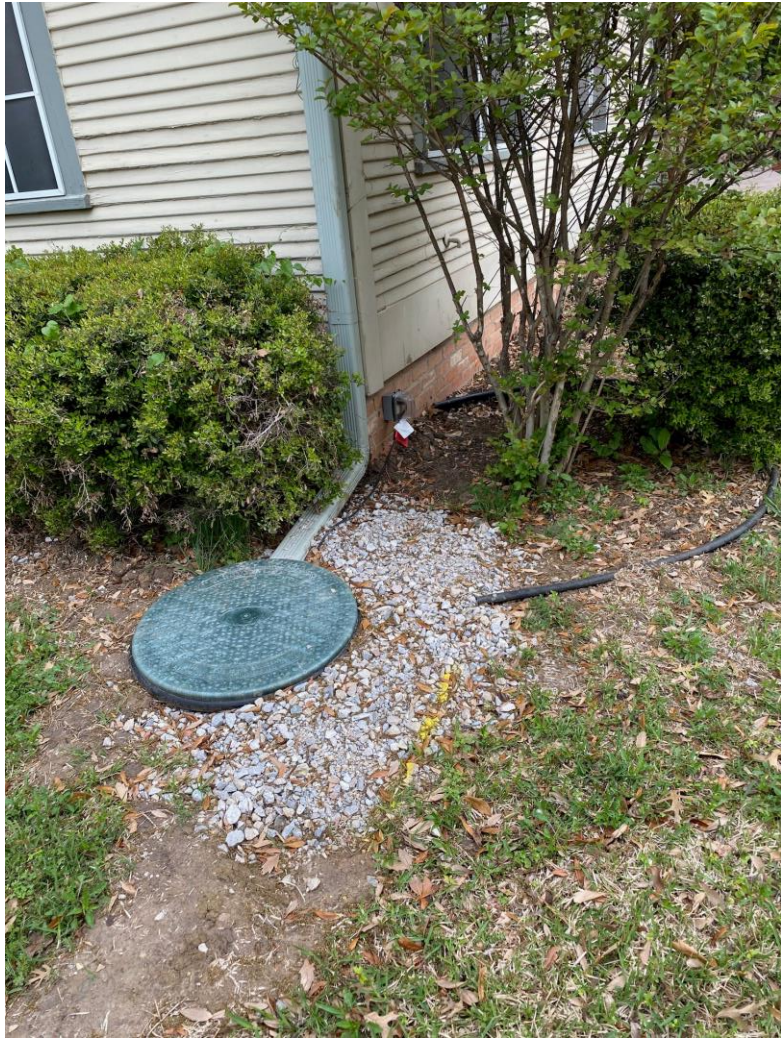
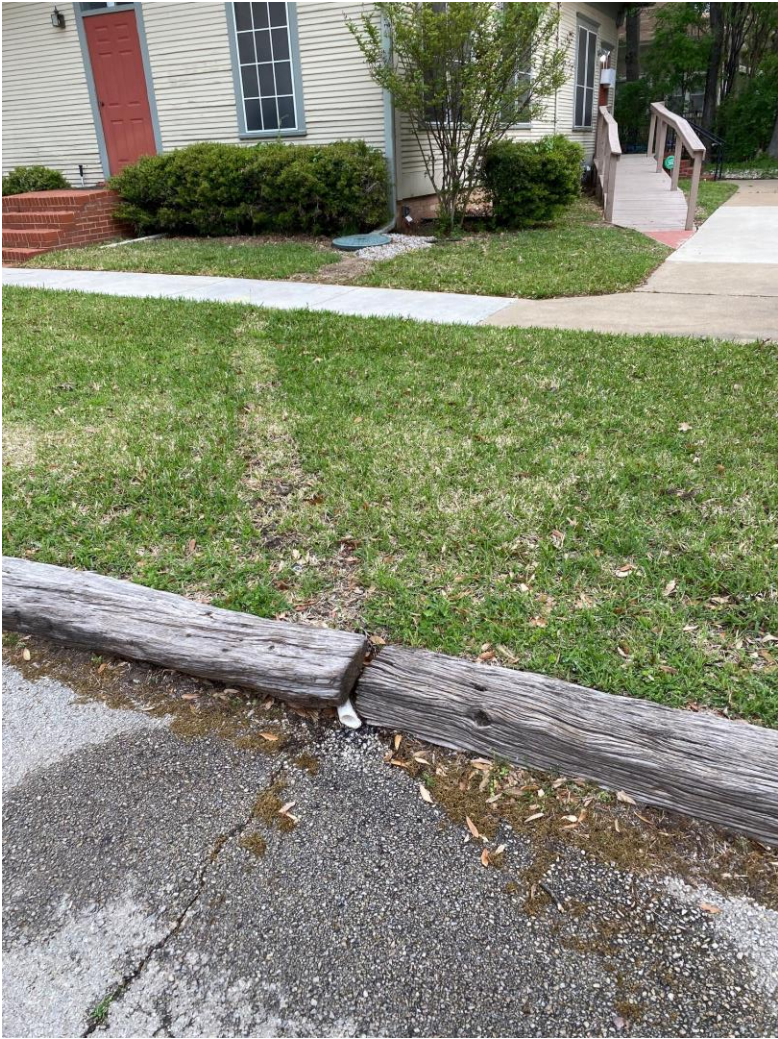
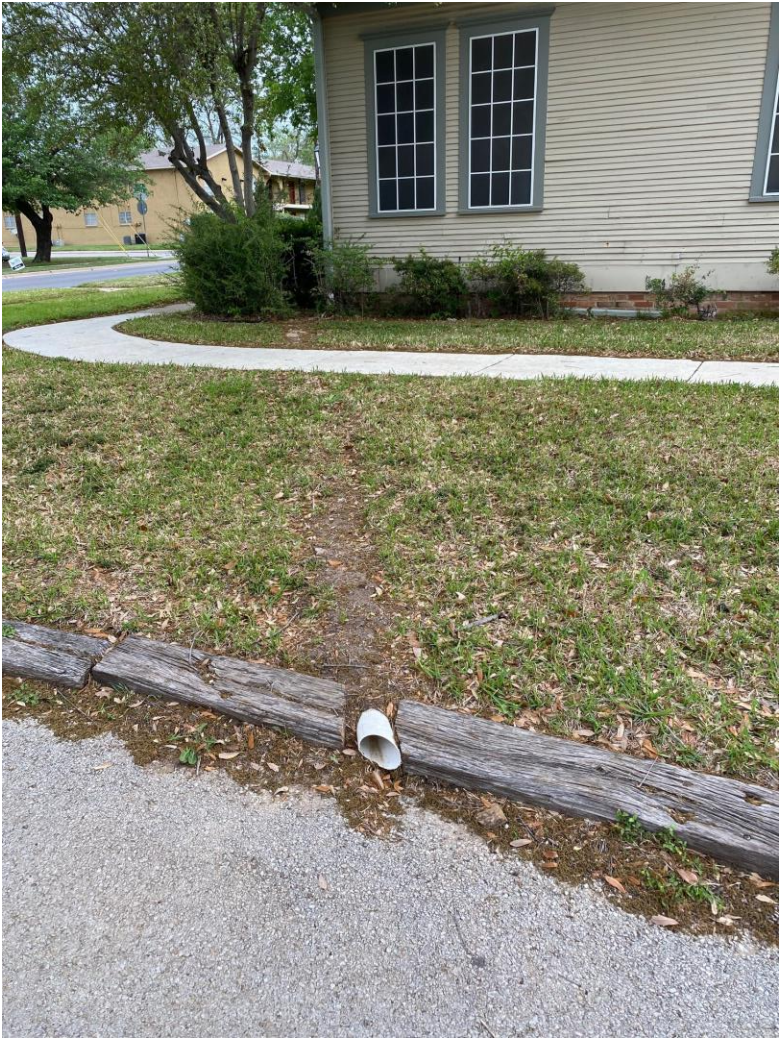
New Water Pumps & Drainage System

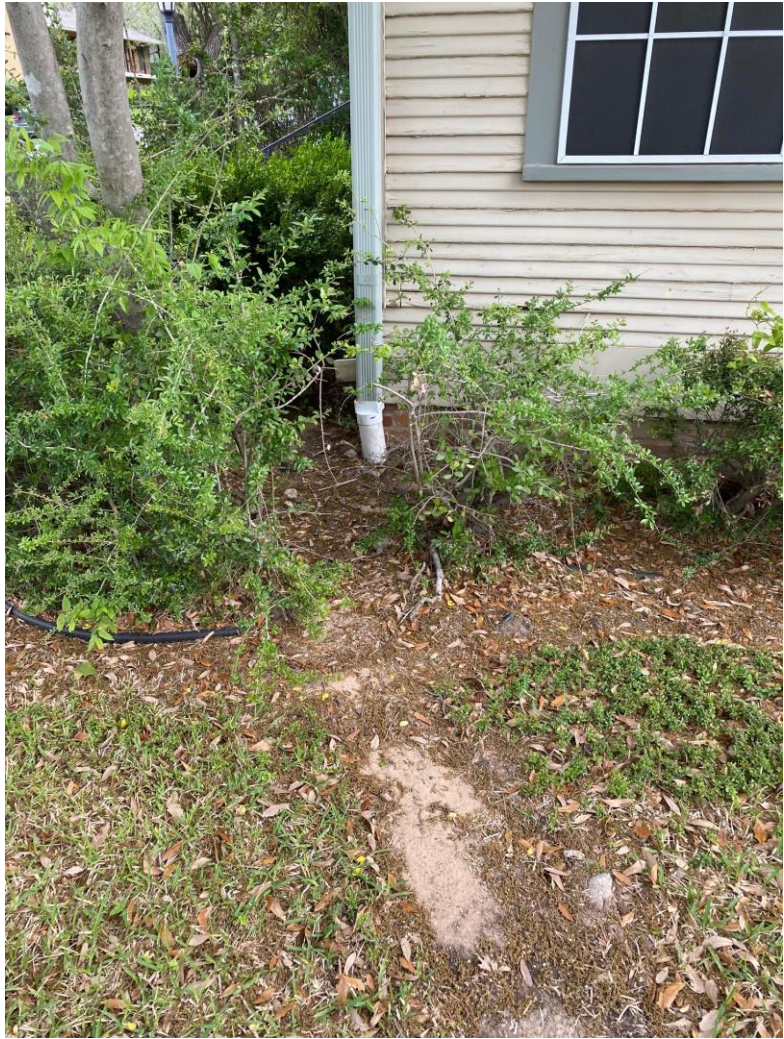
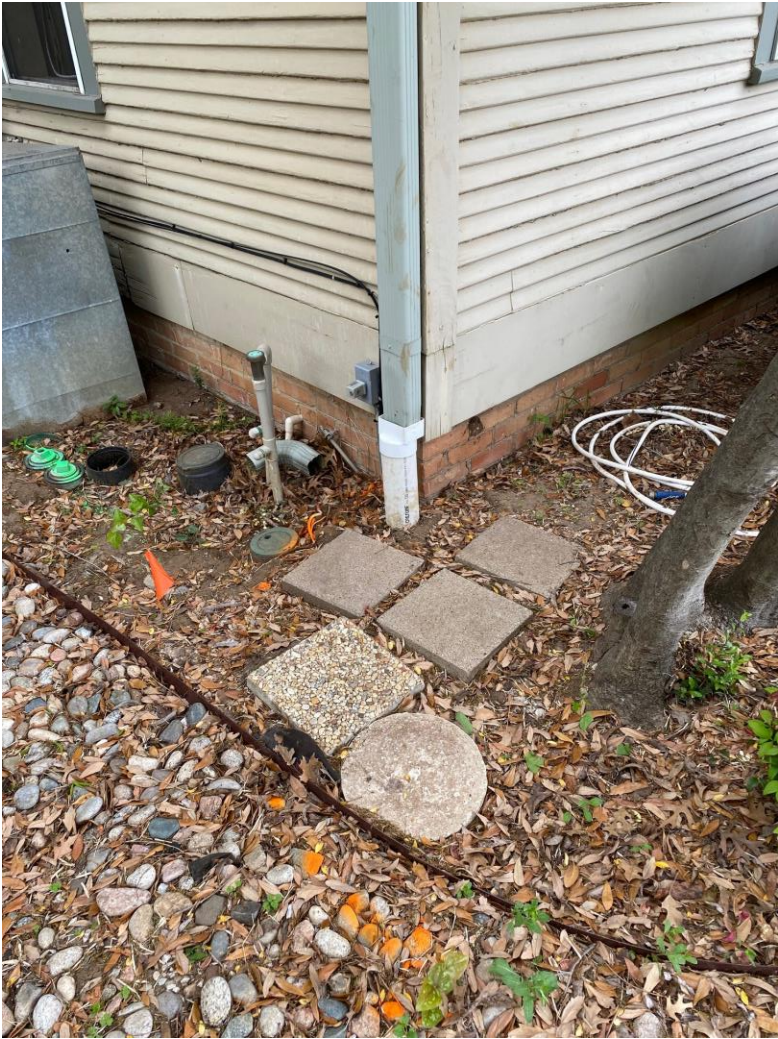
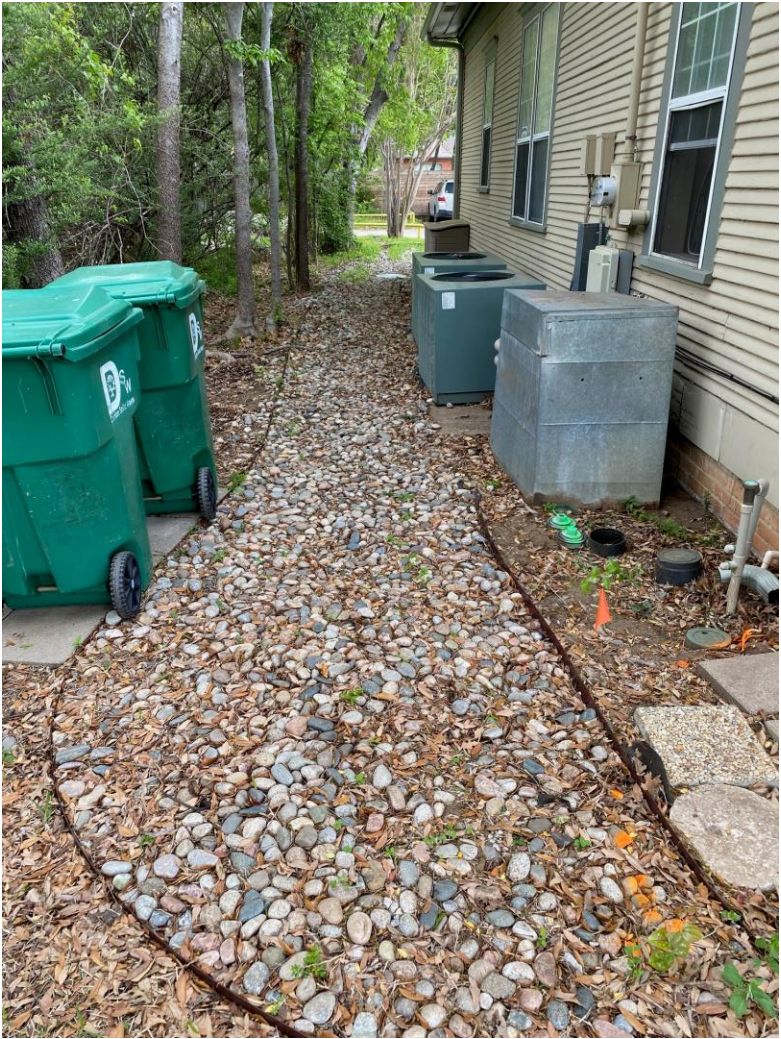
New Drainage System
