# Inspection Report

## Vertical Turbine Pump

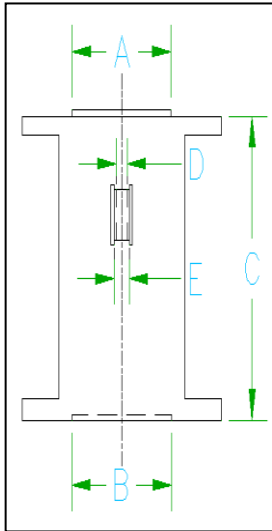
Column Pipes

Number of Columns: \_\_\_\_\_

Which is Elbow?: \_\_\_\_\_

Gaskets? YES NO

Gasket Thickness: \_\_\_\_\_

(Column 1 = Top, 2 = 2nd from Top, Etc.)

| <u>Column</u> | <u>Top Fit (A)</u> | <u>Bottom Fit (B)</u> | <u>Length (C)</u> | <u>Spider ID (E)</u> |

Condition of Columns (If any are damaged, indicate which ones): \_\_\_\_\_
